Congleton Town Council

Town Hall, Assets & Services Committee – 16th September 2021

9. Roof Repairs Drone Survey (Enclosed)

COMMITTEE:	Town Hall, Assets and Services		
MEETING DATE AND TIME	16th September 2021	LOCATION	Congleton Town Hall
REPORT FROM	Town Hall Manager – Mark Worthington		
AGENDA ITEM REPORT TITLE	9 Roof Repairs Drone Survey (i)		
Background	<p>A Town Hall Maintenance Plan has been developed to highlight and categorise maintenance works required around the Town Hall and other assets. Using the Maintenance Plan, it was agreed at the Town Hall Working Group on 1st July 2020 that the areas most in need of attention were the roofs at various locations around the Town Hall where water ingress is an obvious issue, and painting to the woodwork on the front elevation of the Town Hall. Due to the cost of erecting scaffolding to access areas of the roof, it was agreed that a more cost-effective method would be to arrange an aerial drone survey of the Town Hall and Museum.</p>		
Update	<p>Three specialist companies were contacted to provide quotes to carry out an aerial drone survey and associated report into the condition of the Town Hall roofs. Quotes ranged from £750 to

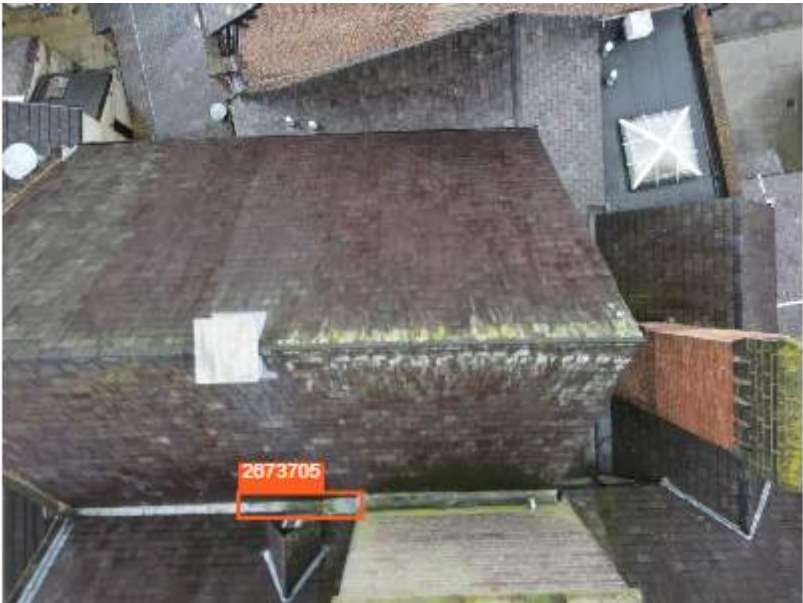
2673705 Severity: 3 Loose Object

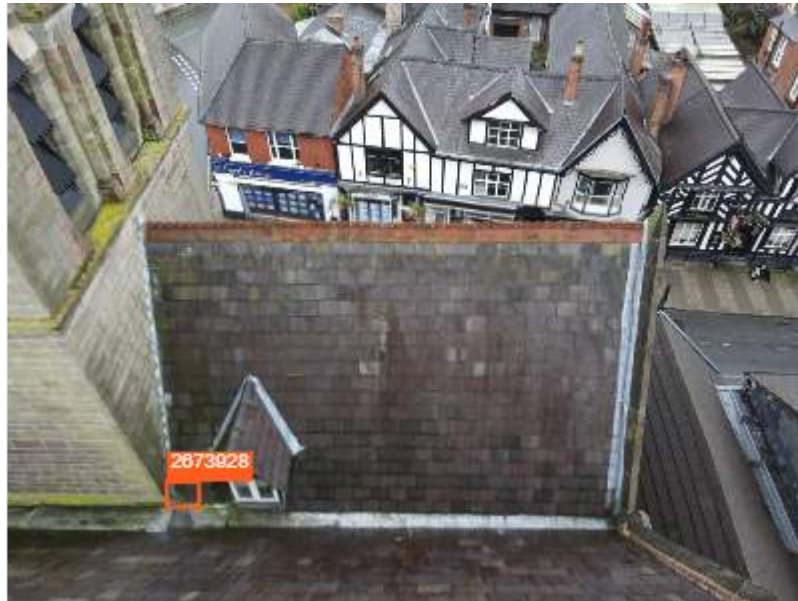
2673928 Severity: 3 Damaged Slate

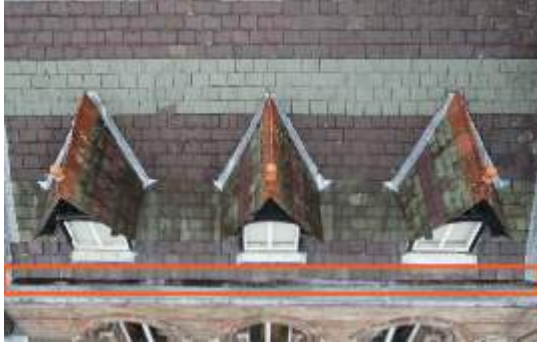
2674206 Severity: 3 Minor Debris in Gutter

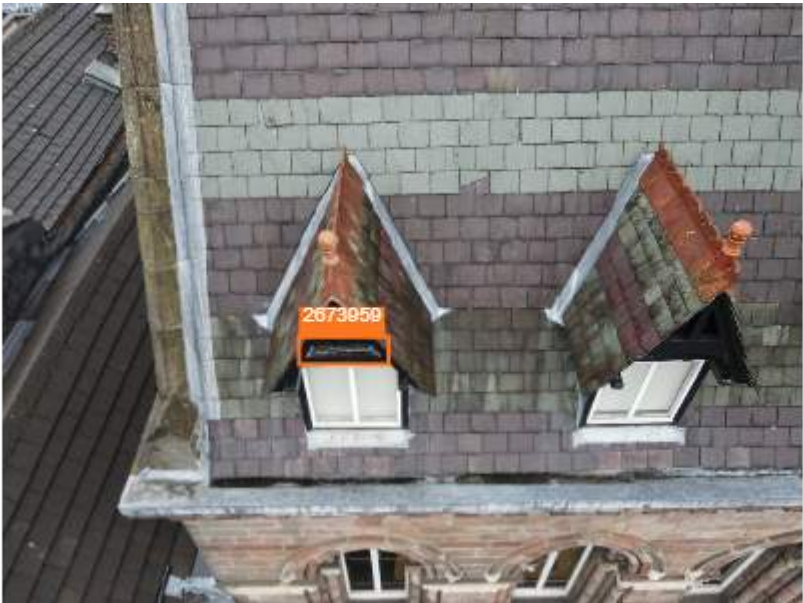
2673959 Severity: 2 Paint Coat Failed

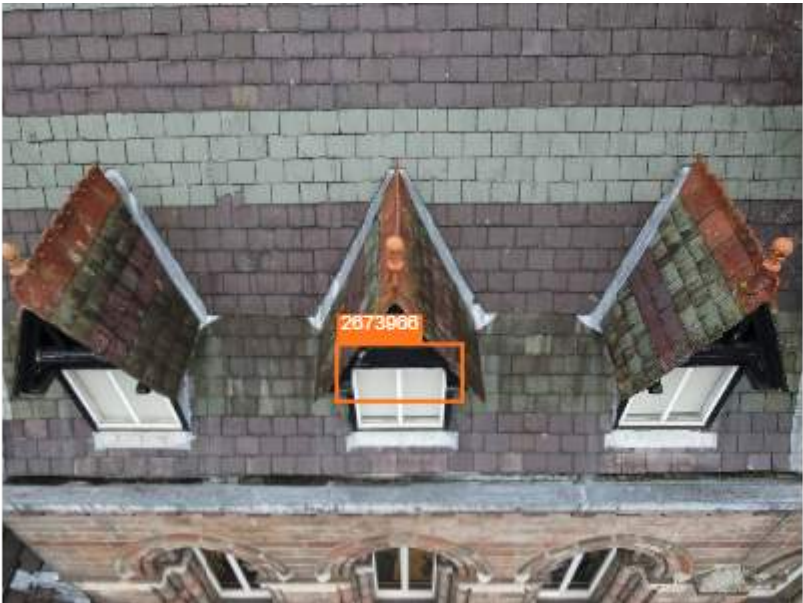
2673966 Severity: 2 Paint Coat Failed

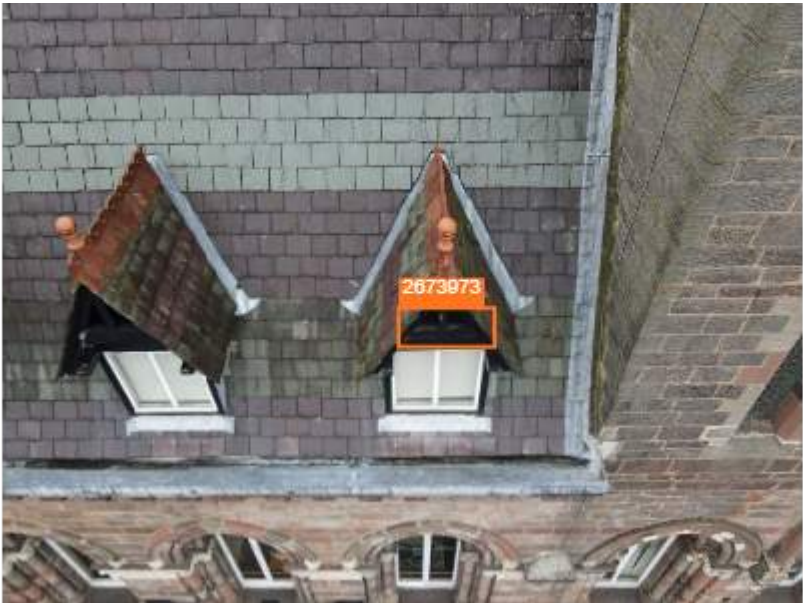
2673973 Severity: 2 Paint Coat Failed

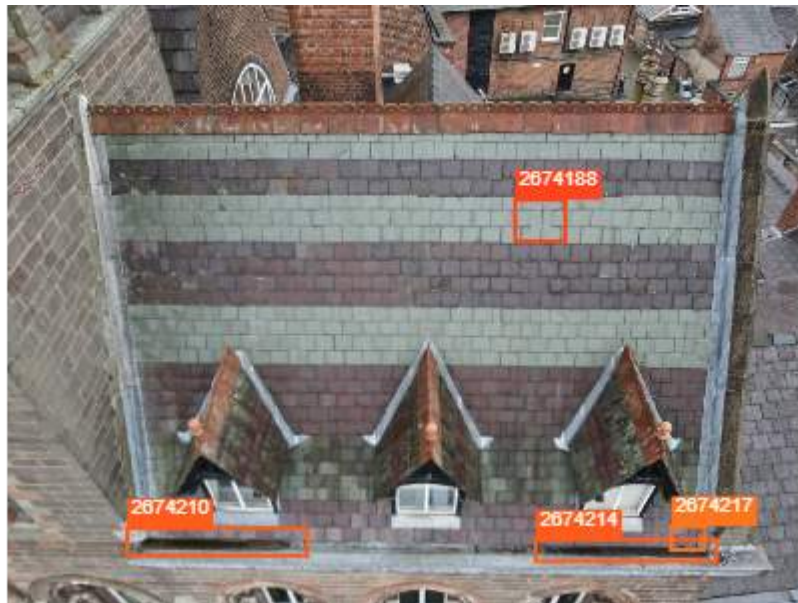
2674188 Severity: 4 Missing Slate

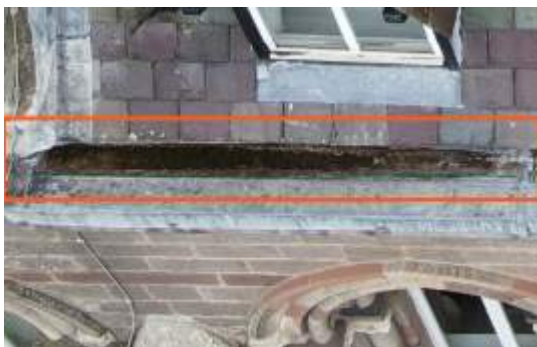
2674210 Severity: 3 Minor Debris in Gutter

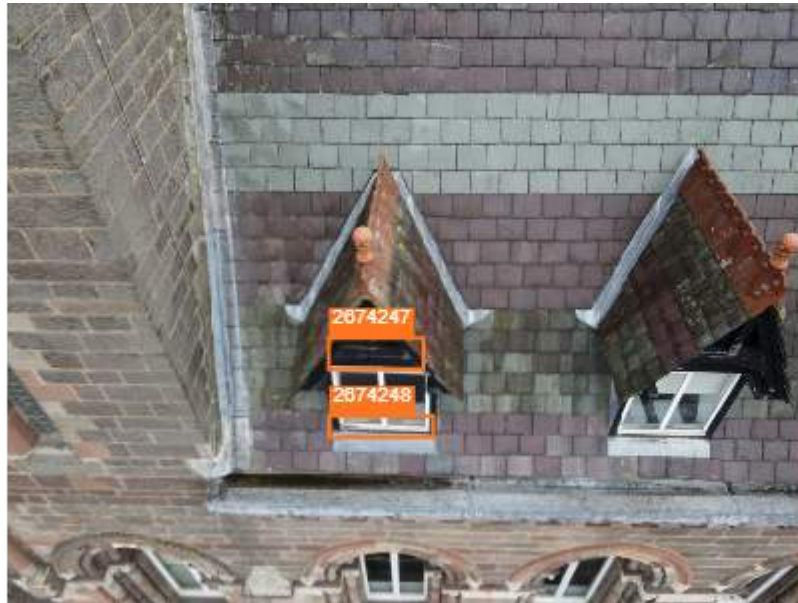
2674247 Severity: 2 Paint Coat Failed

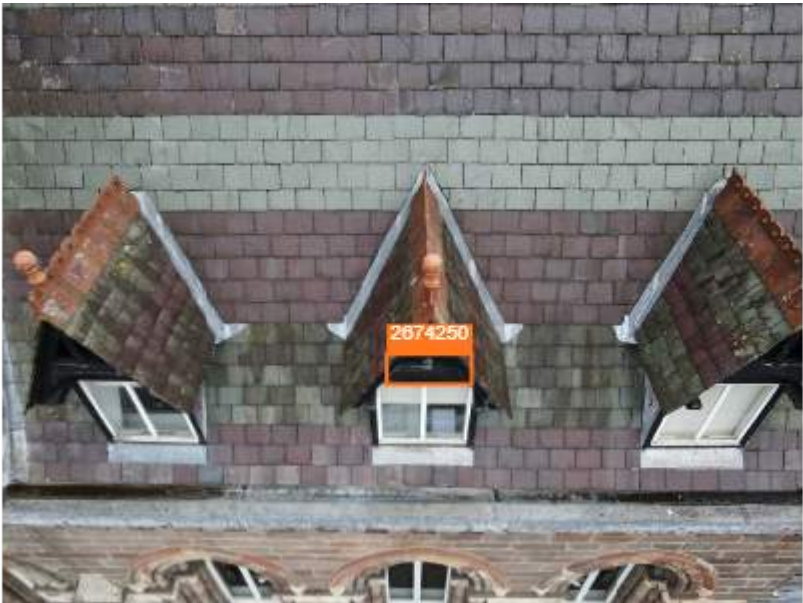
2674250 Severity: 2 Paint Coat Failed

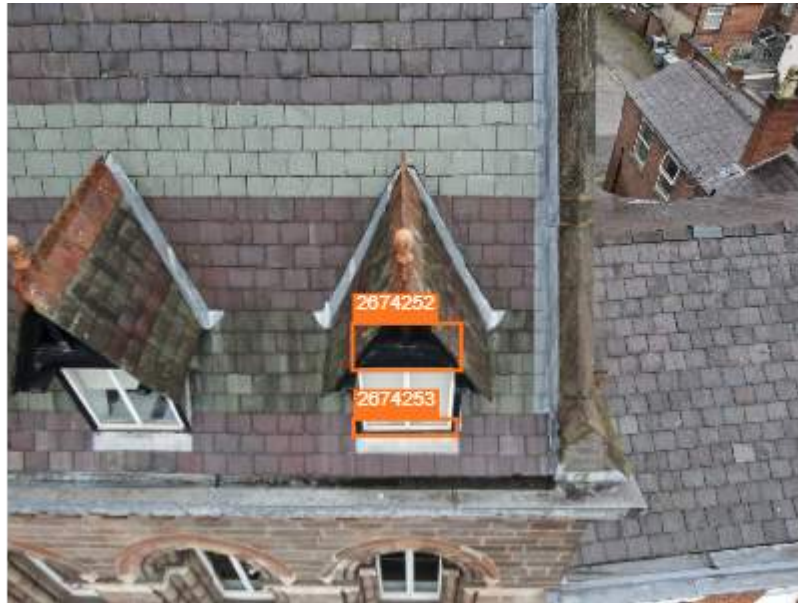
2674252 Severity: 2 Paint Coat Failed

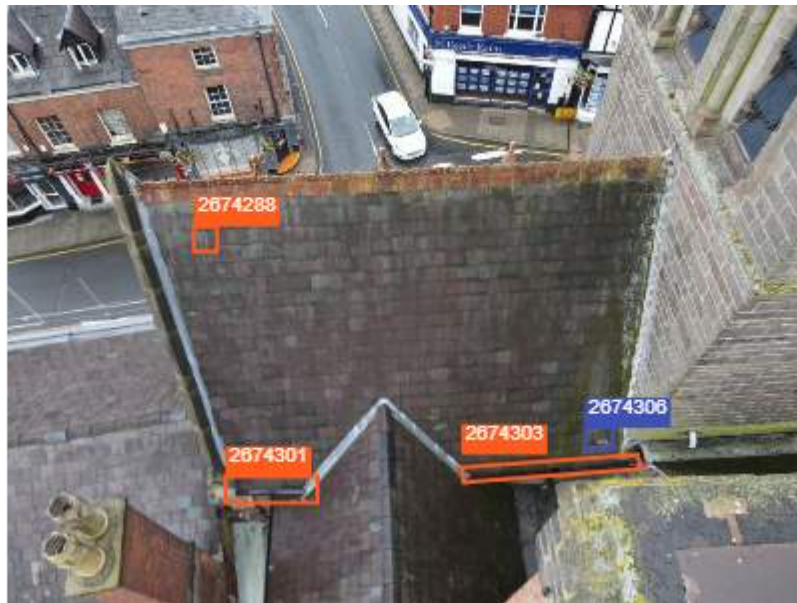
2674288 Severity: 3 Damaged Slate

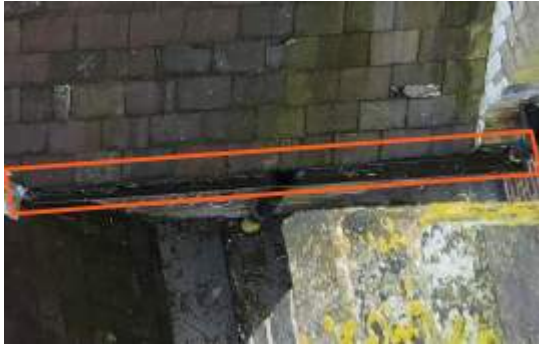
2674303 Severity: 3 Minor Debris in Gutter

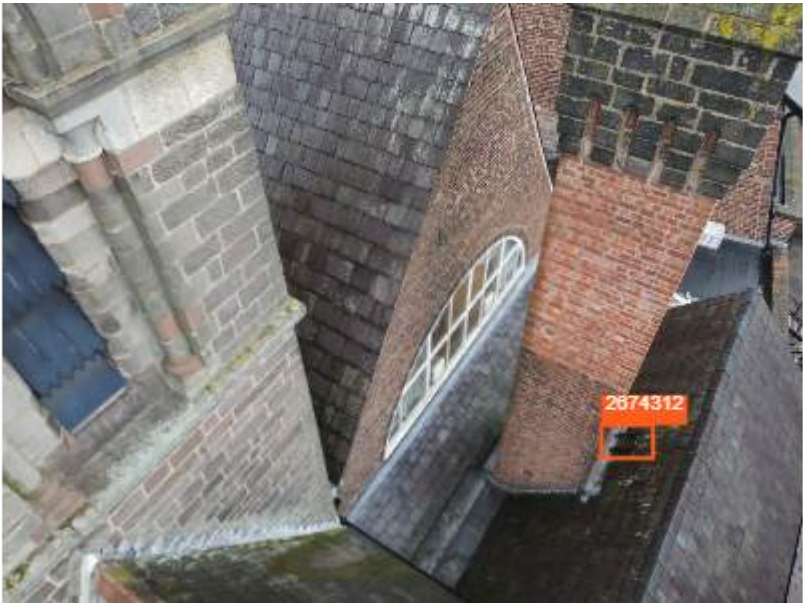
2674312 Severity: 3 Loose Object

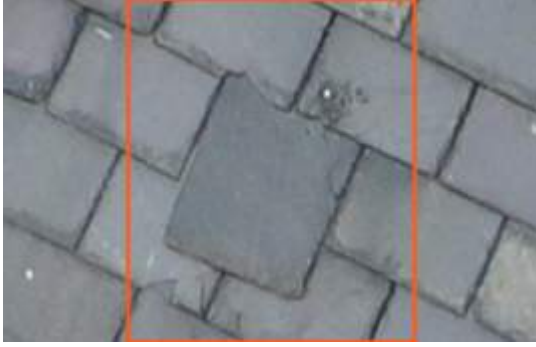
2674632 Severity: 3 Slipped Slate

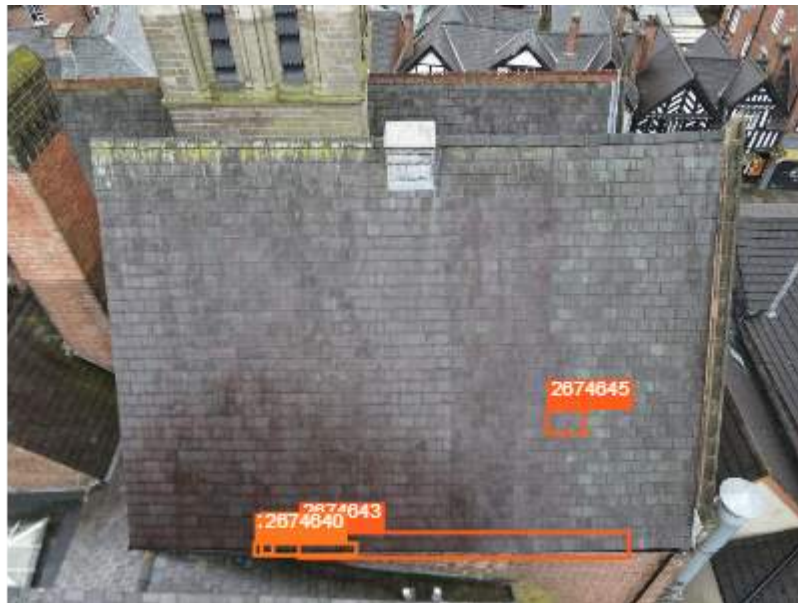
2674640 Severity: 2 Damaged Slate

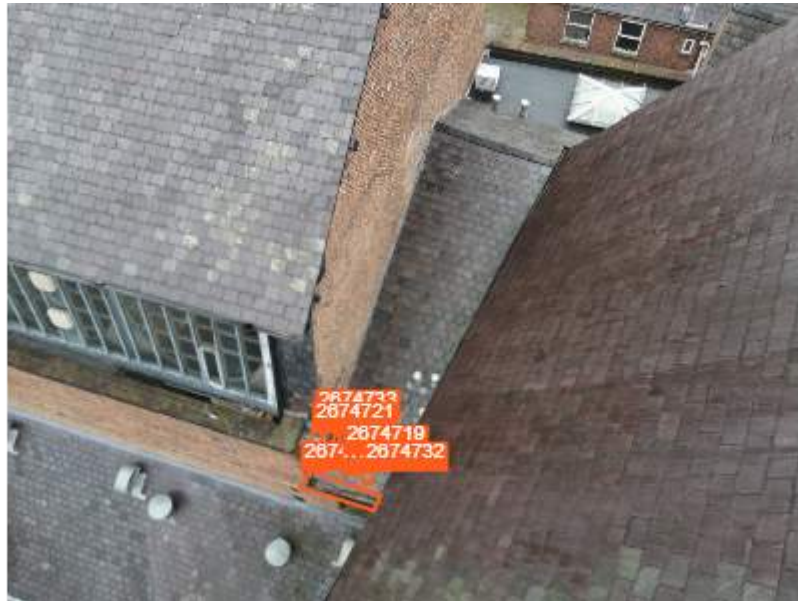
2674719 Severity: 3 Damaged Slate

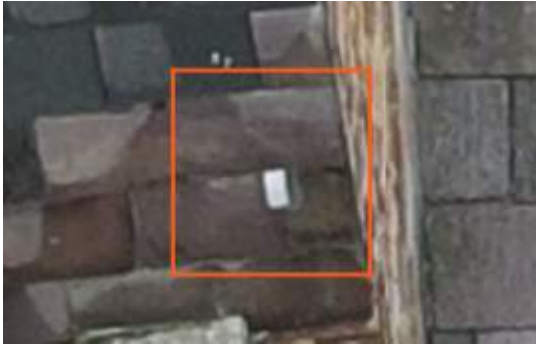
2674737 Severity: 3 Slate

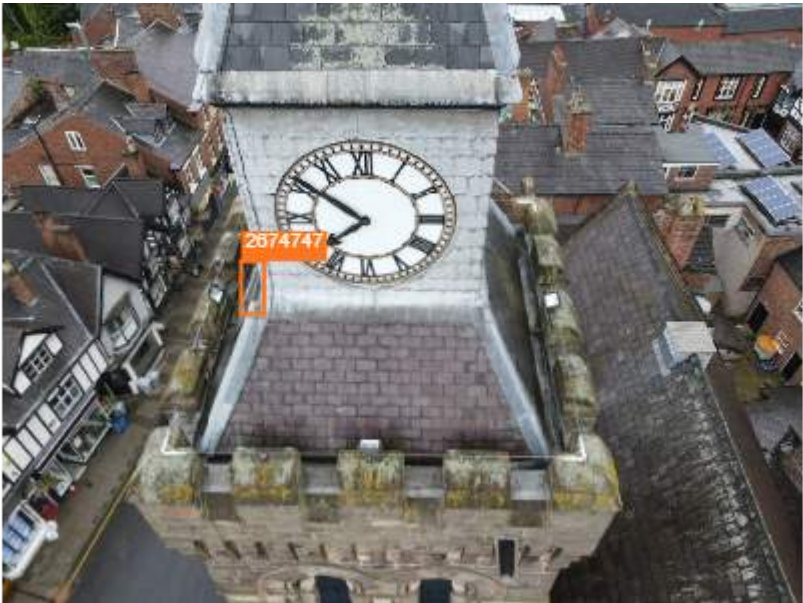
2674747 Severity: 2 Minor Timber Decay

Neil Poynor
Access hatch cover requires attention

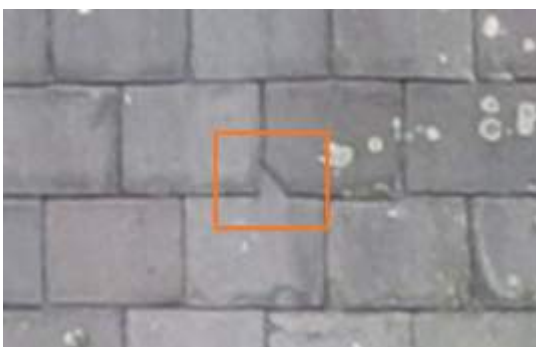
2674765 Severity: 2 Damaged Slate

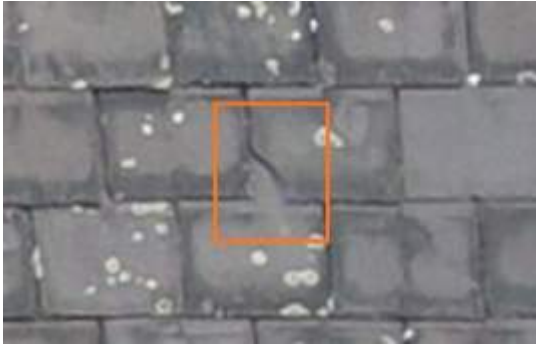
2674764 Severity: 2 Damaged Slate

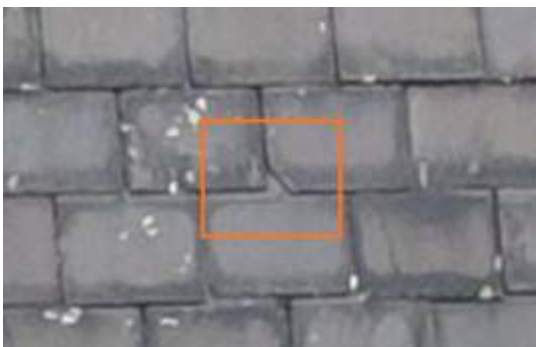
2674768 Severity: 2 Damaged Slate

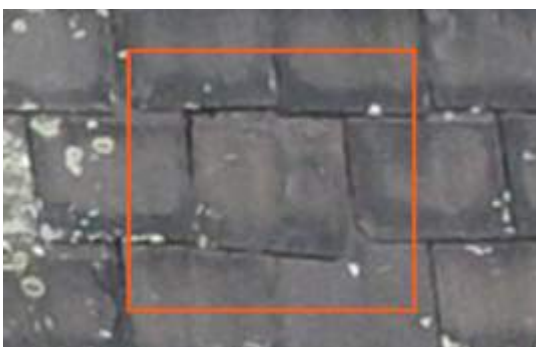
2674769 Severity: 3 Slipped Slate

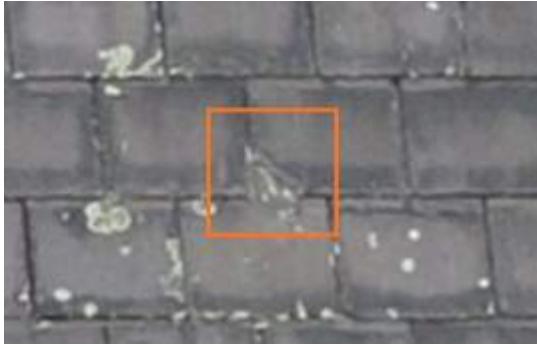
2674770 Severity: 2 Damaged Slate

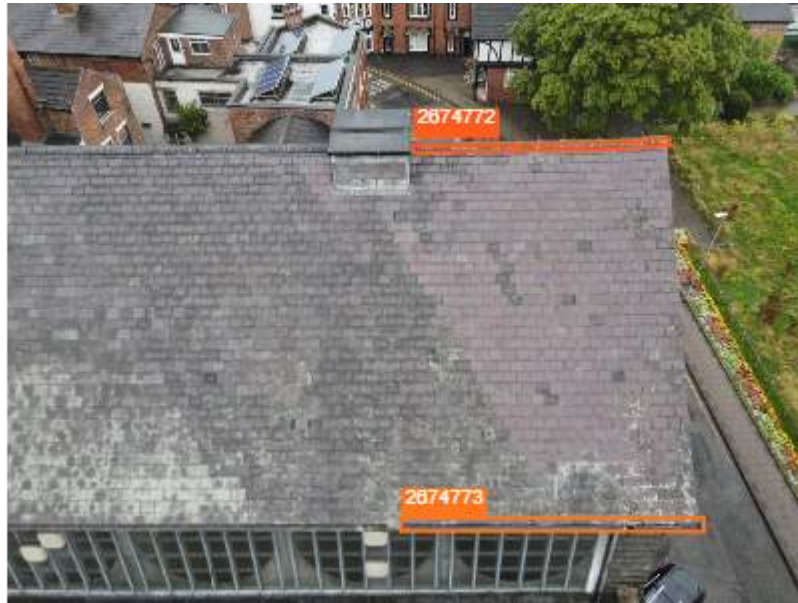
2674772 Severity: 3 Missing Mortar to Ridge

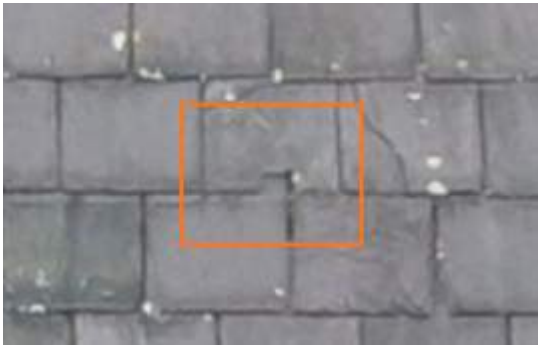
2674782 Severity: 2 Damaged Slate

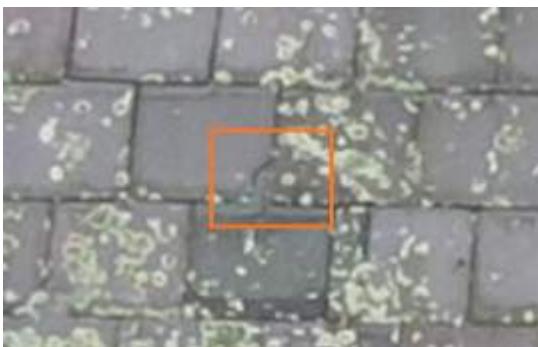
2674783 Severity: 2 Damaged Slate

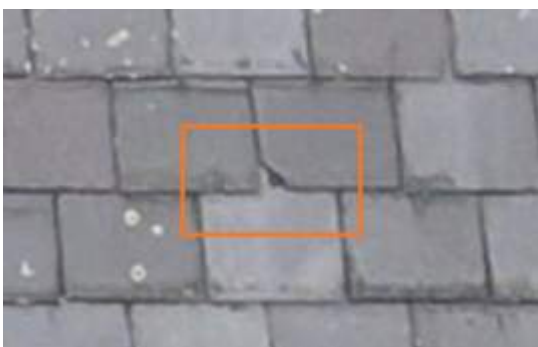
2674784 Severity: 2 Damaged Slate

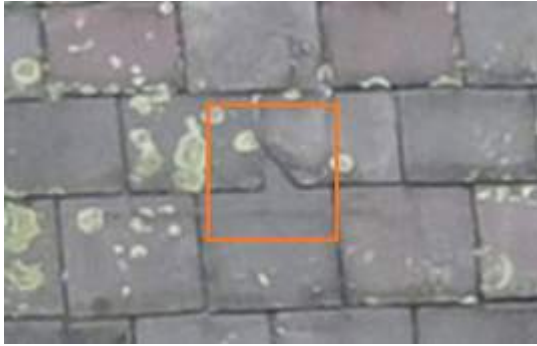
2674789 Severity: 2 Damaged Slate

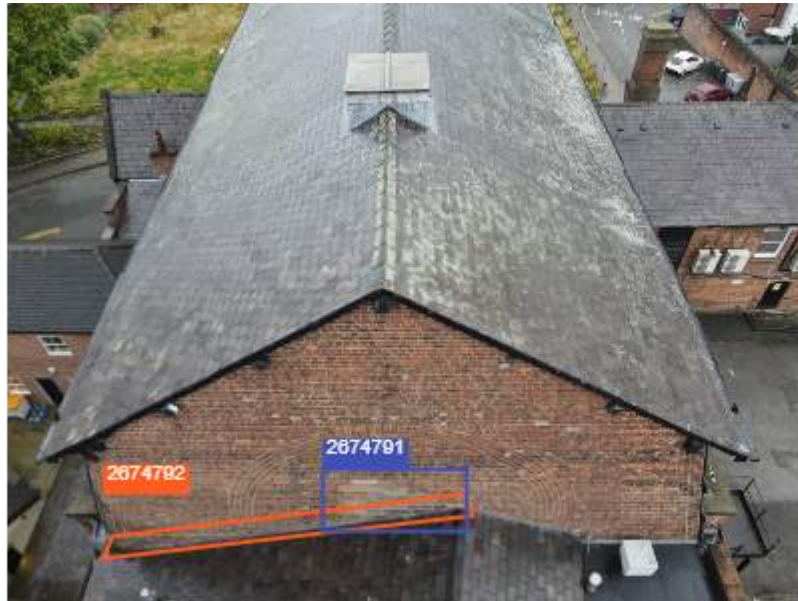
2674791 Severity: 0 Historic Repair

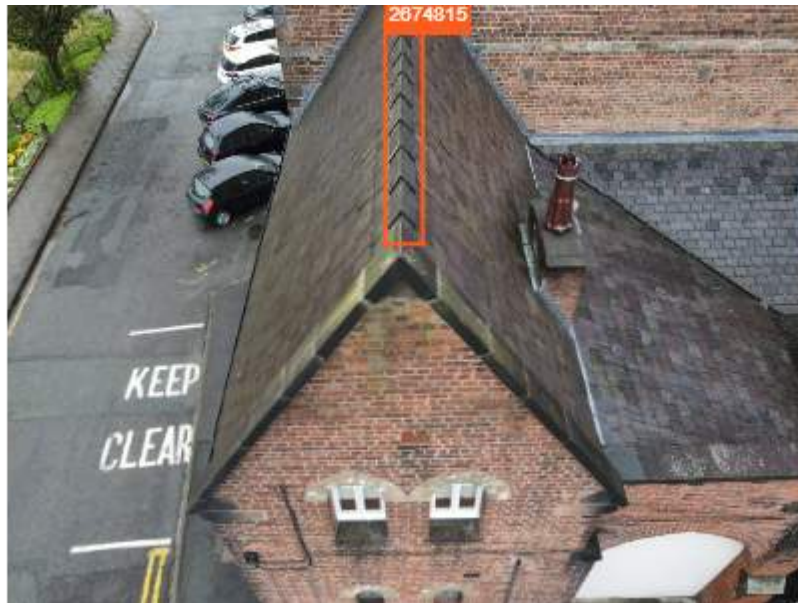
2674815 Severity: 3 Missing Mortar to Ridge

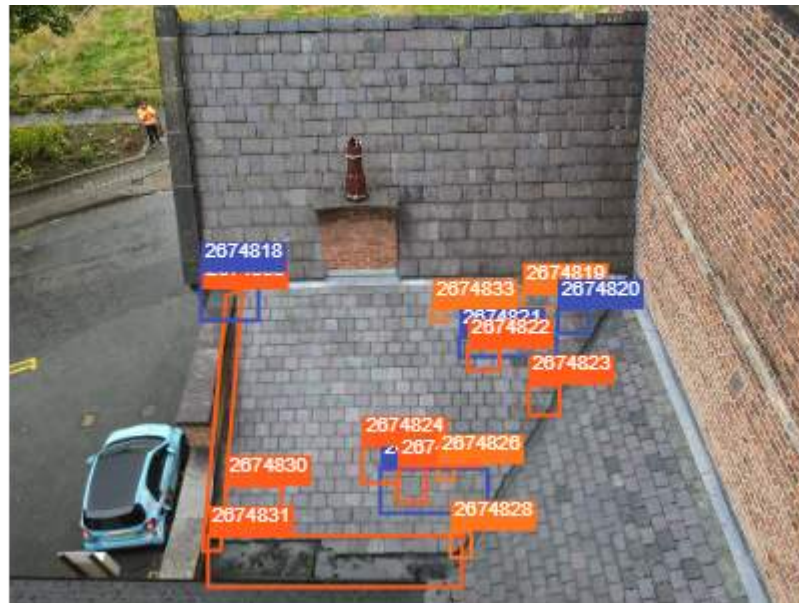
2674818 Severity: 0 Historic Repair

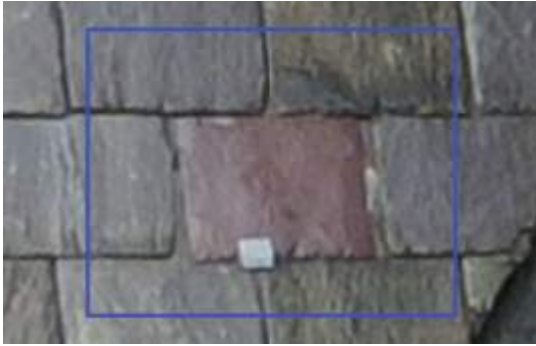
2674820 Severity: 0 Historic Repair

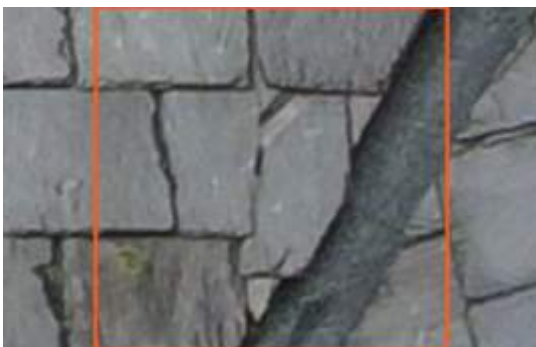
2674823 Severity: 3 Damaged Slate

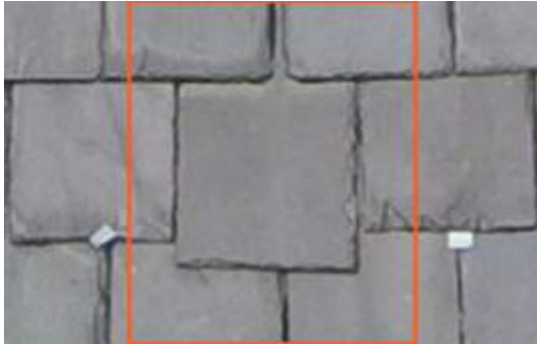
2674825 Severity: 3 Slipped Slate

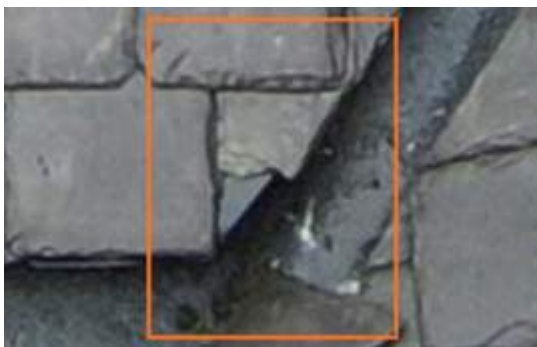
2674828 Severity: 2 Damaged Slate

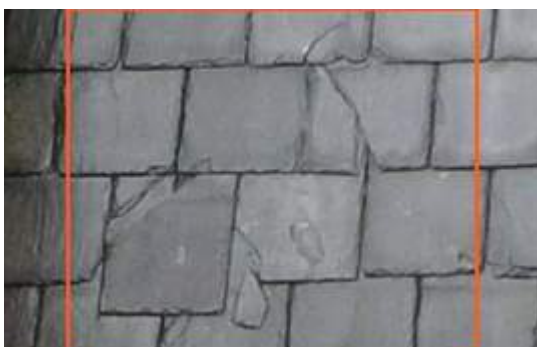
2674830 Severity: 3 Damaged Slate

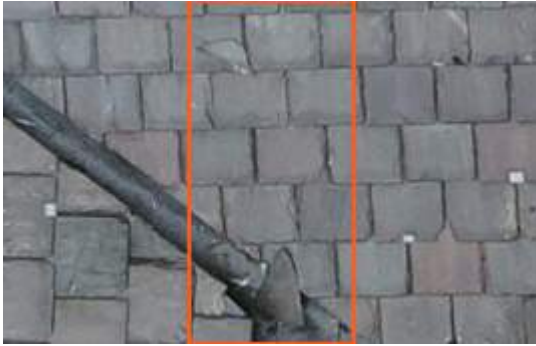
2674843 Severity: 3 Loose Object

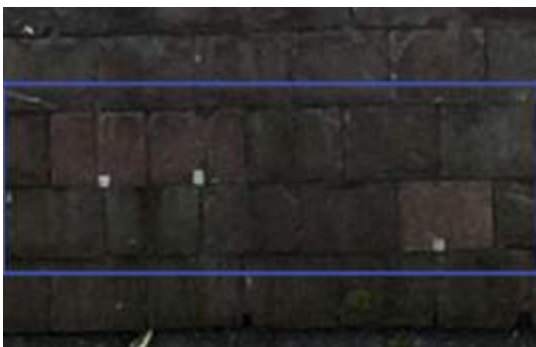
2675478 Severity: 0 Historic Repair

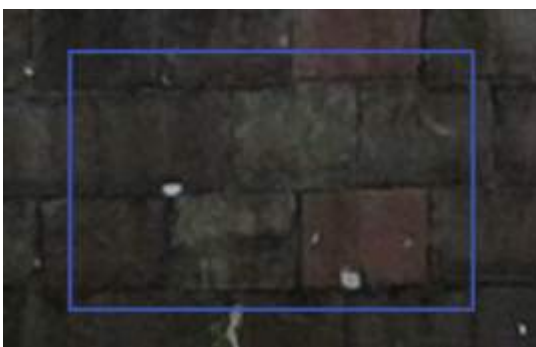
2675479 Severity: 0 Historic Repair

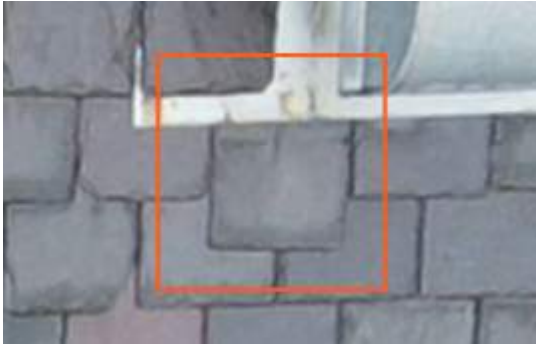
2675480 Severity: 3 Slipped Slate

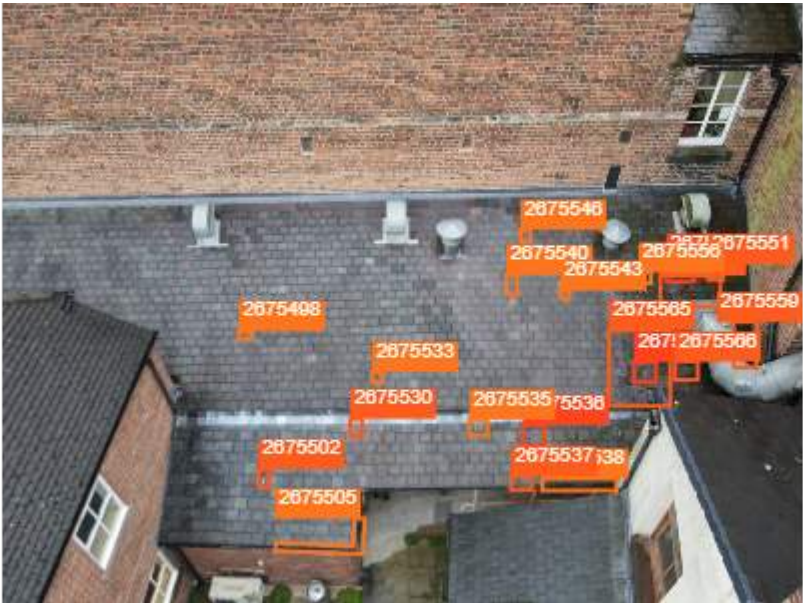
2675498 Severity: 2 Damaged Slate

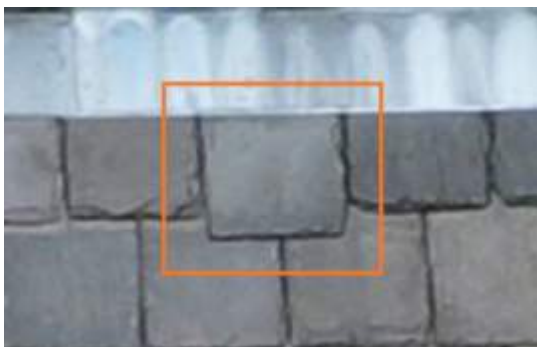
2675535 Severity: 2 Slipped Slate

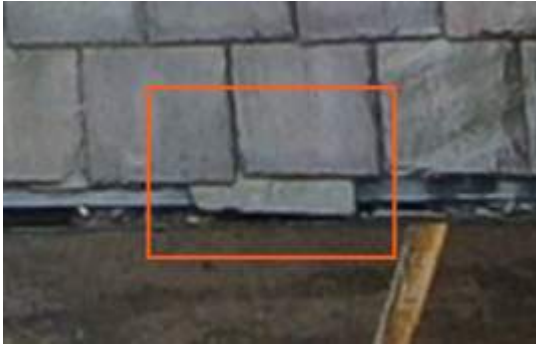
2675537 Severity: 3 Slipped Slate

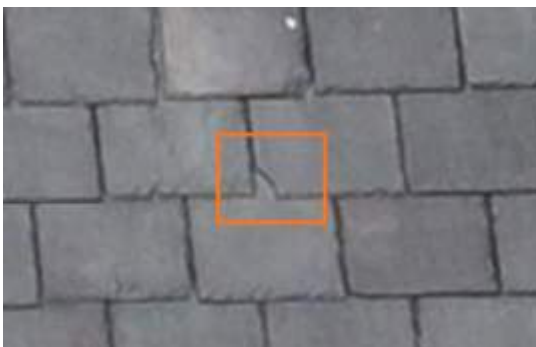
2675543 Severity: 2 Damaged Slate

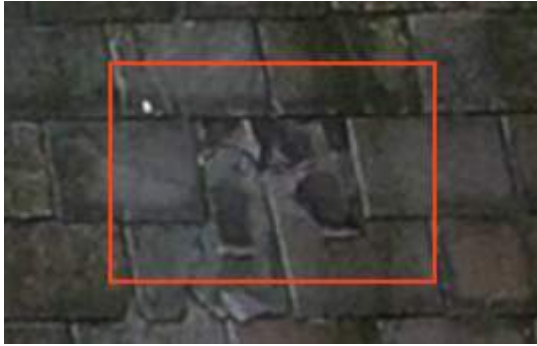
2675550 Severity: 4 Damaged Slate

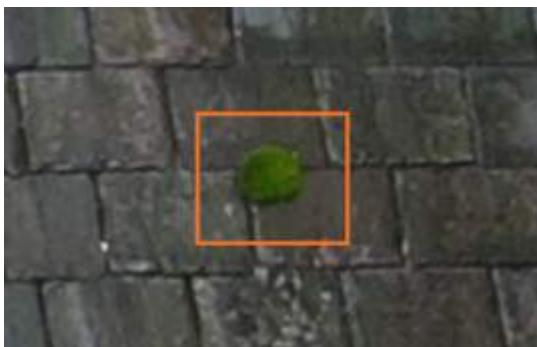
2675556 Severity: 2 Moss Growth

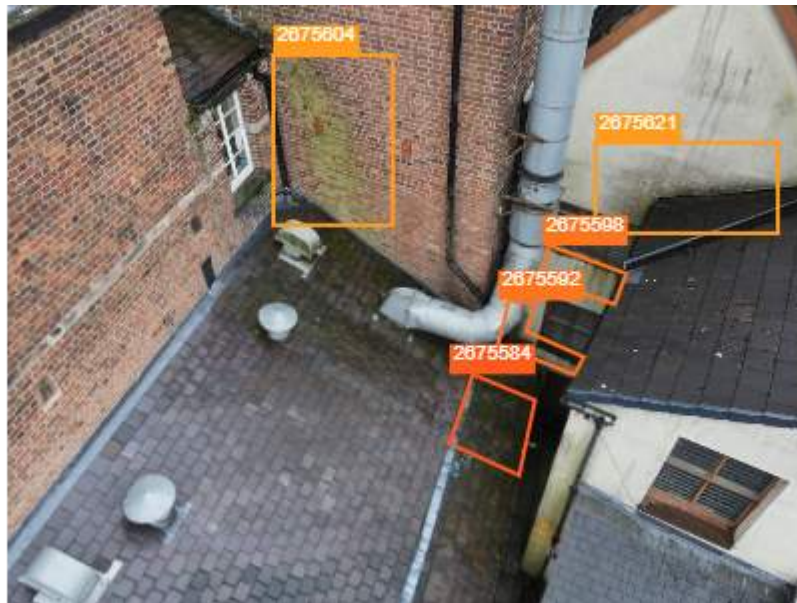
2675584 Severity: 3 Damaged Slate

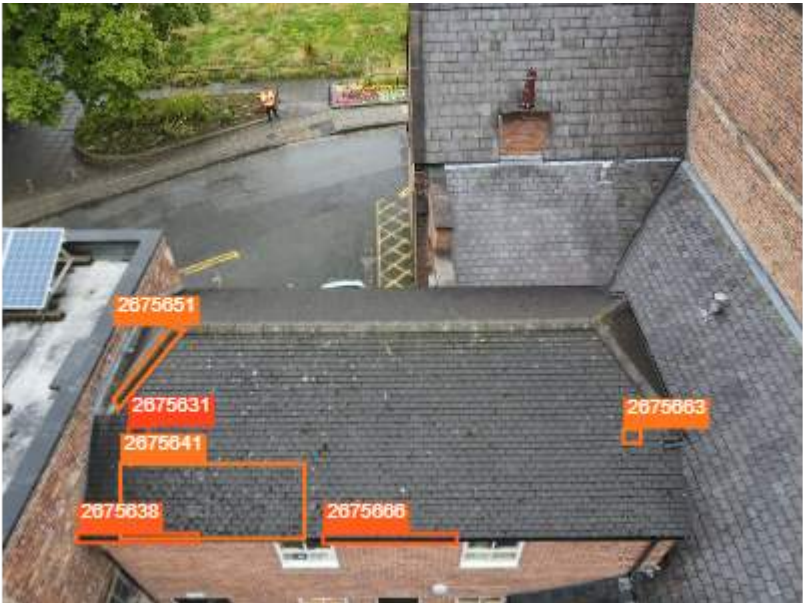
2675631 Severity: 4 Damaged Tile

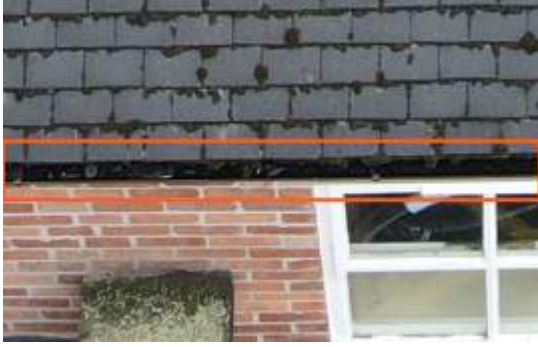
2675681 Severity: 3 Minor Debris in Gutter

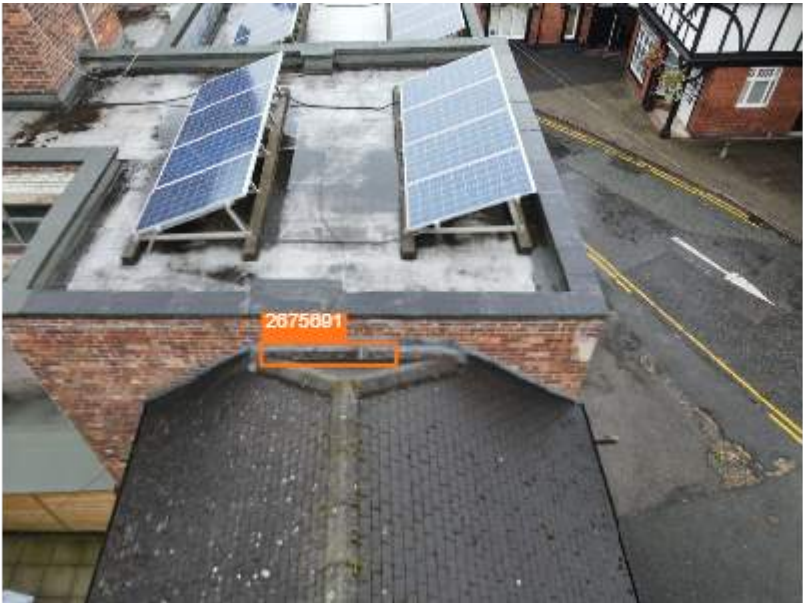
2675691 Severity: 2 Loose Object

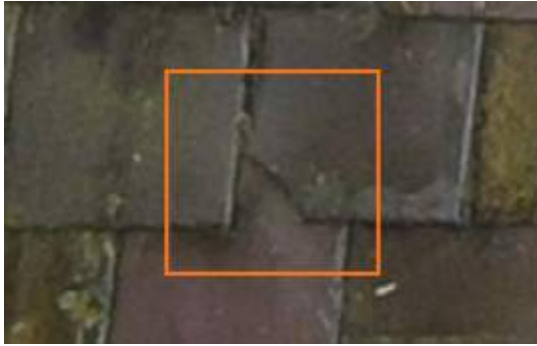
2675714 Severity: 2 Damaged Slate

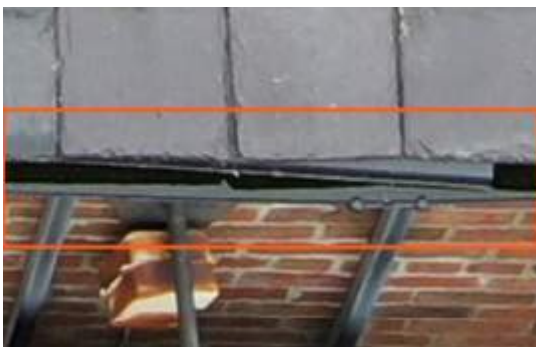
2675749 Severity: 3 Loose Object

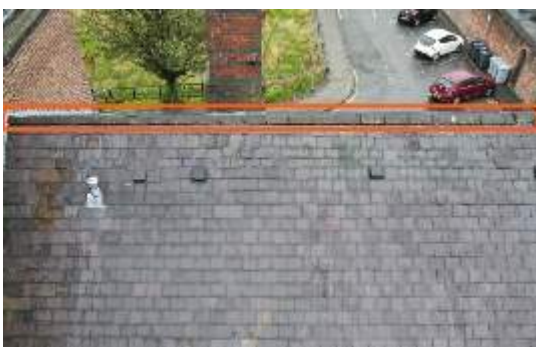
2675760 Severity: 3 Missing Mortar to Ridge

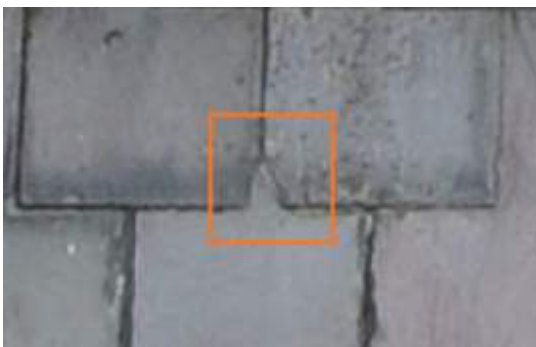
2675771 Severity: 2 Damaged Slate

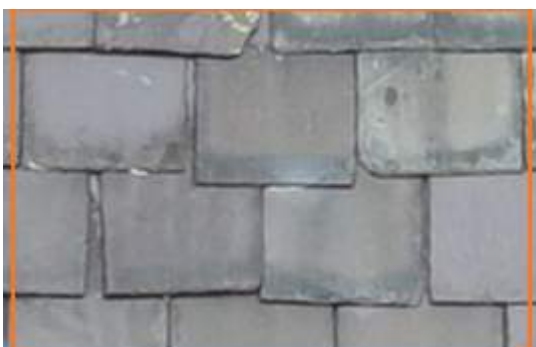
2675776 Severity: 2 Misaligned Slate

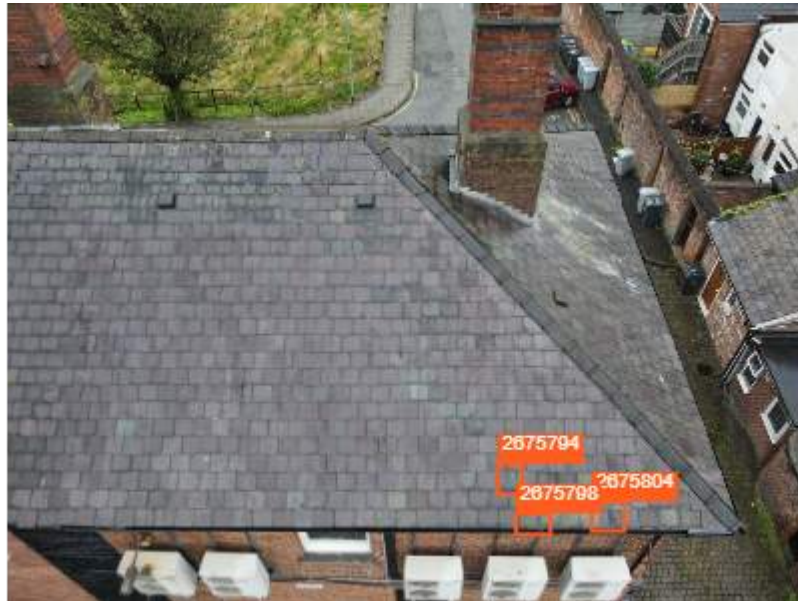
2675794 Severity: 3 Damaged Slate

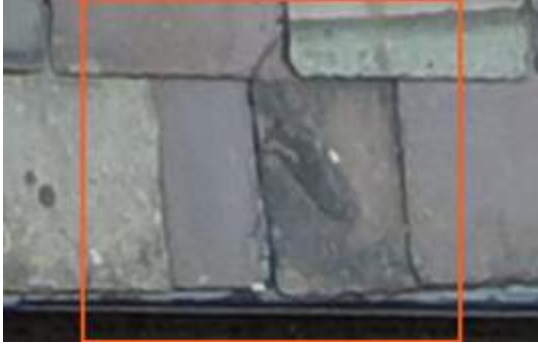
2675804 Severity: 3 Damaged Slate

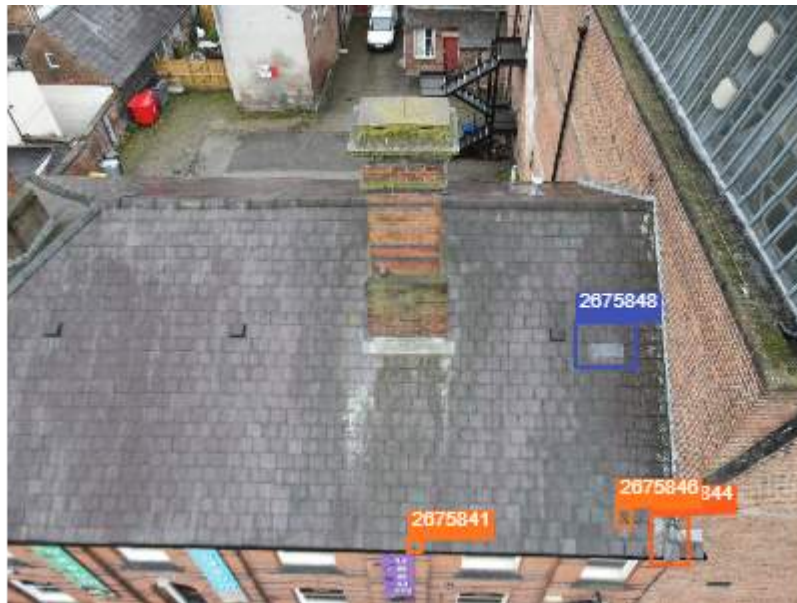
2675841 Severity: 2 Damaged Slate

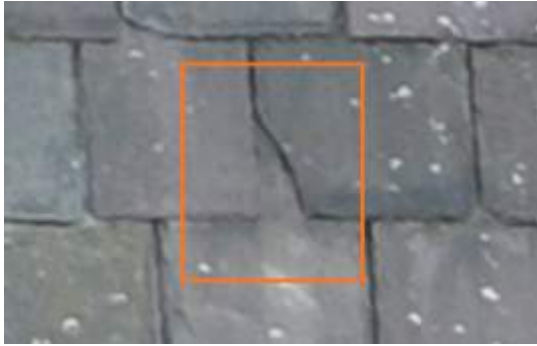
2675846 Severity: 2 Damaged Slate

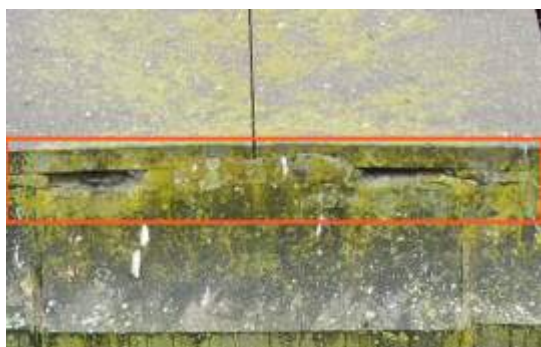
2675859 Severity: 3 Missing Mortar

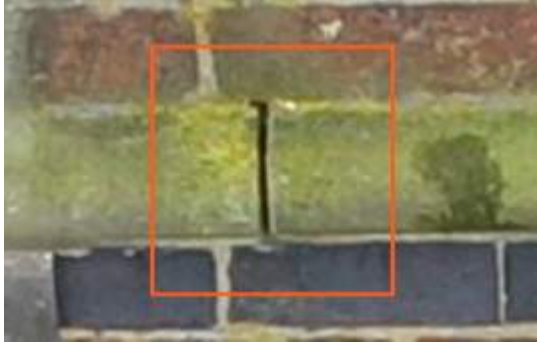
2675863 Severity: 3 Missing Mortar

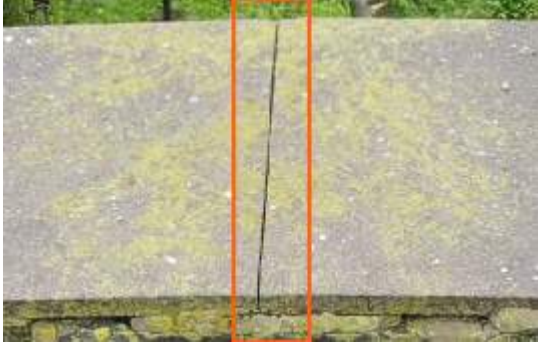
2675879 Severity: 3 Missing Mortar

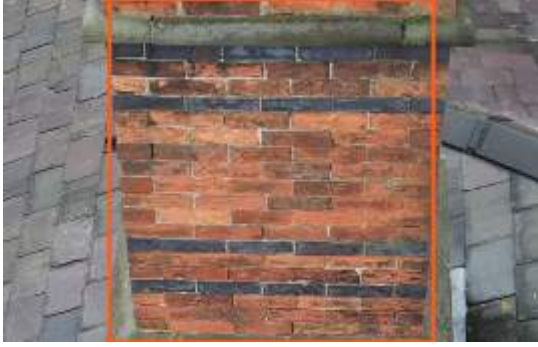
2675892 Severity: 3 Missing Mortar

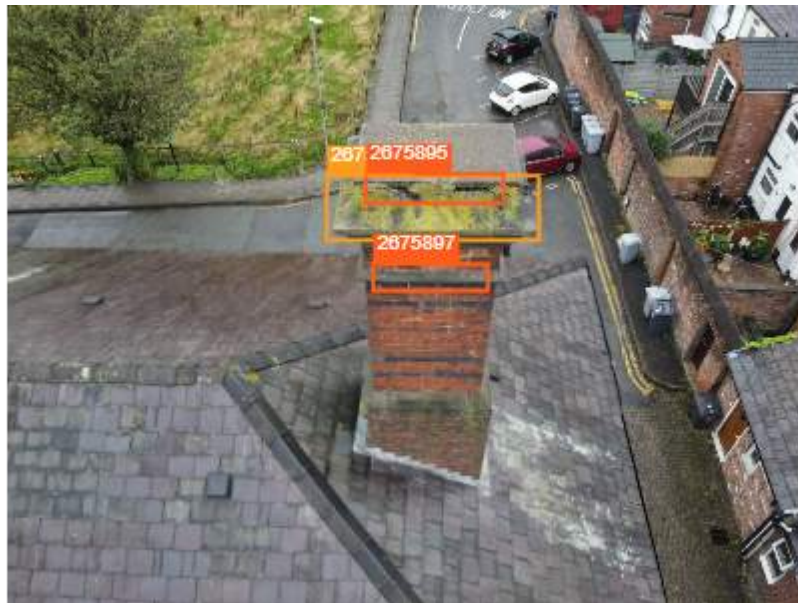
2675895 Severity: 3 Missing Mortar

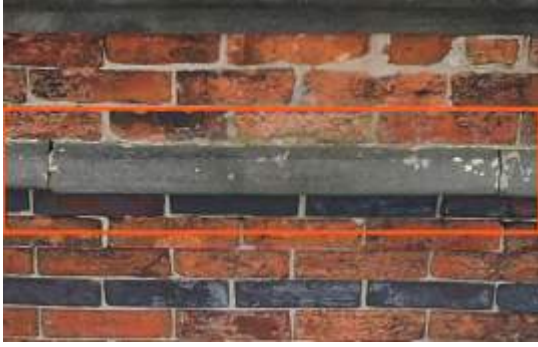
2675897 Severity: 3 Missing Mortar

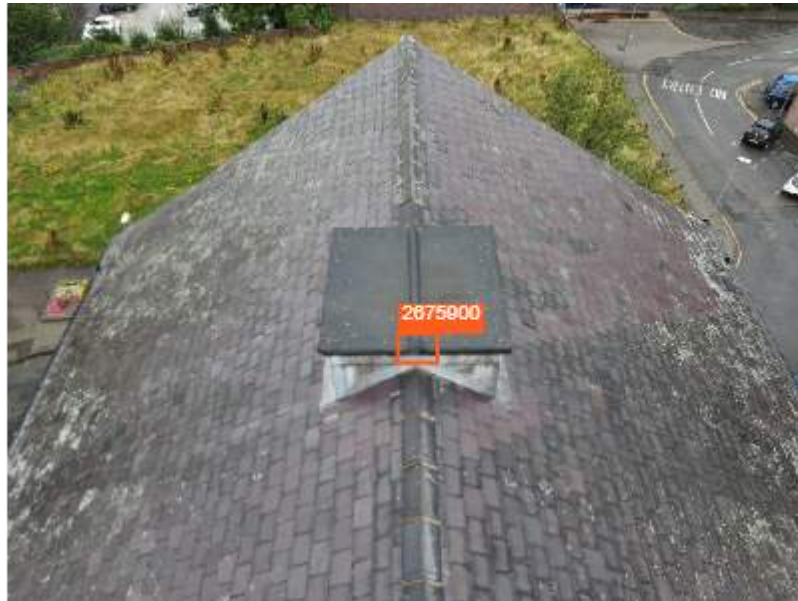
2675900 Severity: 3 Felt Defect
