Congleton Town Council

Town Hall, Assets & Services Committee – 16th September 2021

9. Roof Repairs Drone Survey (Enclosed)

COMMITTEE:	Town Hall, Assets and Services		
MEETING DATE AND TIME	16th September 2021	LOCATION	Congleton Town Hall
REPORT FROM	Town Hall Manager – Mark Worthington		
AGENDA ITEM REPORT TITLE	9 Roof Repairs Drone Survey (i)		
Background	<p>A Town Hall Maintenance Plan has been developed to highlight and categorise maintenance works required around the Town Hall and other assets. Using the Maintenance Plan, it was agreed at the Town Hall Working Group on 1st July 2020 that the areas most in need of attention were the roofs at various locations around the Town Hall where water ingress is an obvious issue, and painting to the woodwork on the front elevation of the Town Hall. Due to the cost of erecting scaffolding to access areas of the roof, it was agreed that a more cost-effective method would be to arrange an aerial drone survey of the Town Hall and Museum.</p>		
Update	<p>Three specialist companies were contacted to provide quotes to carry out an aerial drone survey and associated report into the condition of the Town Hall roofs. Quotes ranged from £750 to

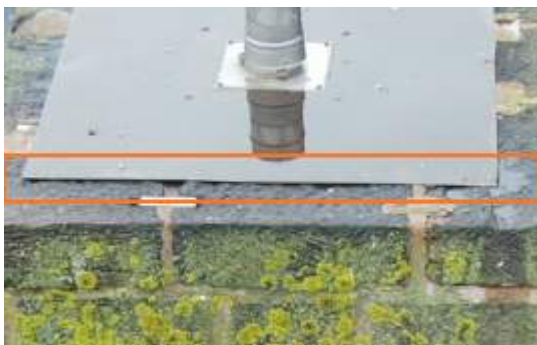
2674335 Severity: 2 Evidence of Standing Water
