Congleton Town Council

Town Hall, Assets & Services Committee – 16th September 2021

9. Roof Repairs Drone Survey (Enclosed)

COMMITTEE:	Town Hall, Assets and Services		
MEETING DATE AND TIME	16th September 2021	LOCATION	Congleton Town Hall
REPORT FROM	Town Hall Manager – Mark Worthington		
AGENDA ITEM REPORT TITLE	9 Roof Repairs Drone Survey (i)		
Background	<p>A Town Hall Maintenance Plan has been developed to highlight and categorise maintenance works required around the Town Hall and other assets. Using the Maintenance Plan, it was agreed at the Town Hall Working Group on 1st July 2020 that the areas most in need of attention were the roofs at various locations around the Town Hall where water ingress is an obvious issue, and painting to the woodwork on the front elevation of the Town Hall. Due to the cost of erecting scaffolding to access areas of the roof, it was agreed that a more cost-effective method would be to arrange an aerial drone survey of the Town Hall and Museum.</p>		
Update	<p>Three specialist companies were contacted to provide quotes to carry out an aerial drone survey and associated report into the condition of the Town Hall roofs. Quotes ranged from £750 to

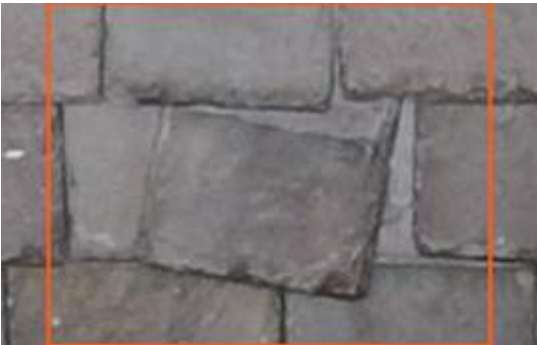
2673672 Severity: 3 Slipped Slate

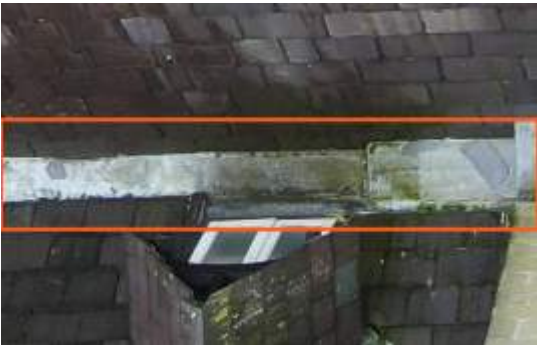
2673705 Severity: 3 Loose Object

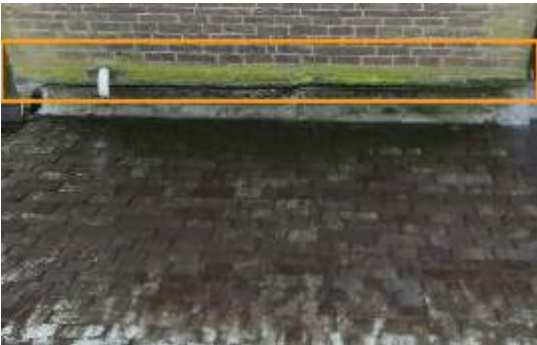
2673788 Severity: 1 Algae

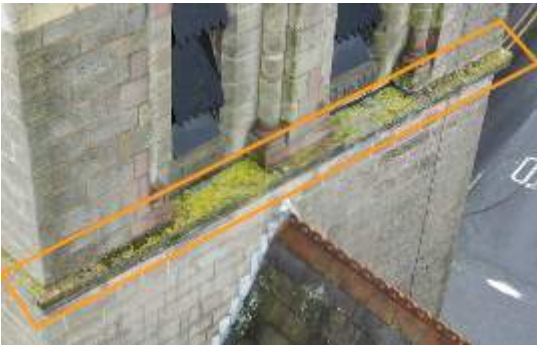
2673831 Severity: 1 Lichen Build Up

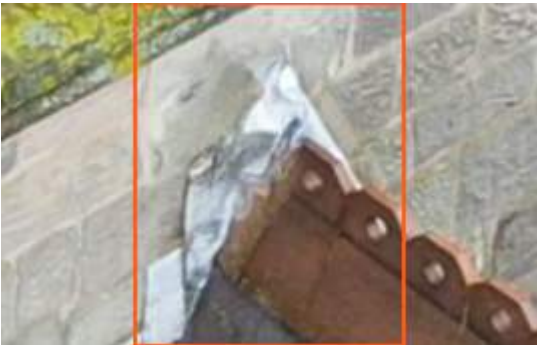
2674002 Severity: 3 Flashing

Neil Poynor
Ensure lead flashing is dressed properly and is watertight.

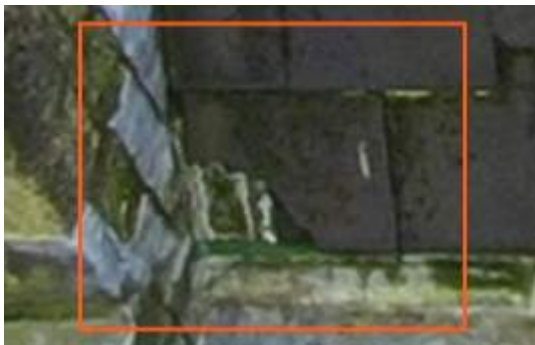
2673928 Severity: 3 Damaged Slate

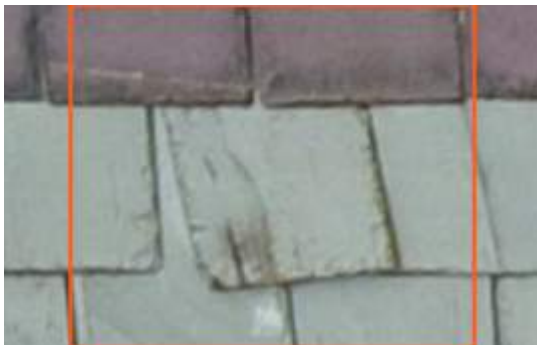
2673946 Severity: 3 Slipped Slate

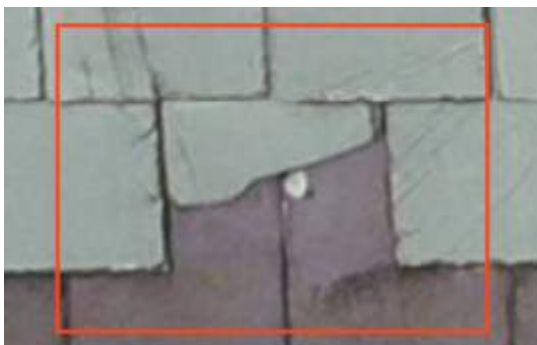
2673947 Severity: 4 Damaged Slate

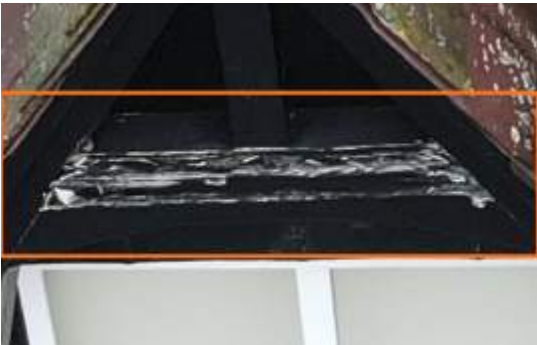
2673959 Severity: 2 Paint Coat Failed

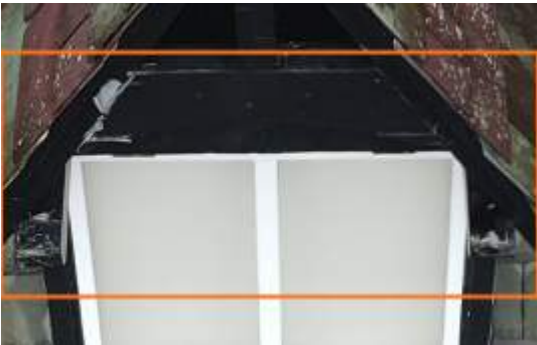
2673966 Severity: 2 Paint Coat Failed

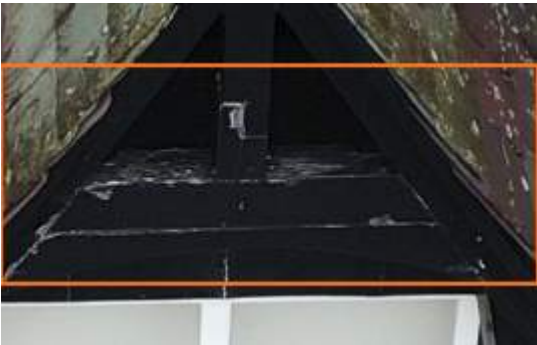
2673973 Severity: 2 Paint Coat Failed

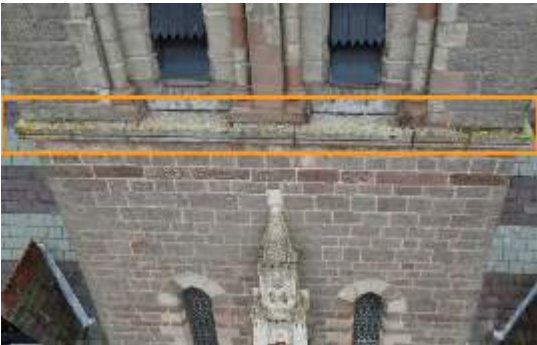
2673981 Severity: 1 Lichen Build Up

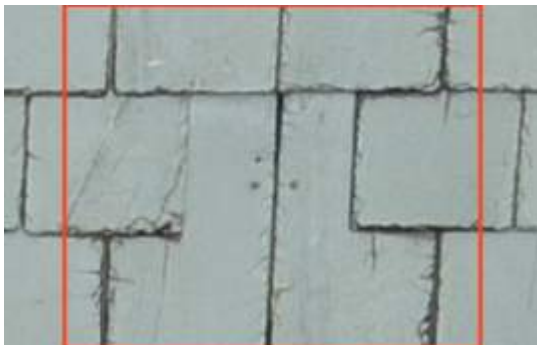
2674188 Severity: 4 Missing Slate

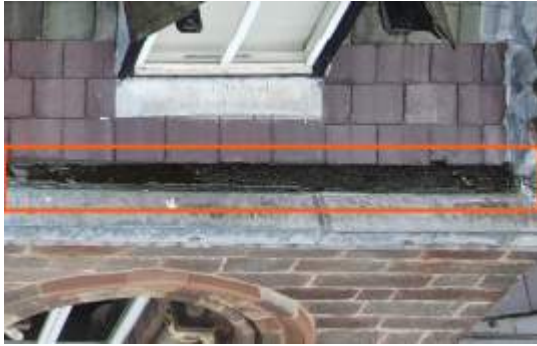
2674214 Severity: 3 Minor Debris in Gutter

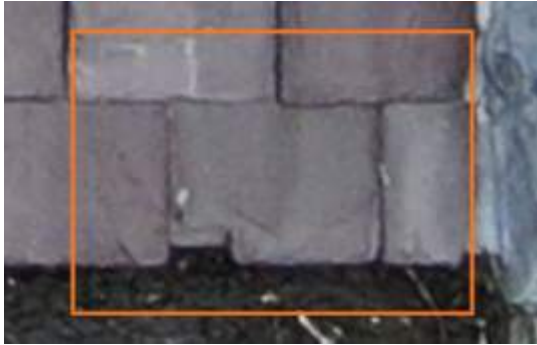
2674217 Severity: 2 Damaged Slate

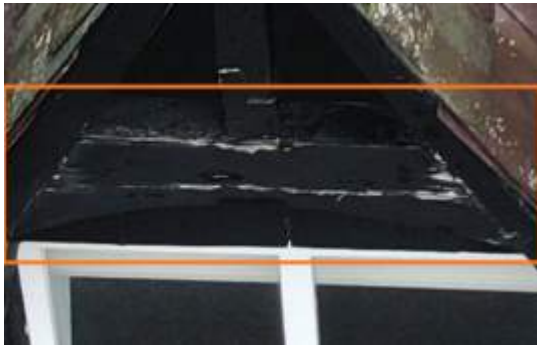
2674247 Severity: 2 Paint Coat Failed

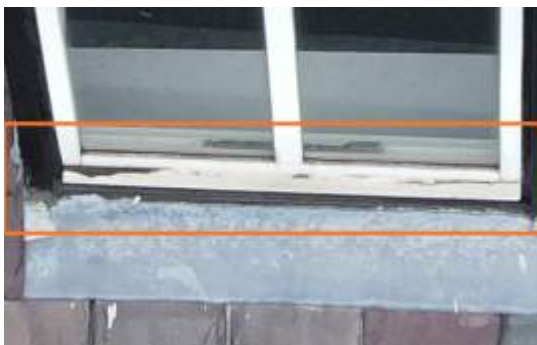
2674248 Severity: 2 Paint Coat Failed

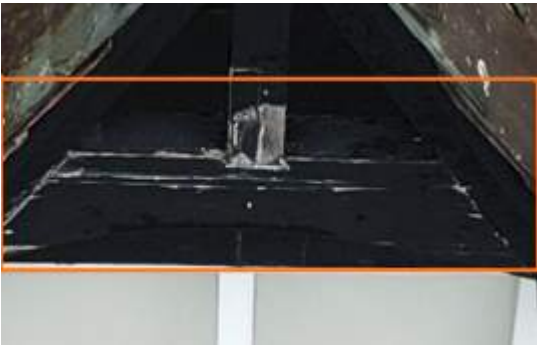
2674250 Severity: 2 Paint Coat Failed

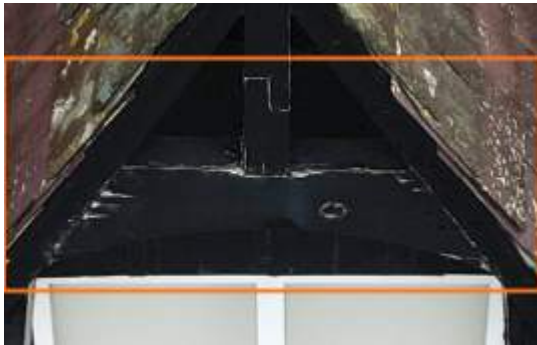
2674252 Severity: 2 Paint Coat Failed

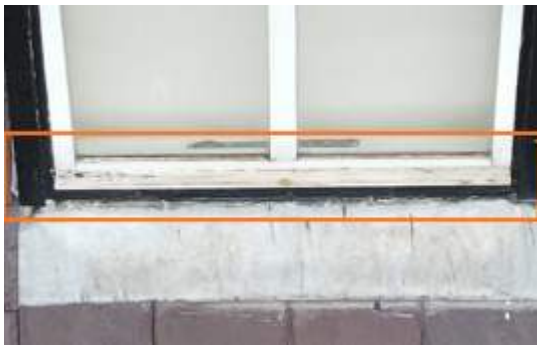
2674253 Severity: 2 Paint Coat Failed

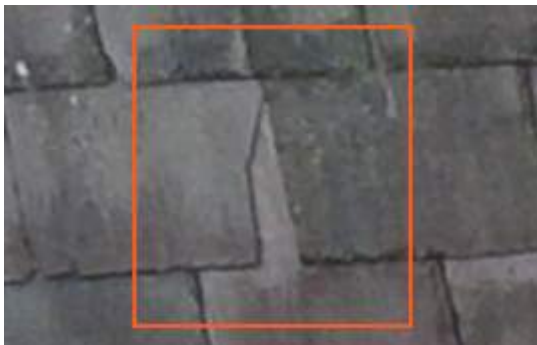
2674288 Severity: 3 Damaged Slate

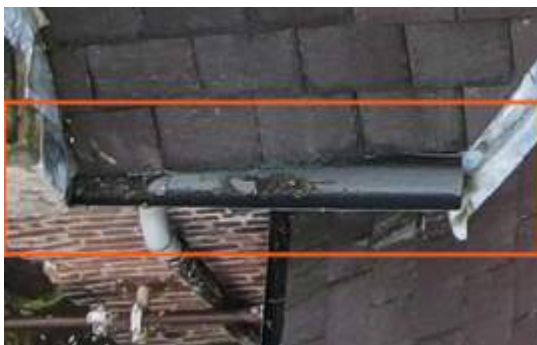
2674301 Severity: 3 Loose/Misaligned Gutter

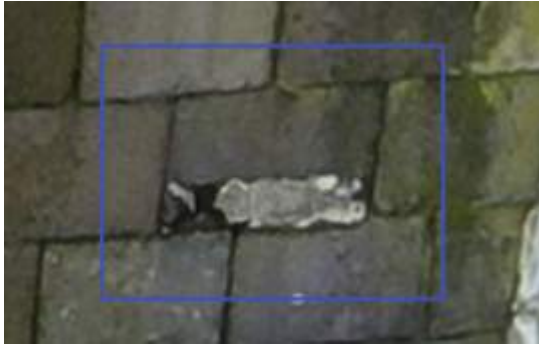
2674306 Severity: 0 Further Clarification Needed

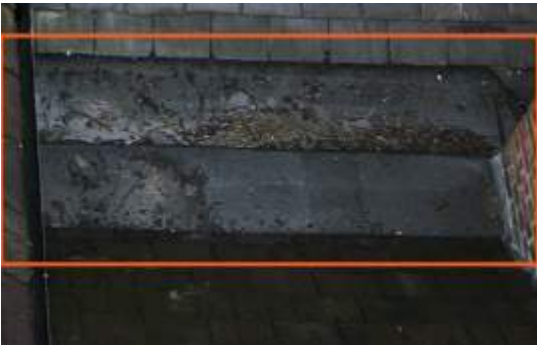
2674309 Severity: 3 Minor Debris in Gutter

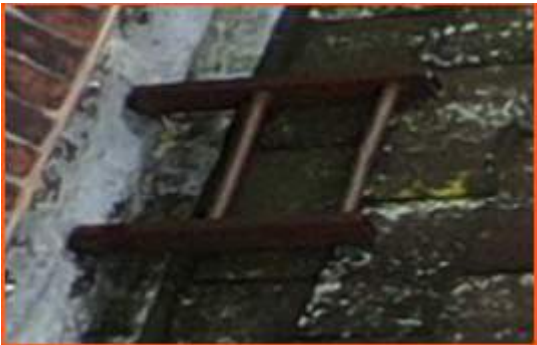
2674312 Severity: 3 Loose Object

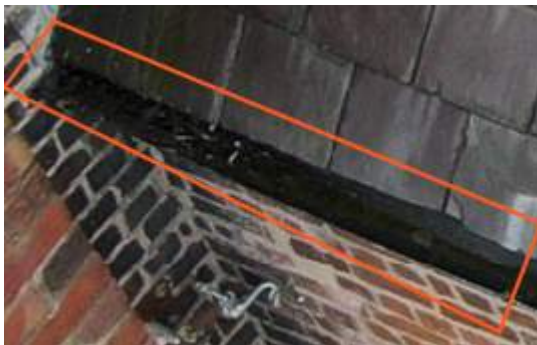
2674327 Severity: 3 Minor Debris in Gutter

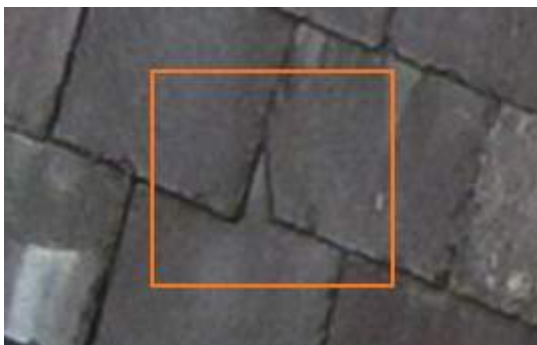
2674328 Severity: 2 Damaged Slate

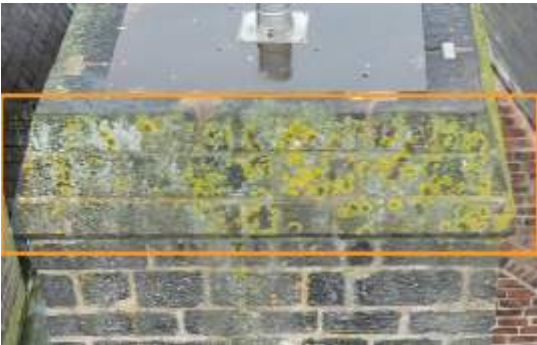
2674334 Severity: 1 Lichen Build Up

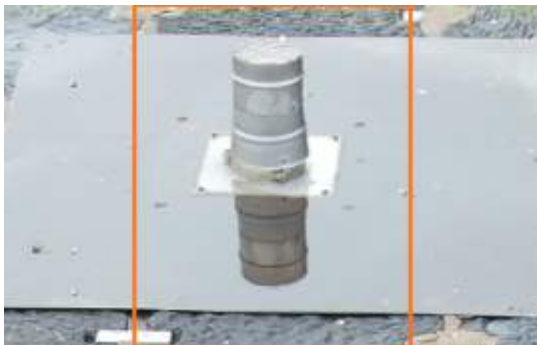
2674335 Severity: 2 Evidence of Standing Water

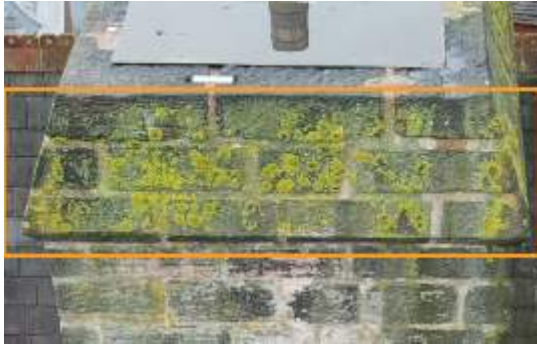
2674534 Severity: 2 Poor Detailing

No apparent seal between capping plate and top of chimney

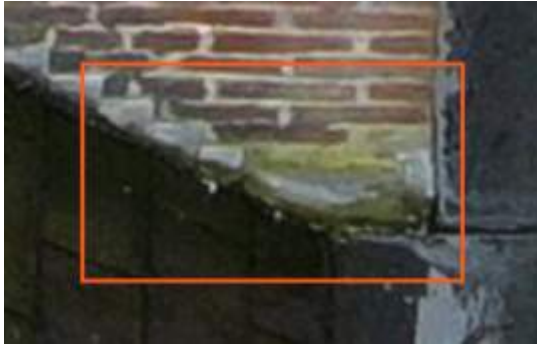
2674537 Severity: 1 Lichen Build Up

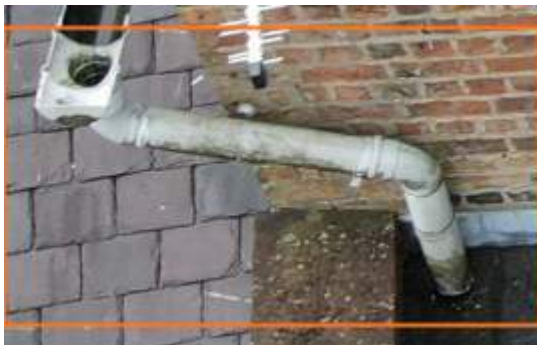
2674582 Severity: 2 Downpipe

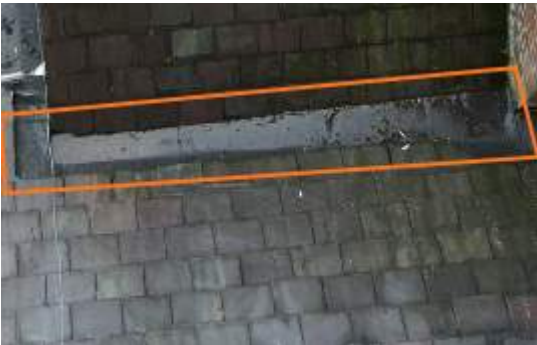
2674587 Severity: 2 Ponding Water

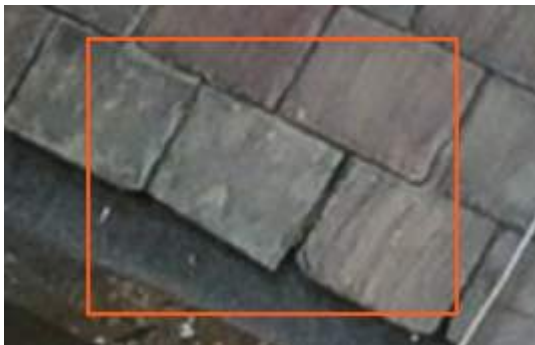
2674588 Severity: 3 Slipped Slate

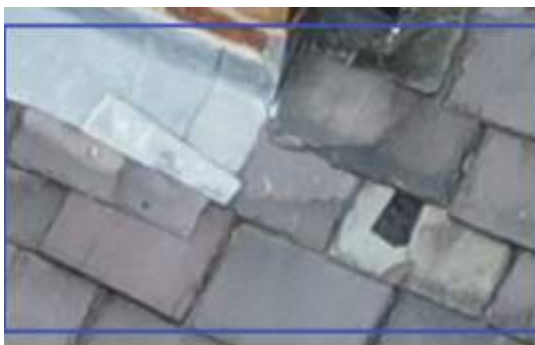
2674626 Severity: 0 Historic Repair

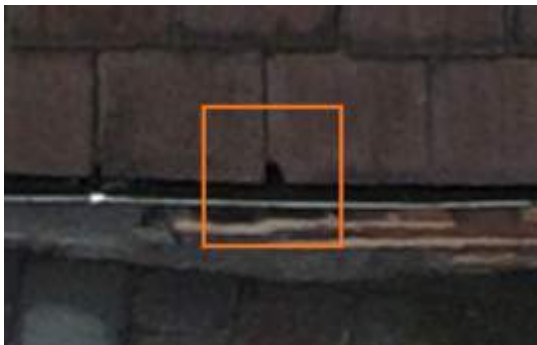
2674640 Severity: 2 Damaged Slate

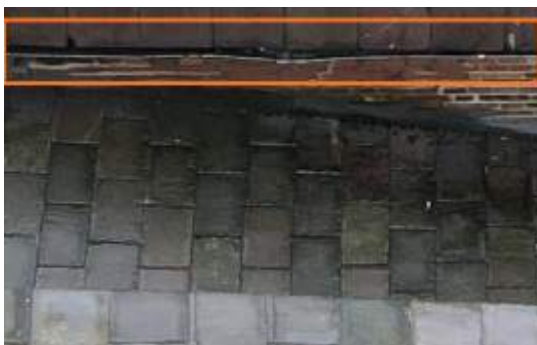
2674642 Severity: 2 Gutter Deformed

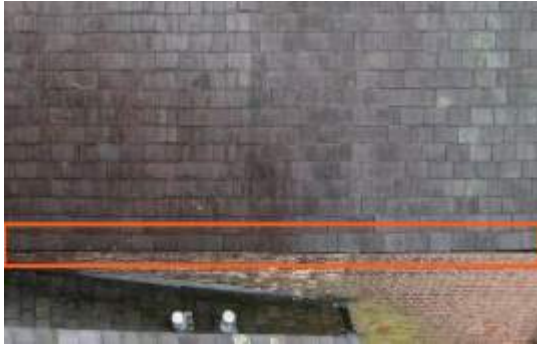
2674643 Severity: 3 Guttering

Gutter appears set back from edge of slate. Ensure water will be collected in gutter without overspill.

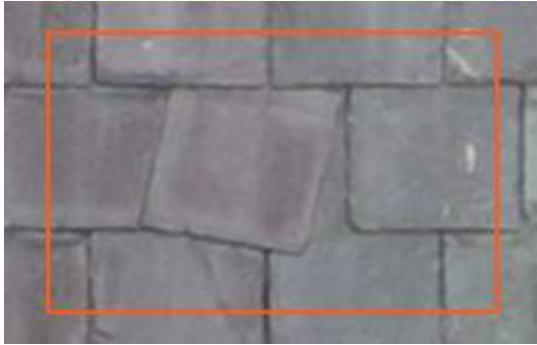
2674645 Severity: 3 Slipped Slate

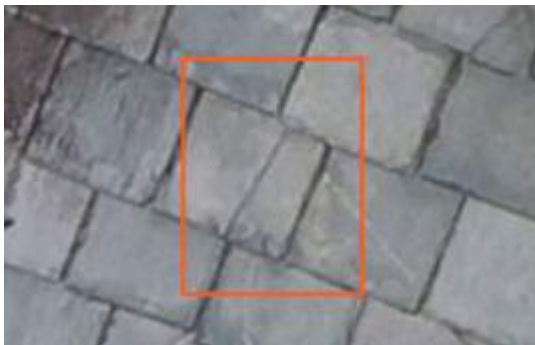
2674719 Severity: 3 Damaged Slate

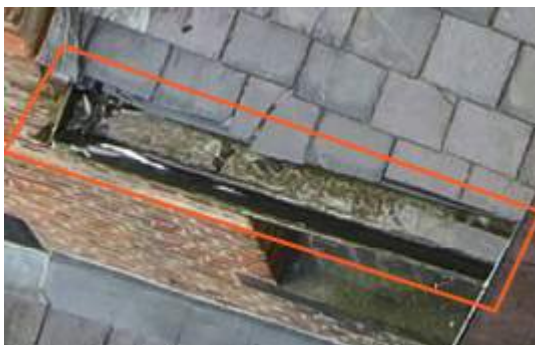
2674720 Severity: 3 Minor Debris in Gutter

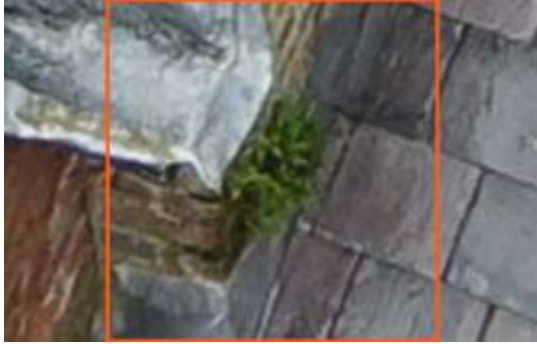
2674721 Severity: 3 Vegetation Growth

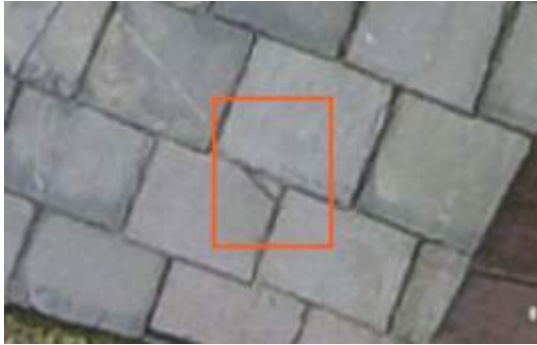
2674732 Severity: 3 Damaged Slate

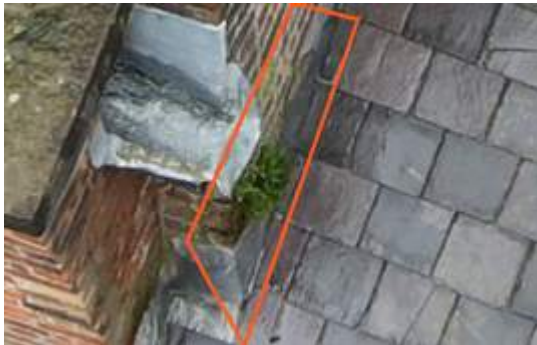
2674733 Severity: 3 Missing Flashing

Ensure flashing is not missing.

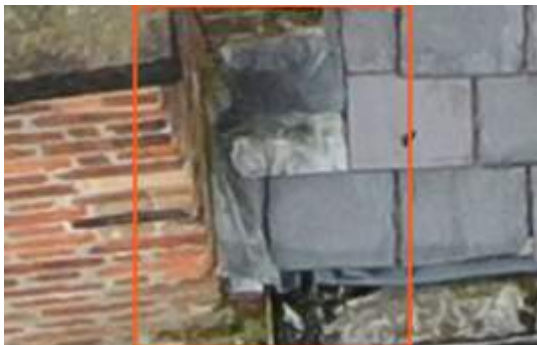
2674729 Severity: 3 Flashing

Further inspection recommended to ensure flashing is adequate.
Lead replacement is not advised if this has been used.

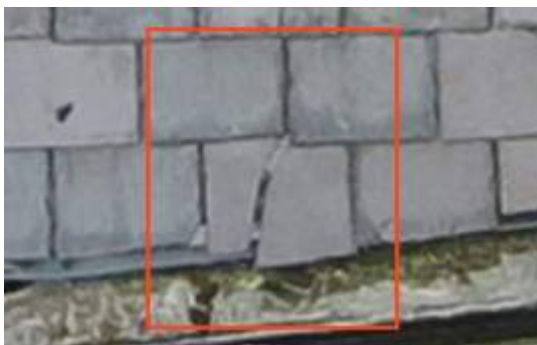
2674730 Severity: 4 Damaged Slate

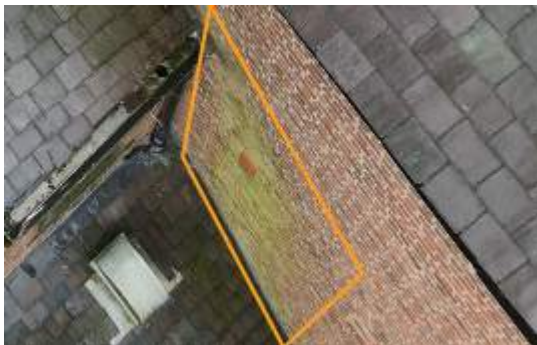
2674739 Severity: 1 Algae

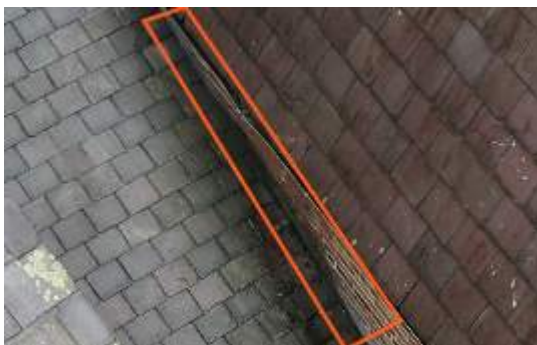
2674741 Severity: 3 Flashing

Ensure flashing is watertight and not missing.

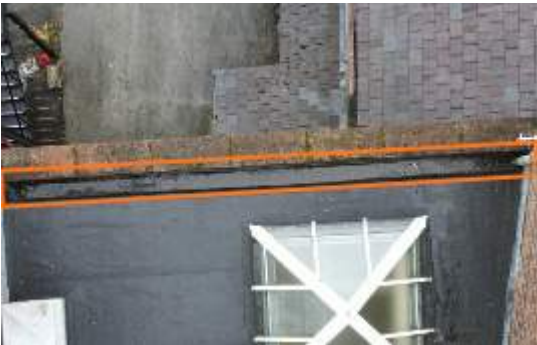
2674742 Severity: 2 Evidence of Standing Water

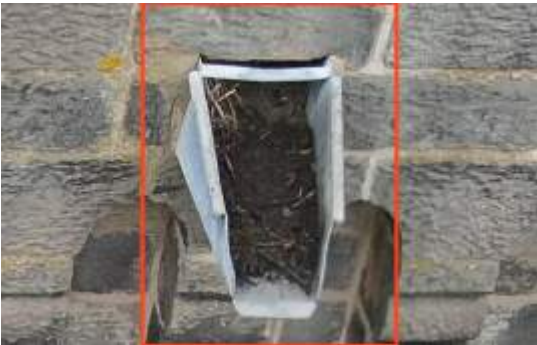
2674743 Severity: 4 Blocked outlet

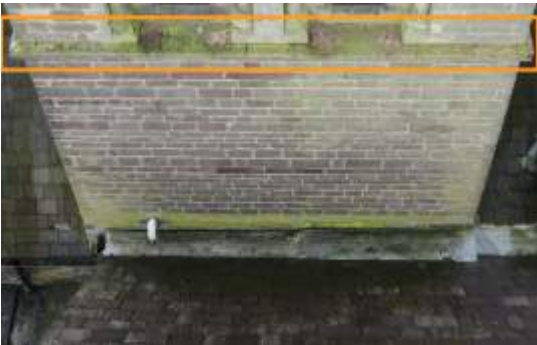
2674745 Severity: 1 Lichen Build Up

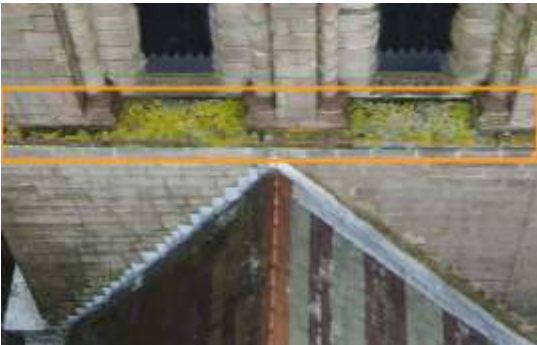
2674746 Severity: 1 Lichen Build Up

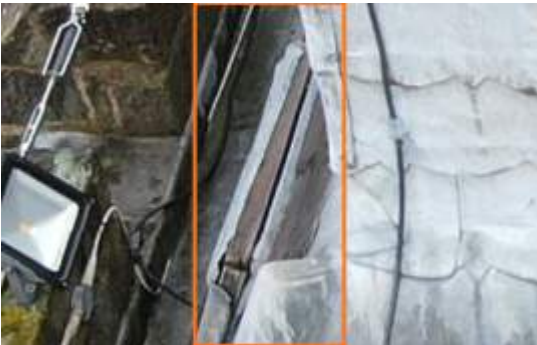
2674747 Severity: 2 Minor Timber Decay

Neil Poynor
Access hatch cover requires attention

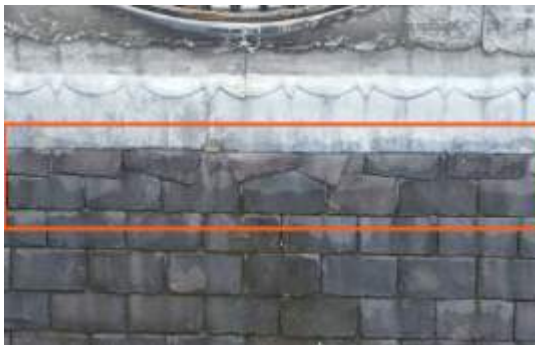
2674748 Severity: 3 Misaligned Slate

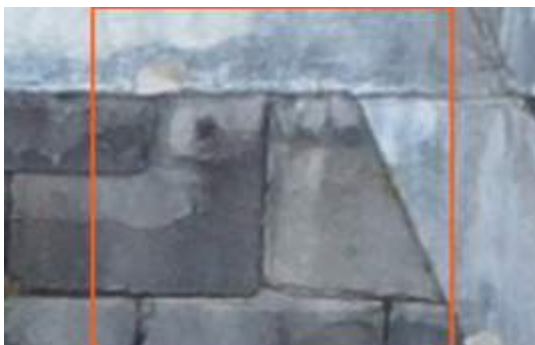
2674749 Severity: 3 Missing Slate

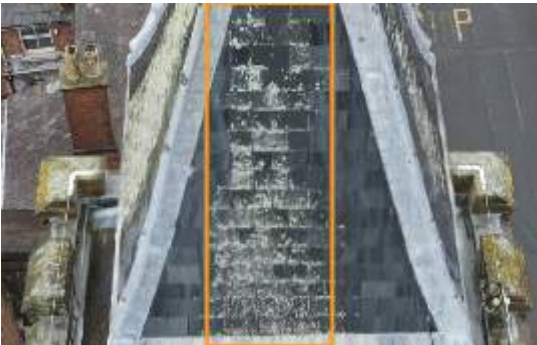
2674750 Severity: 1 Lichen Build Up

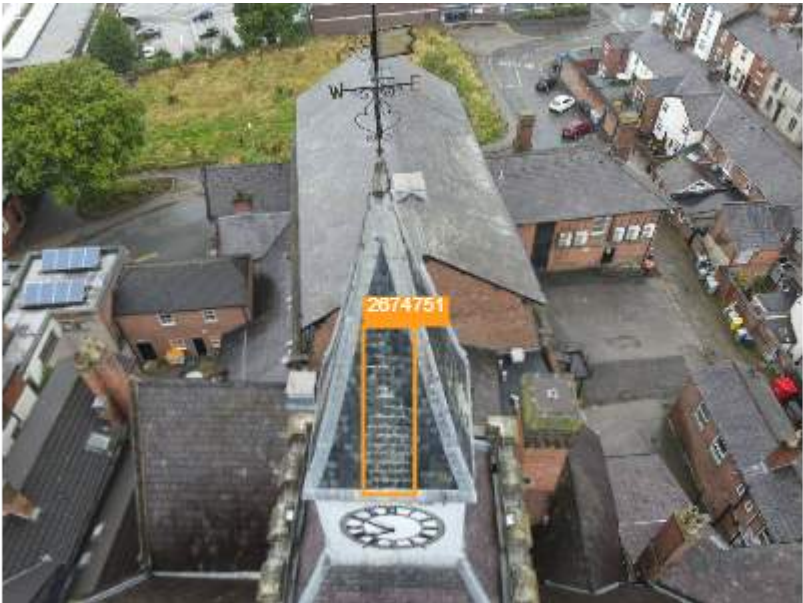
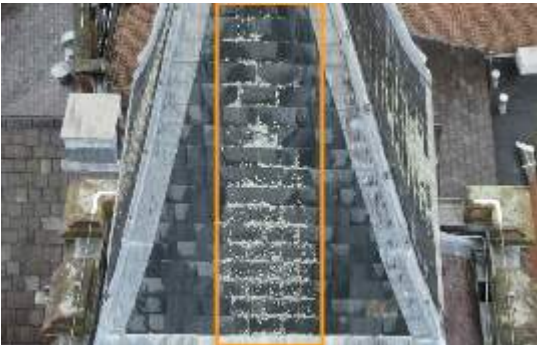
2674751 Severity: 1 Lichen Build Up

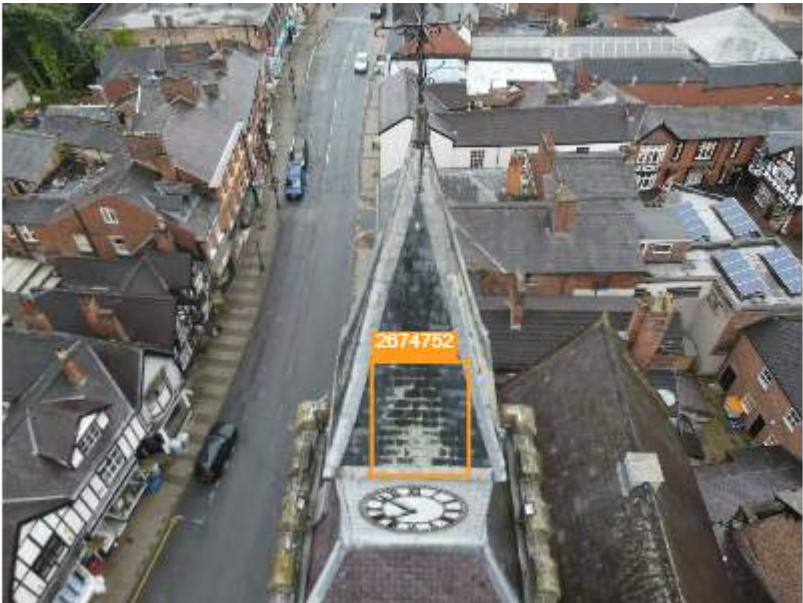
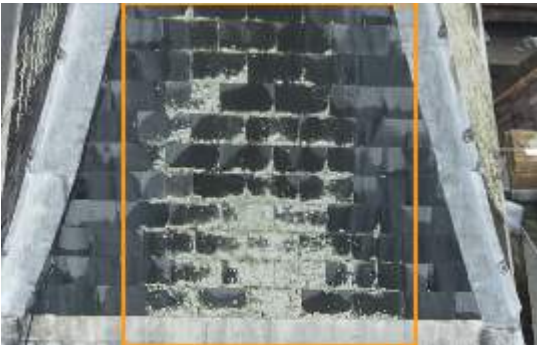
2674752 Severity: 1 Lichen Build Up

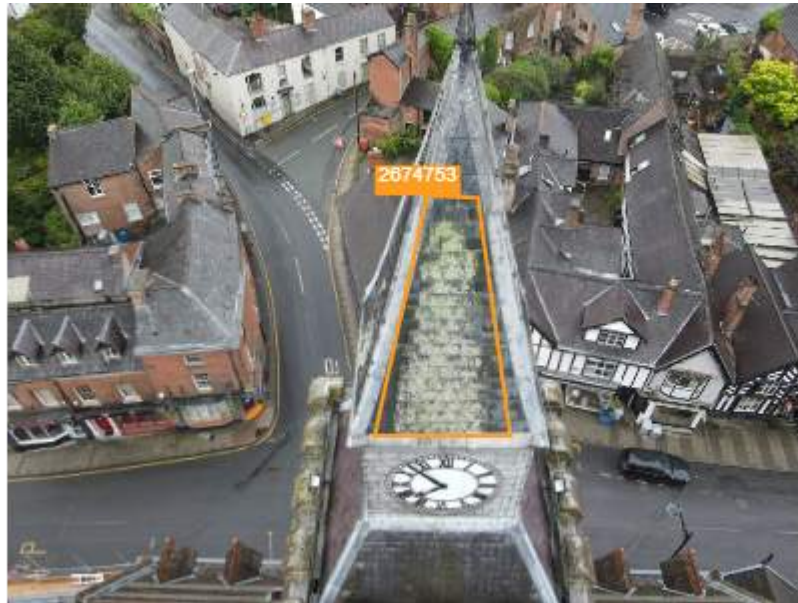
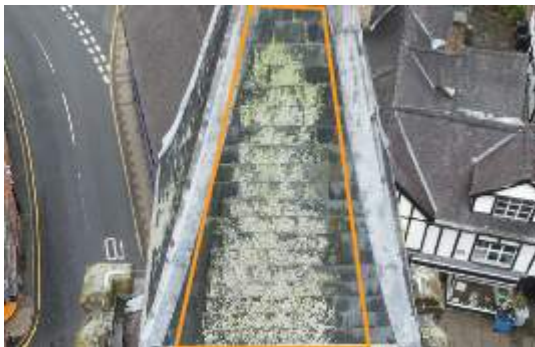
2674753 Severity: 1 Lichen Build Up

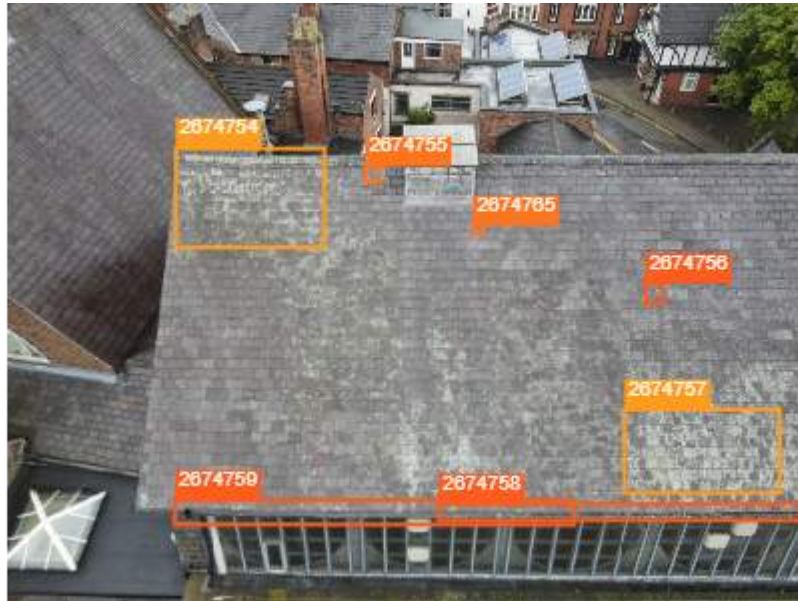
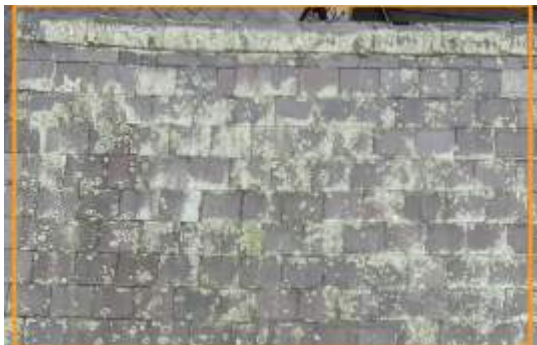
2674754 Severity: 1 Lichen Build Up

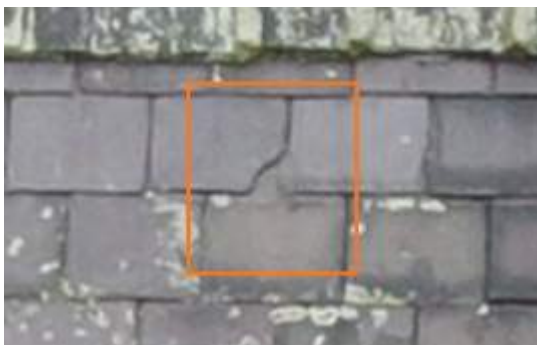
2674755 Severity: 2 Damaged Slate

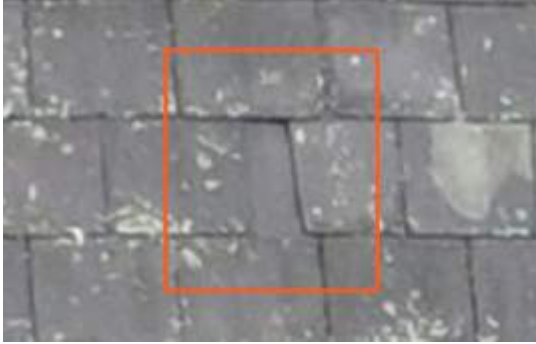
2674756 Severity: 3 Damaged Slate

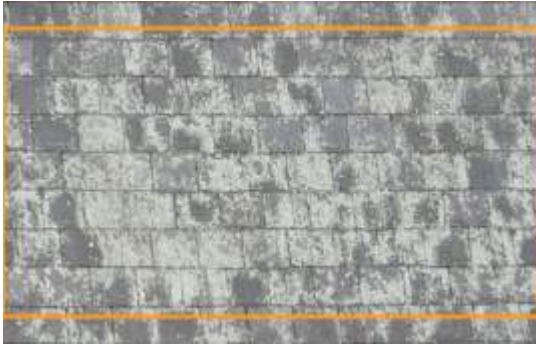
2674757 Severity: 1 Lichen Build Up

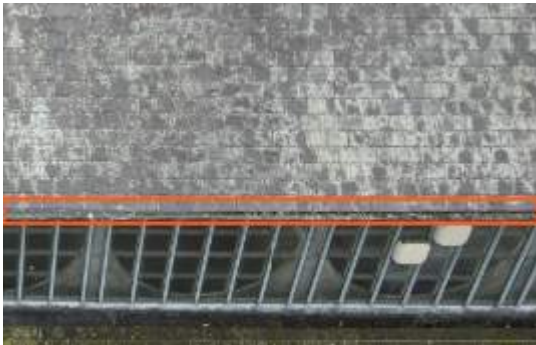
2674758 Severity: 3 Significant Debris in Gutter

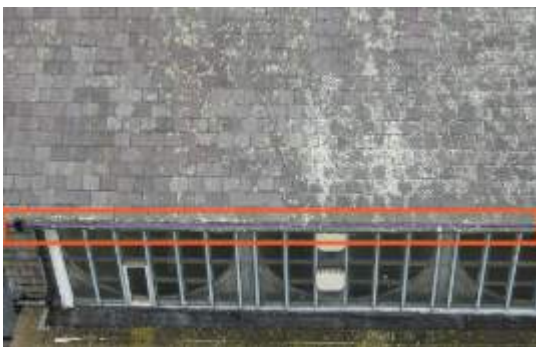
2674759 Severity: 3 Gutter Deformed

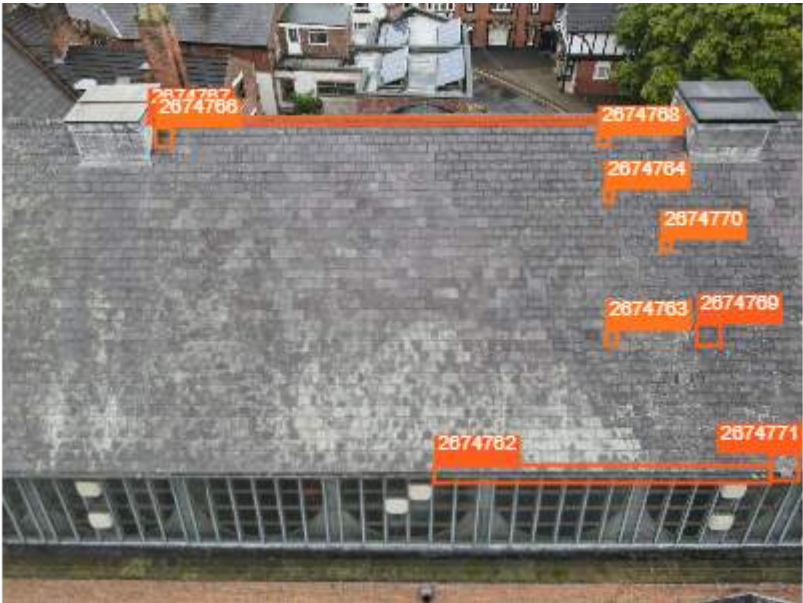
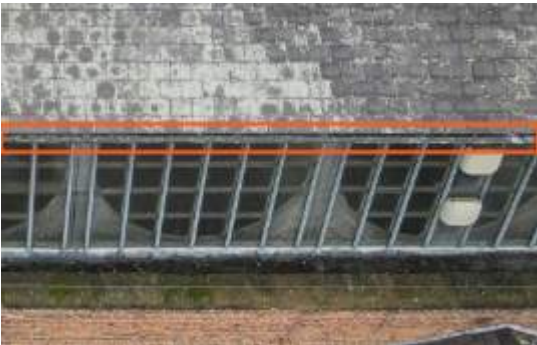
2674762 Severity: 3 Significant Debris in Gutter

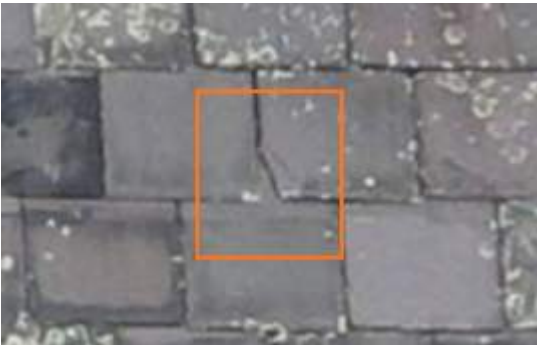
2674763 Severity: 2 Damaged Slate

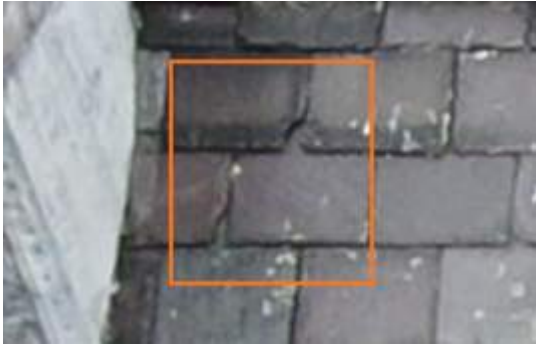
2674766 Severity: 2 Damaged Slate

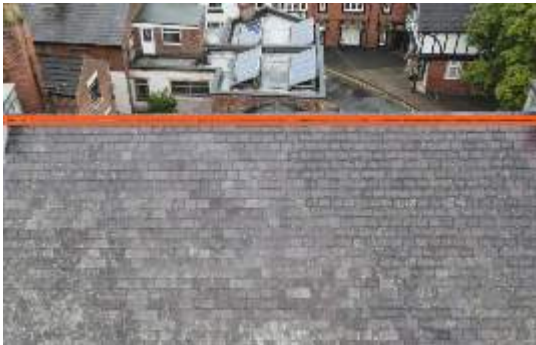
2674767 Severity: 3 Missing Mortar to Ridge

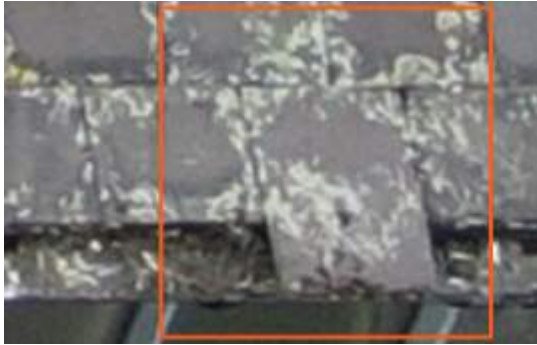
2674771 Severity: 3 Slipped Slate

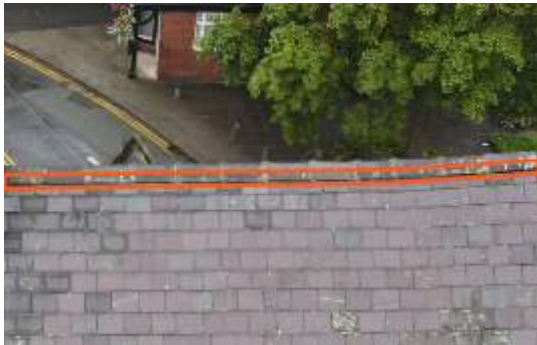
2674772 Severity: 3 Missing Mortar to Ridge

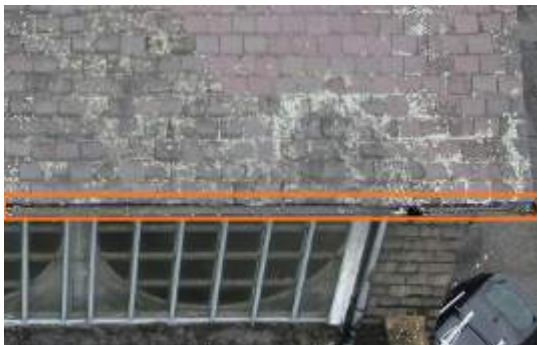
2674773 Severity: 2 Standing Water in Gutter

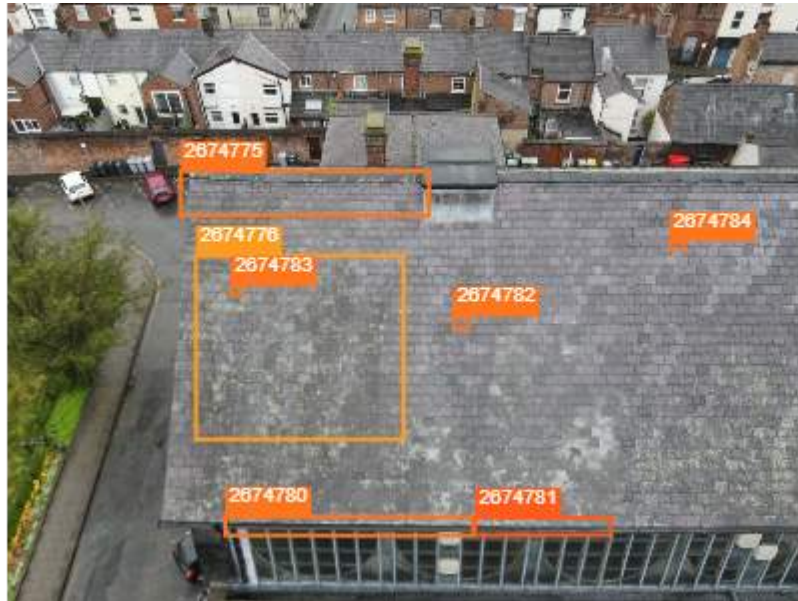
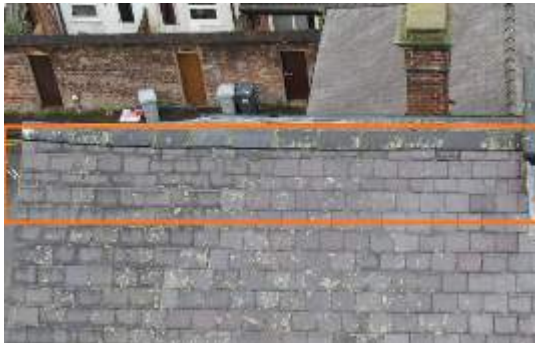
2674775 Severity: 2 Slate

Neil Poynor
Alternating laps

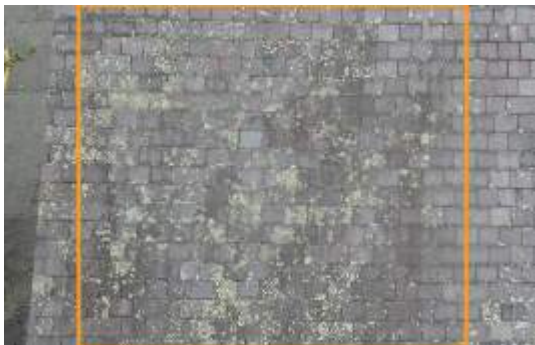
2674776 Severity: 1 Lichen Build Up

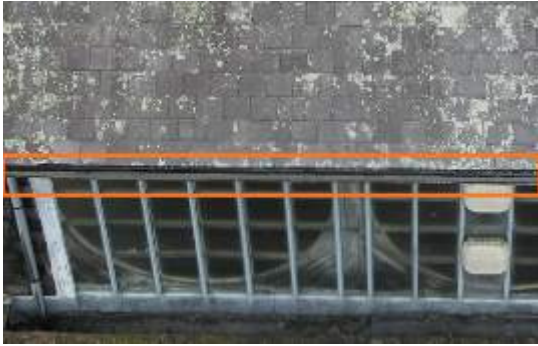
2674780 Severity: 2 Standing Water in Gutter

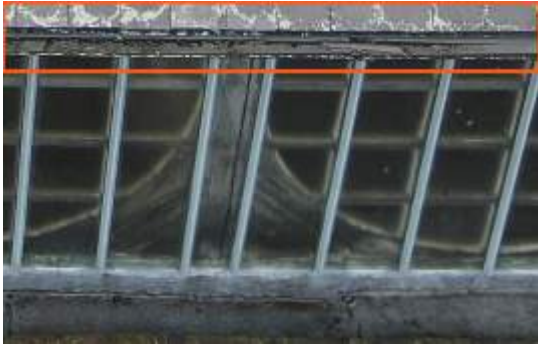
2674781 Severity: 3 Significant Debris in Gutter

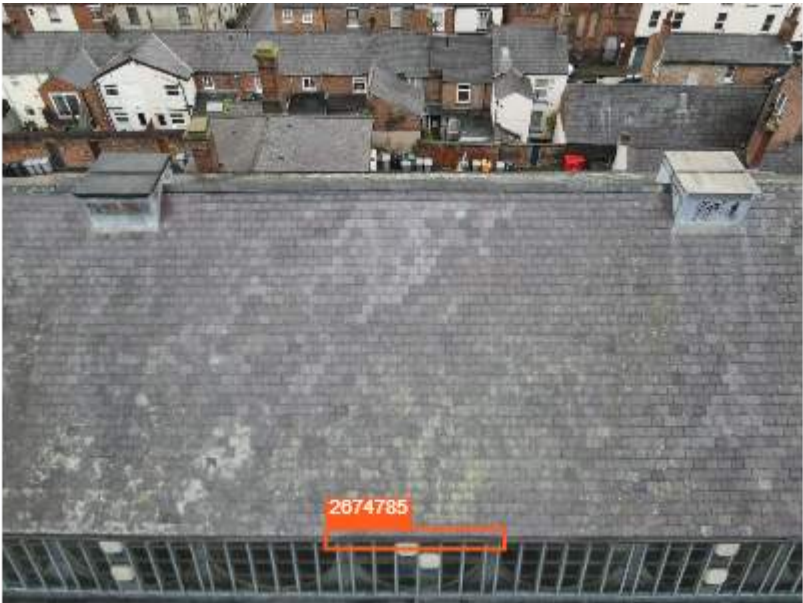
2674785 Severity: 3 Significant Debris in Gutter

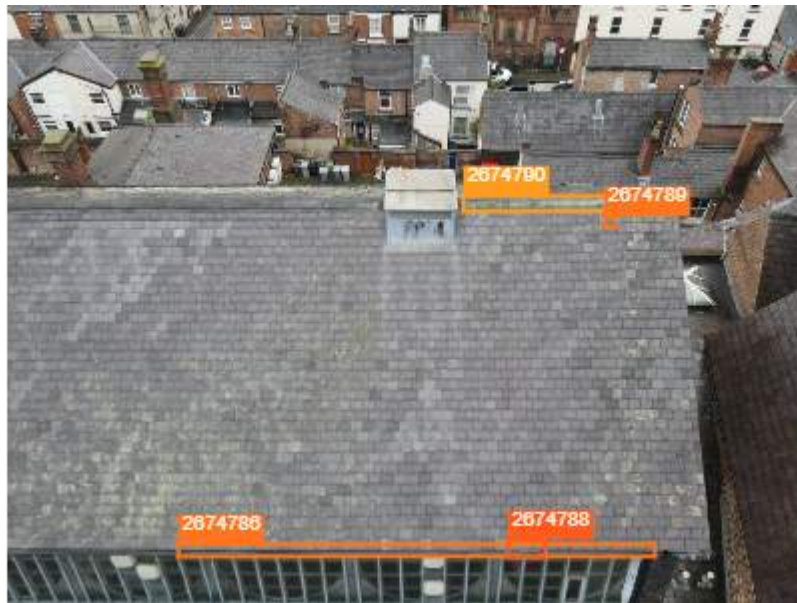
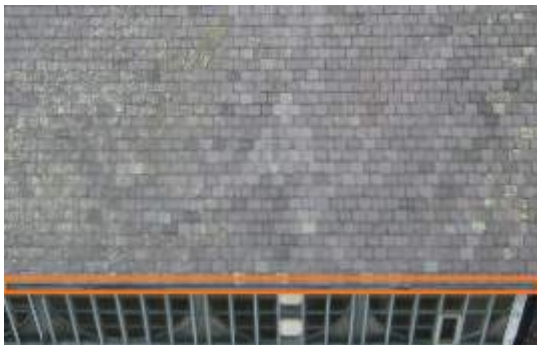
2674786 Severity: 2 Standing Water in Gutter

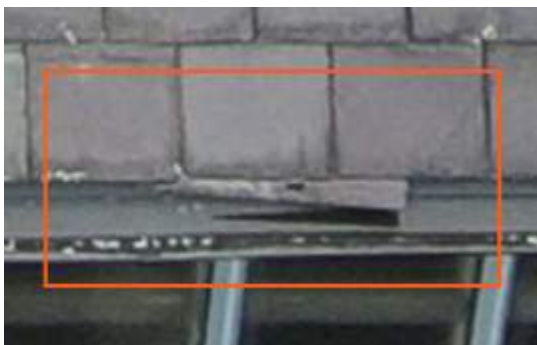
2674788 Severity: 3 Slipped Slate

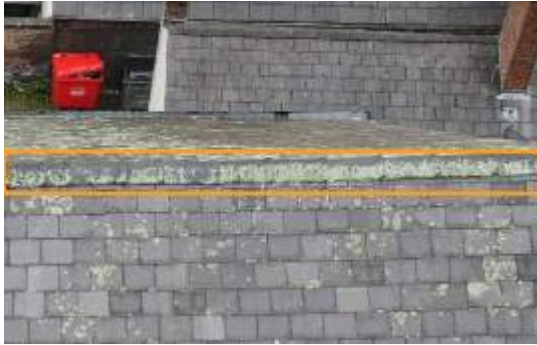
2674790 Severity: 1 Lichen Build Up

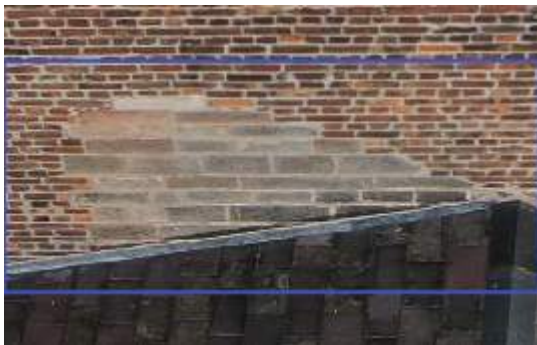
2674791 Severity: 0 Historic Repair

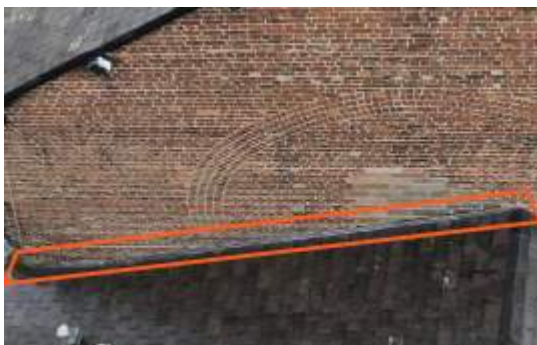
2674792 Severity: 3 Slate

Neil Poynor

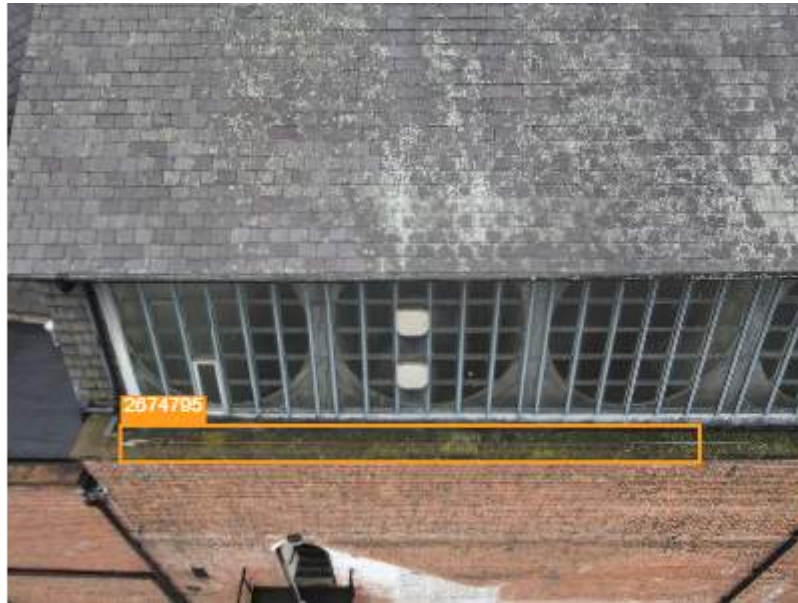
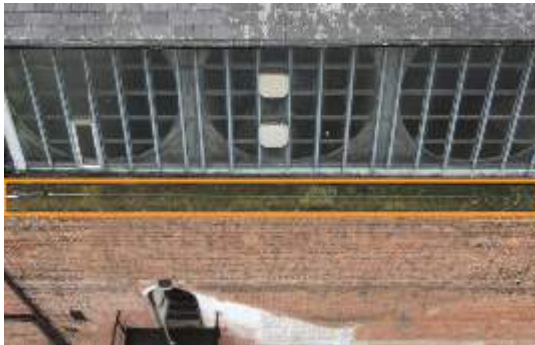
2674795 Severity: 1 Moss Growth

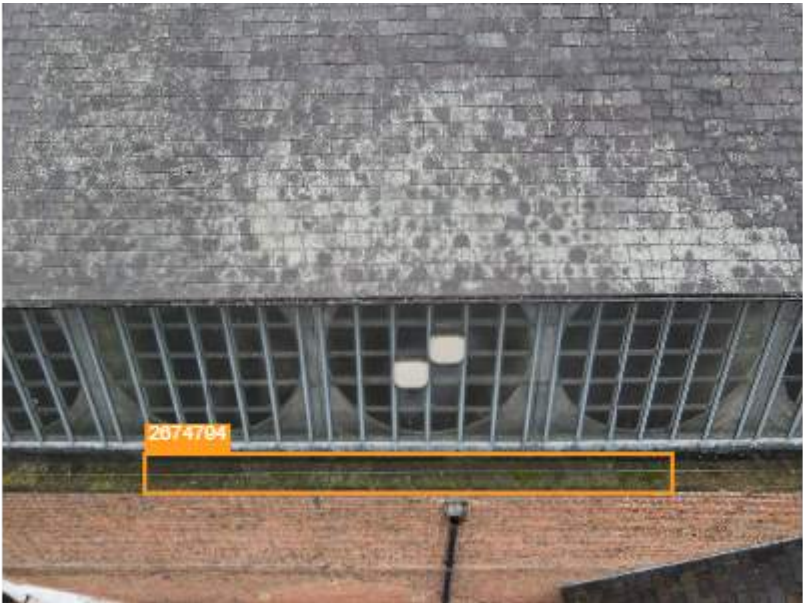
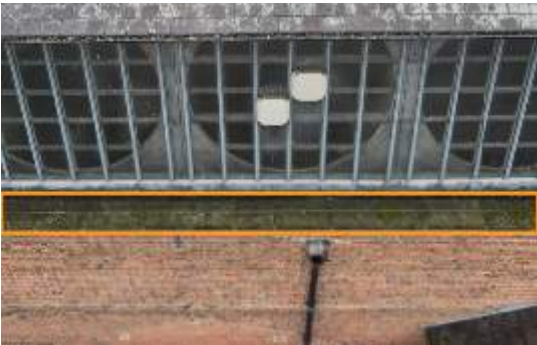
2674794 Severity: 1 Moss Growth

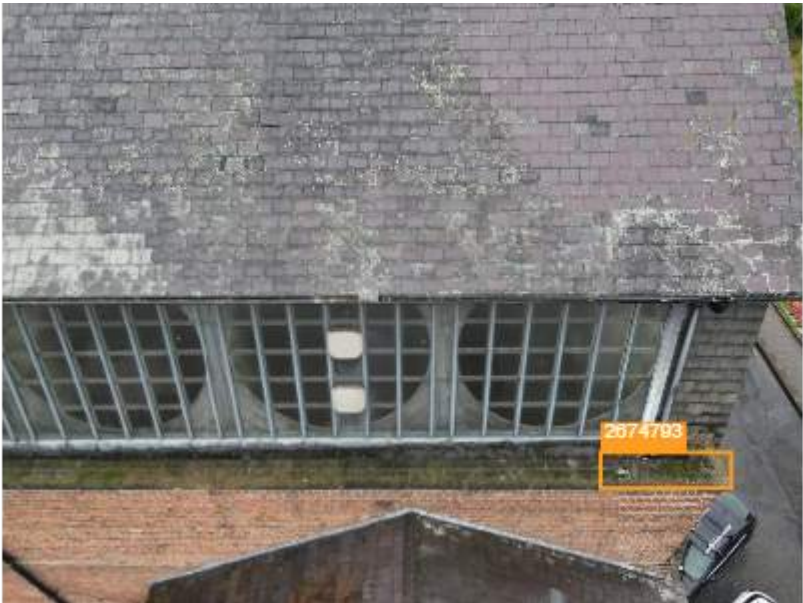
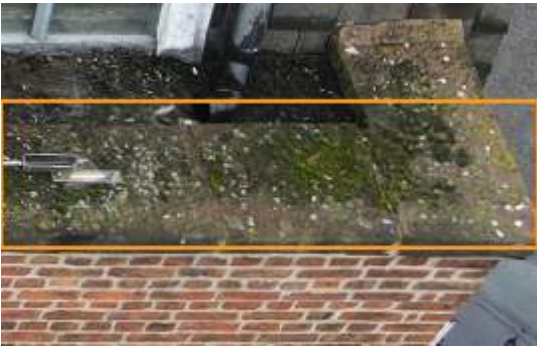
2674793 Severity: 1 Moss Growth

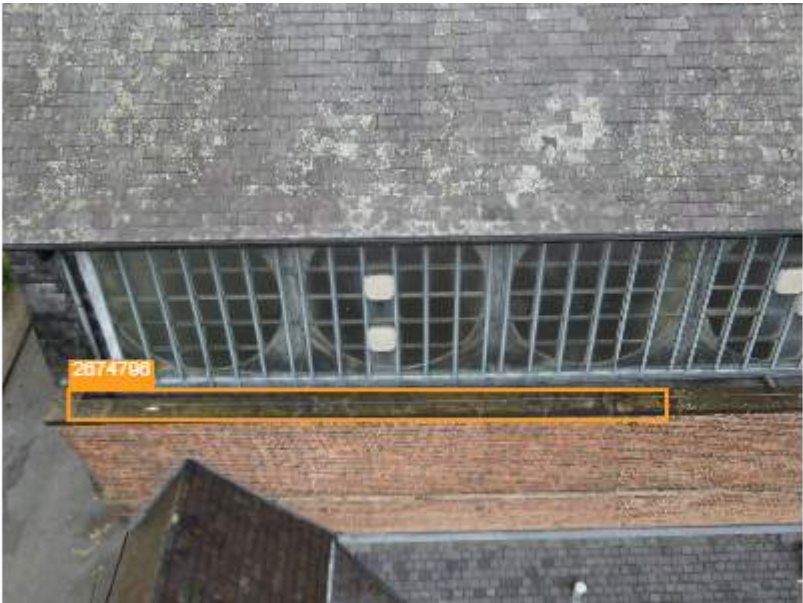
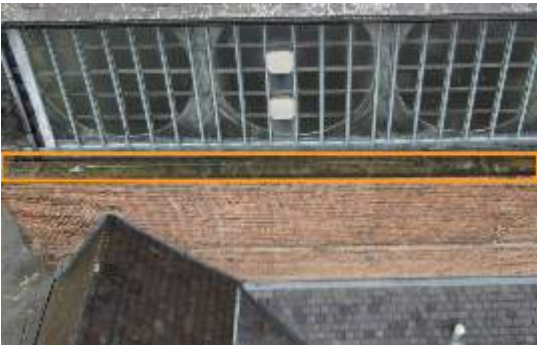
2674796 Severity: 1 Moss/Lichen Build Up
