Congleton Town Council

Town Hall, Assets & Services Committee – 16th September 2021

9. Roof Repairs Drone Survey (Enclosed)

COMMITTEE:	Town Hall, Assets and Services		
MEETING DATE AND TIME	16th September 2021	LOCATION	Congleton Town Hall
REPORT FROM	Town Hall Manager – Mark Worthington		
AGENDA ITEM REPORT TITLE	9 Roof Repairs Drone Survey (i)		
Background	<p>A Town Hall Maintenance Plan has been developed to highlight and categorise maintenance works required around the Town Hall and other assets. Using the Maintenance Plan, it was agreed at the Town Hall Working Group on 1st July 2020 that the areas most in need of attention were the roofs at various locations around the Town Hall where water ingress is an obvious issue, and painting to the woodwork on the front elevation of the Town Hall. Due to the cost of erecting scaffolding to access areas of the roof, it was agreed that a more cost-effective method would be to arrange an aerial drone survey of the Town Hall and Museum.</p>		
Update	<p>Three specialist companies were contacted to provide quotes to carry out an aerial drone survey and associated report into the condition of the Town Hall roofs. Quotes ranged from £750 to

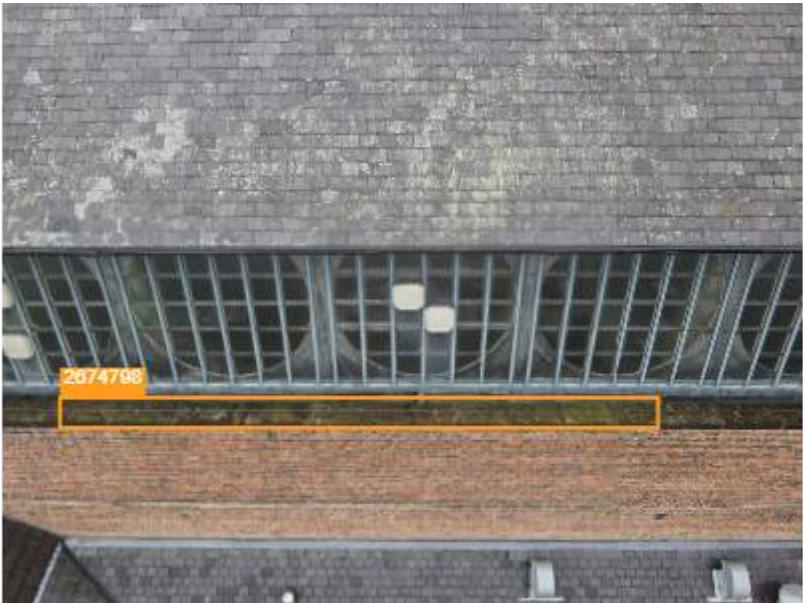
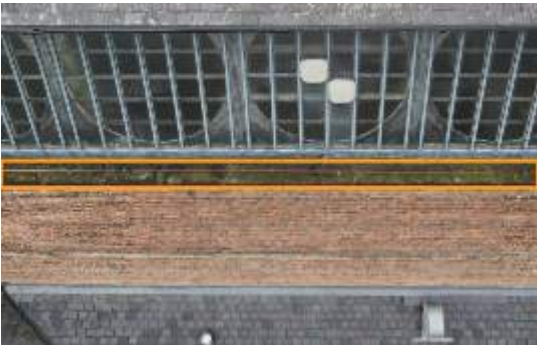
2674798 Severity: 1 Moss/Lichen Build Up

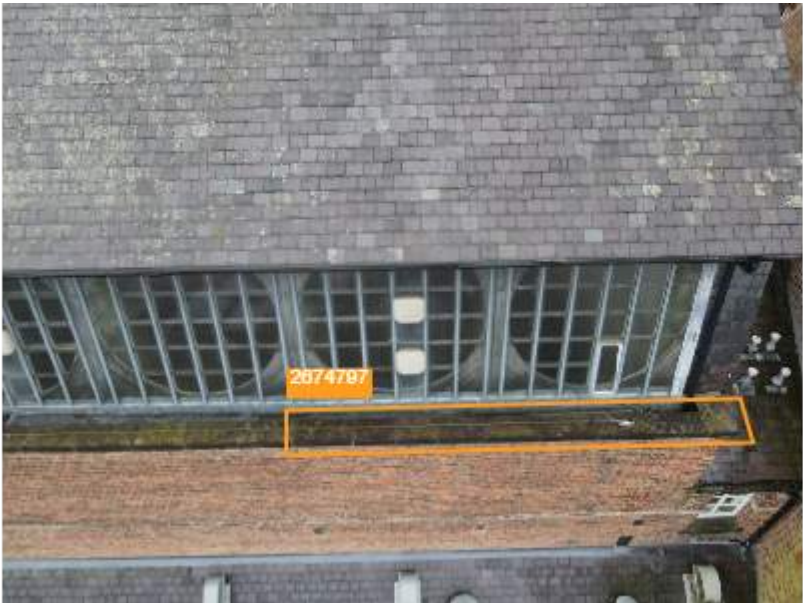
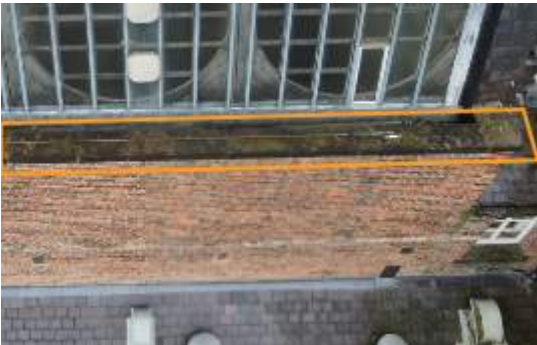
2674797 Severity: 1 Moss/Lichen Build Up

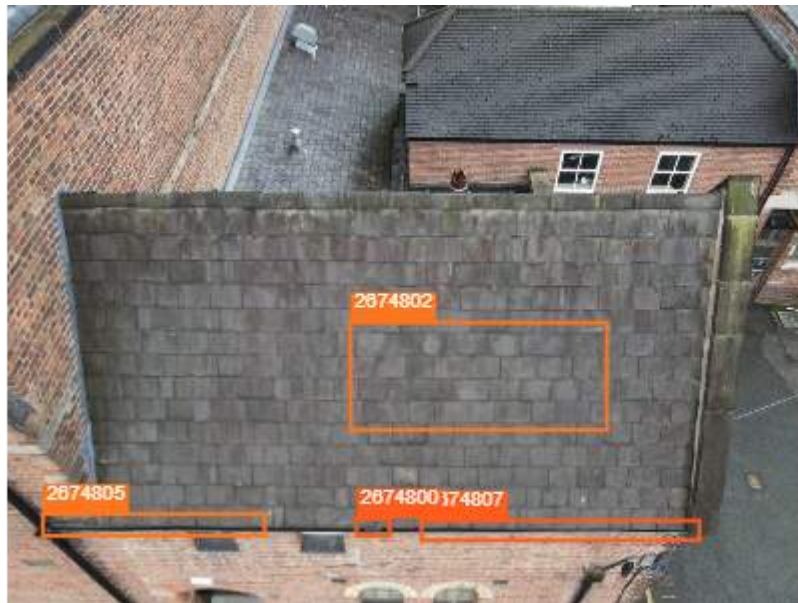
2674800 Severity: 3 Slipped Slate

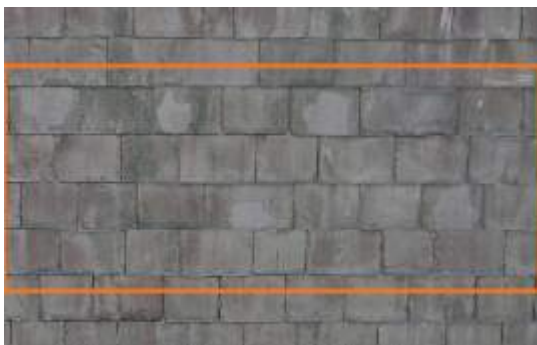
2674802 Severity: 2 Slate

Neil Poynor
Slates laminating

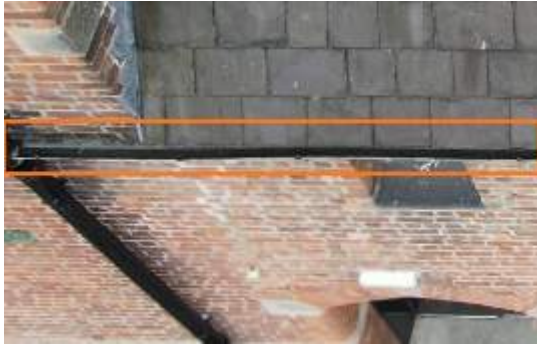
2674805 Severity: 2 Standing Water in Gutter

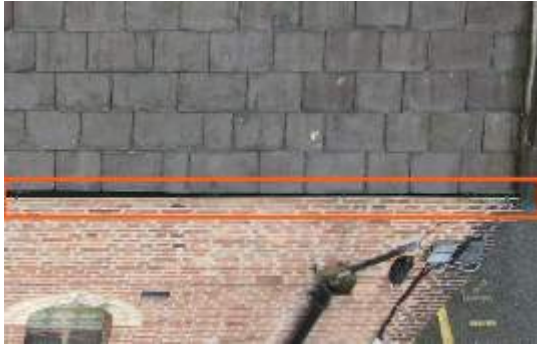
2674807 Severity: 3 Guttering

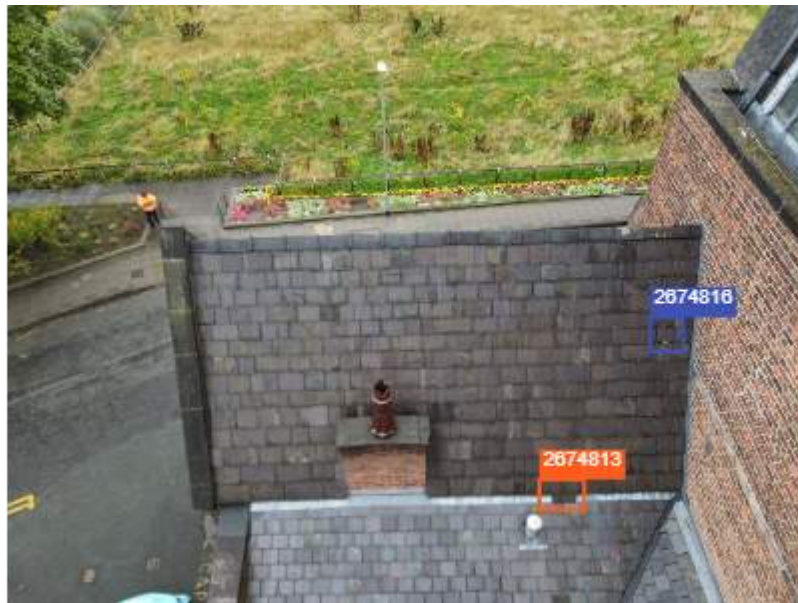
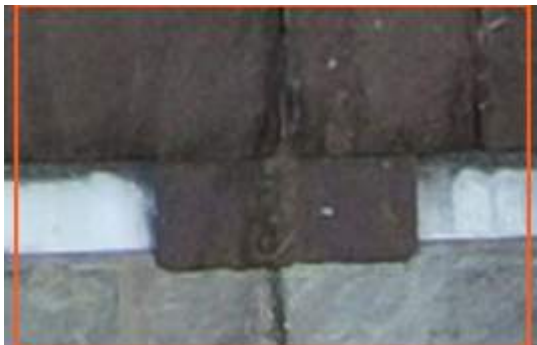
2674813 Severity: 3 Slipped Slate

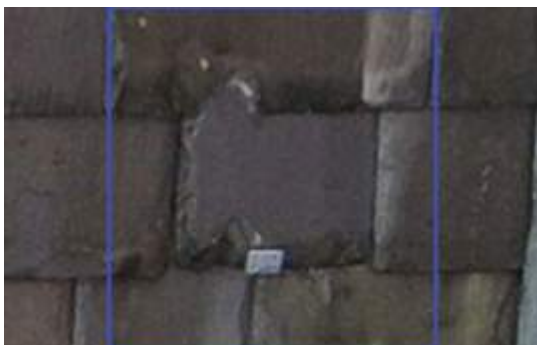
2674816 Severity: 0 Historic Repair

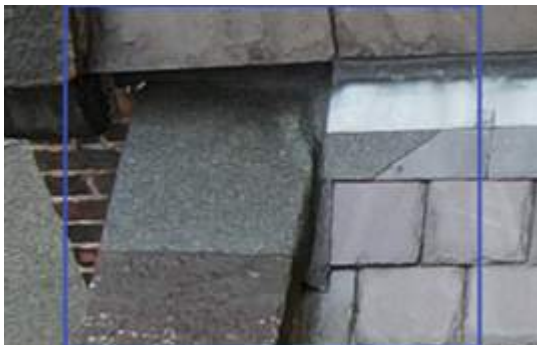
2674818 Severity: 0 Historic Repair

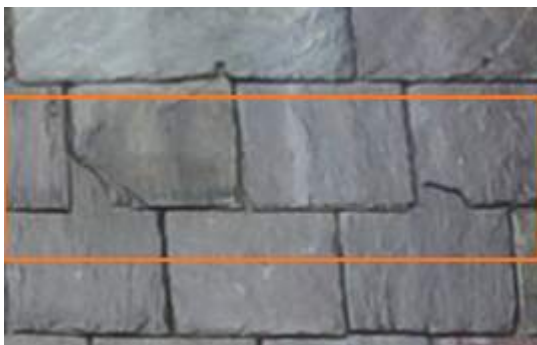
2674819 Severity: 2 Damaged Slate

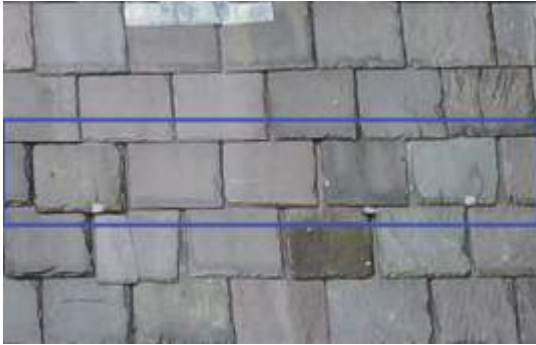
2674821 Severity: 0 Historic Repair

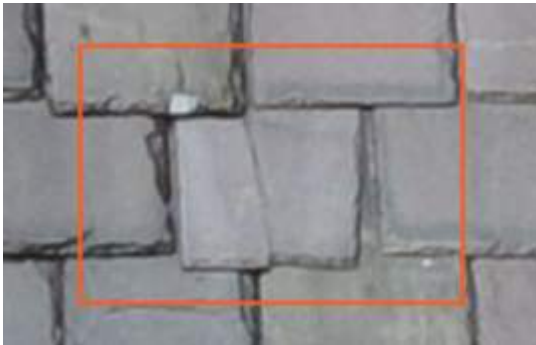
2674822 Severity: 3 Damaged Slate

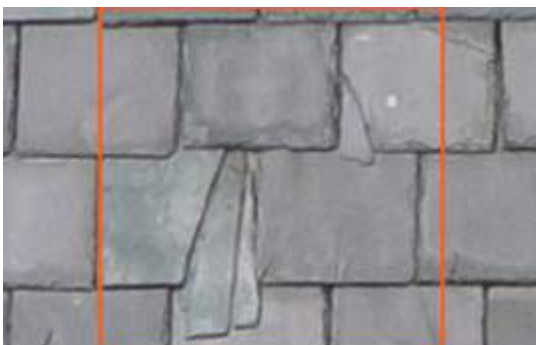
2674824 Severity: 3 Damaged Slate

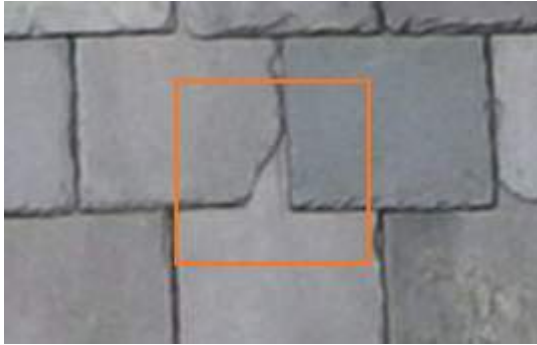
2674826 Severity: 2 Damaged Slate

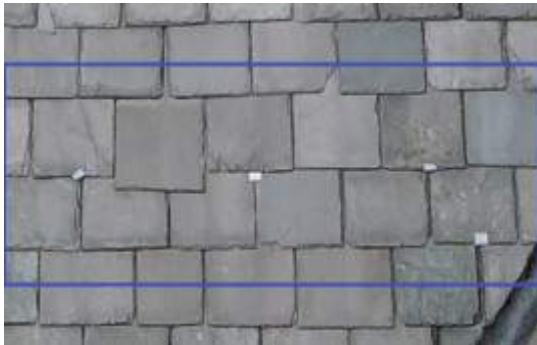
2674827 Severity: 0 Historic Repair

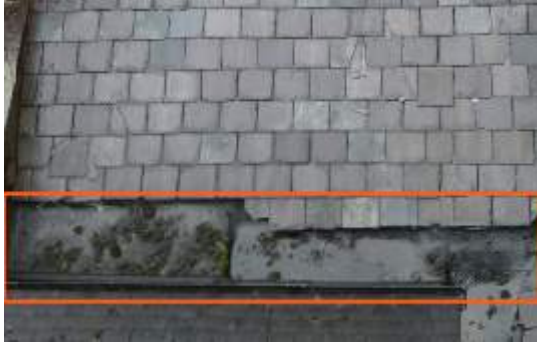
2674831 Severity: 3 Minor Debris in Gutter

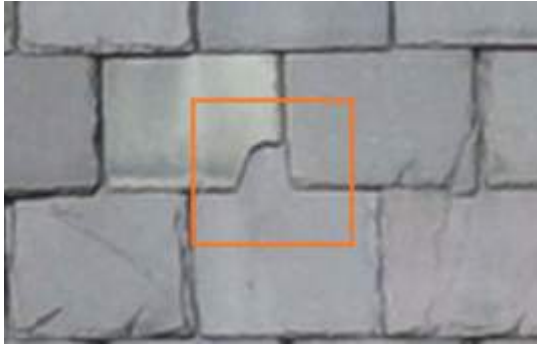
2674833 Severity: 2 Damaged Slate

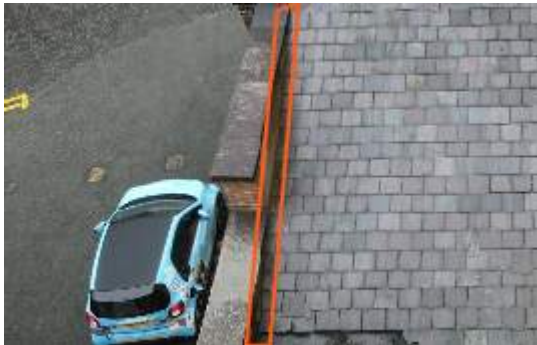
2674838 Severity: 3 Flashing

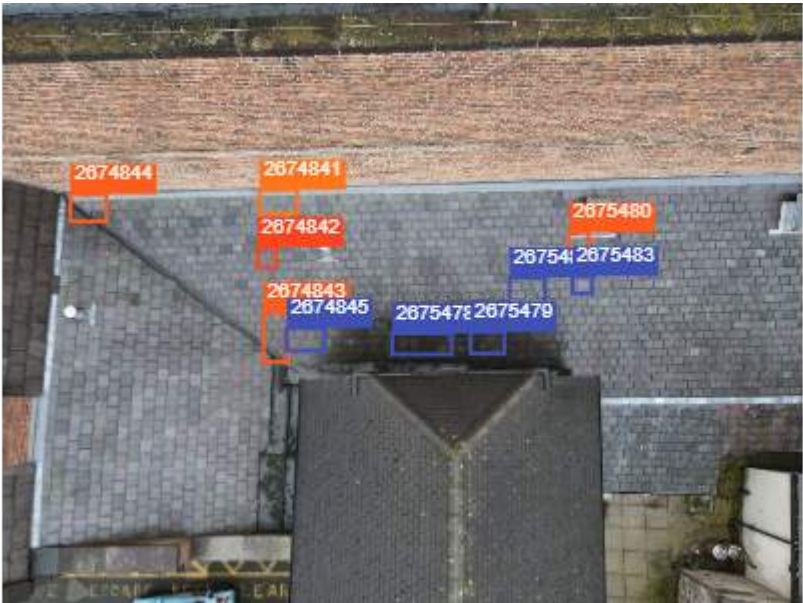
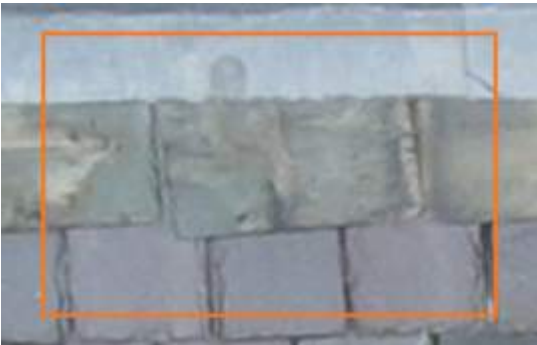
2674841 Severity: 2 Misaligned Slate

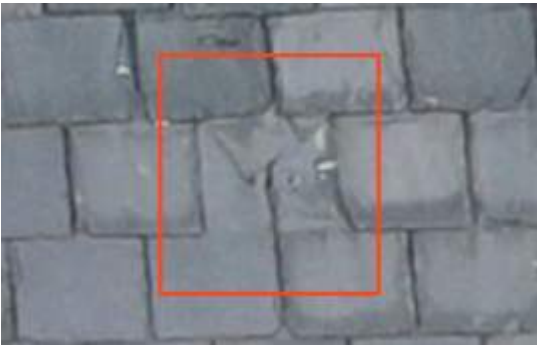
2674842 Severity: 4 Damaged Slate

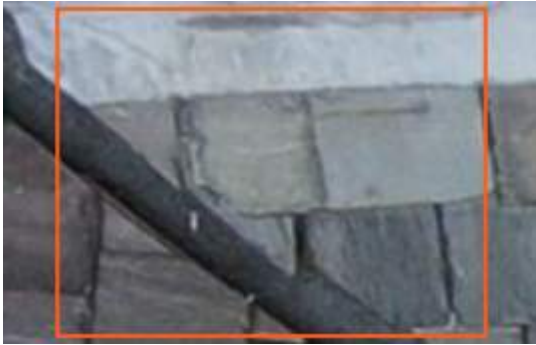
2674844 Severity: 3 Slipped Slate

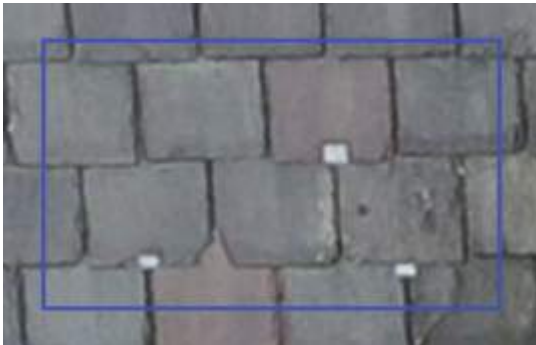
2674845 Severity: 0 Historic Repair

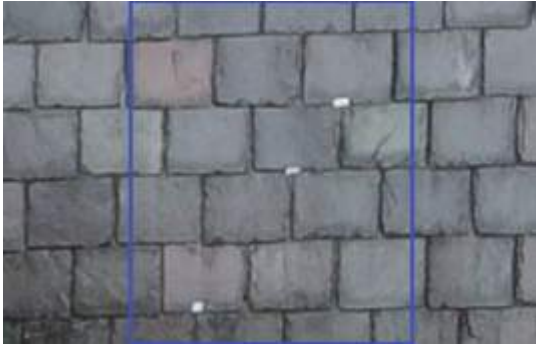
2675482 Severity: 0 Historic Repair

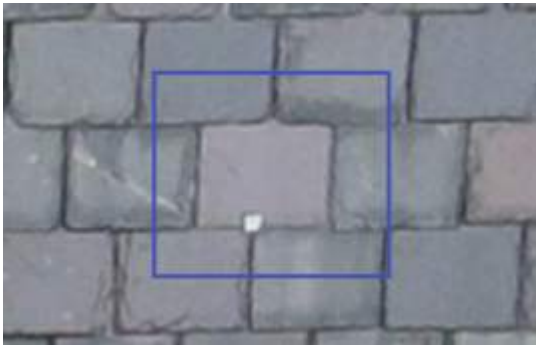
2675483 Severity: 0 Historic Repair

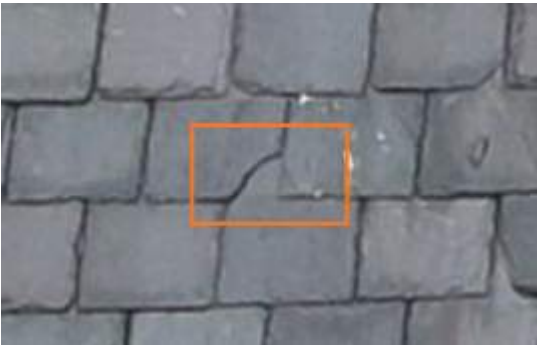
2675498 Severity: 2 Damaged Slate

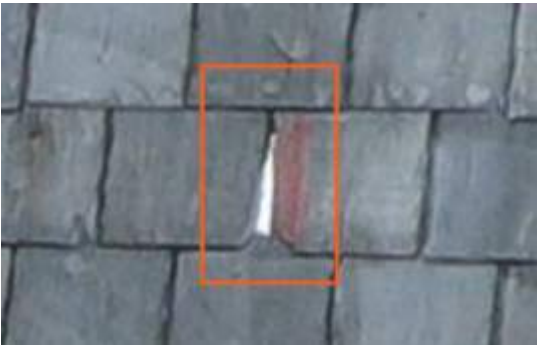
2675502 Severity: 3 Further Clarification Needed

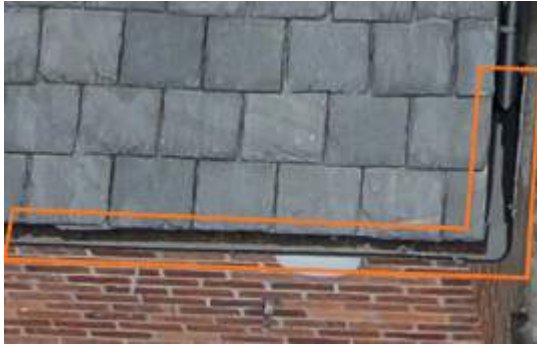
2675505 Severity: 2 Standing Water in Gutter

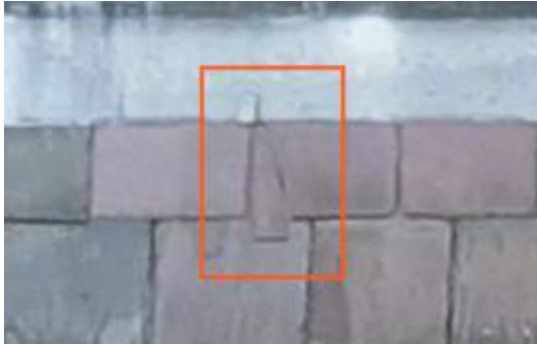
2675530 Severity: 3 Damaged Slate

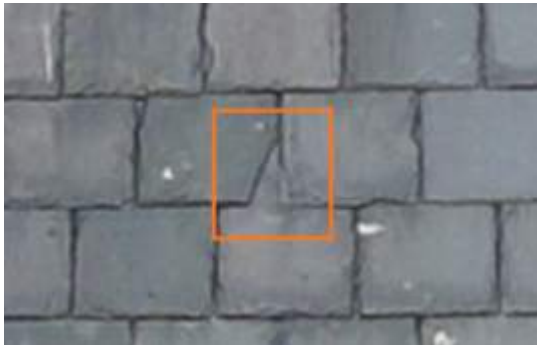
2675533 Severity: 2 Damaged Slate

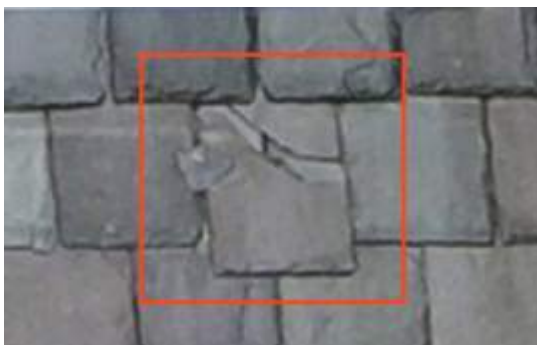
2675536 Severity: 4 Damaged Slate

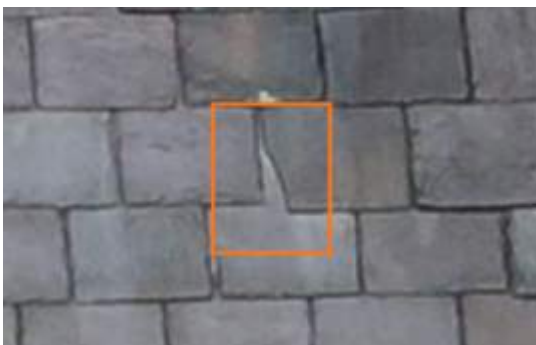
2675543 Severity: 2 Damaged Slate

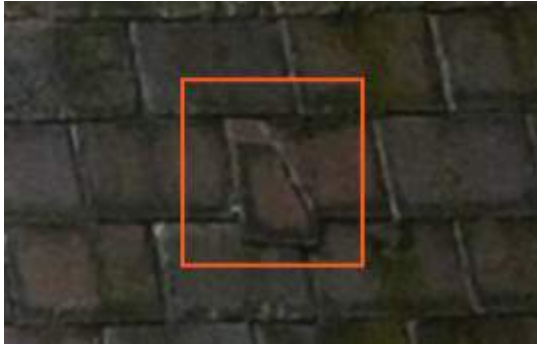
2675550 Severity: 4 Damaged Slate

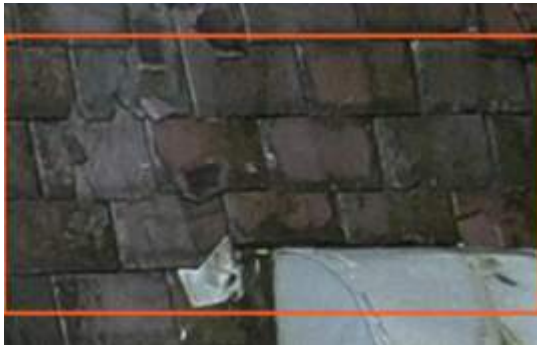
2675551 Severity: 3 Damaged Slate

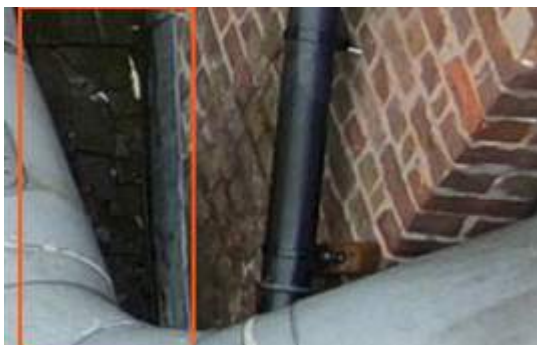
2675556 Severity: 2 Moss Growth

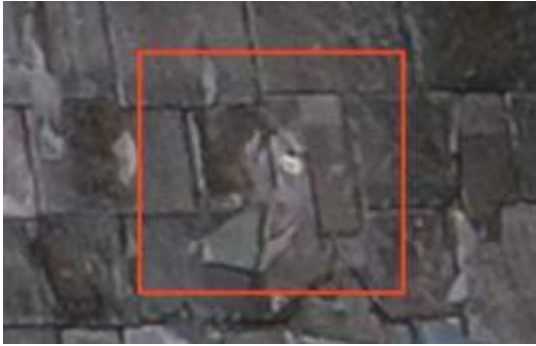
2675559 Severity: 3 Damaged Slate

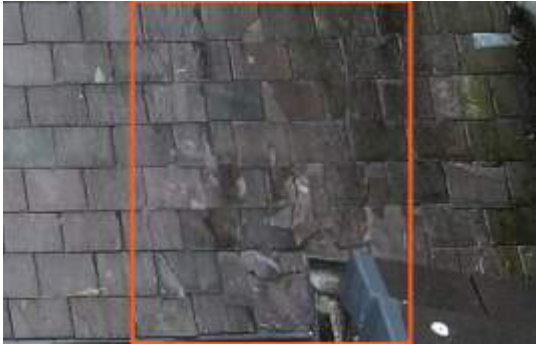
2675562 Severity: 4 Damaged Slate

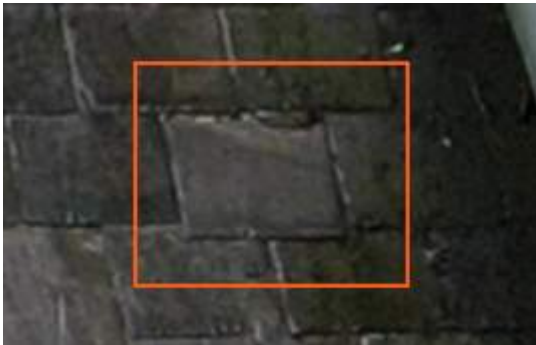
2675565 Severity: 3 Damaged Slate

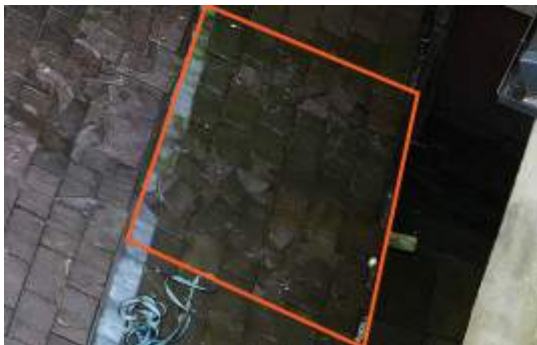
2675584 Severity: 3 Damaged Slate

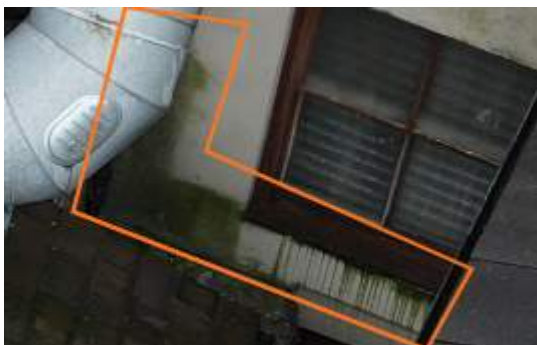
2675592 Severity: 2 Algae

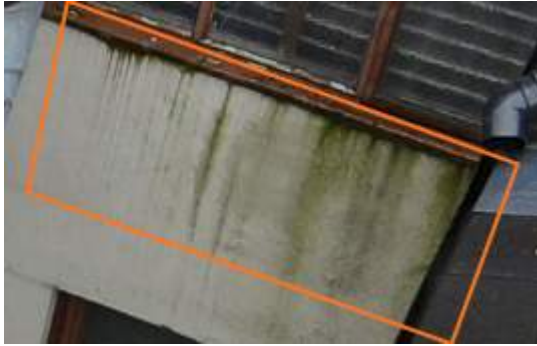
2675598 Severity: 2 Algae

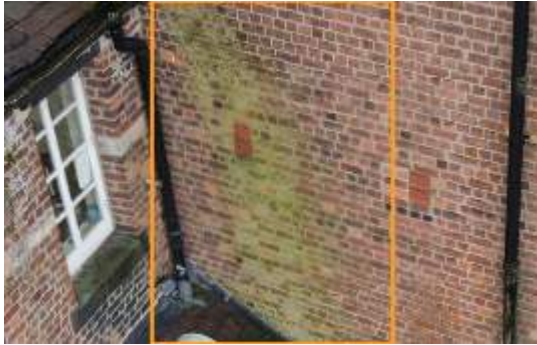
2675604 Severity: 1 Algae

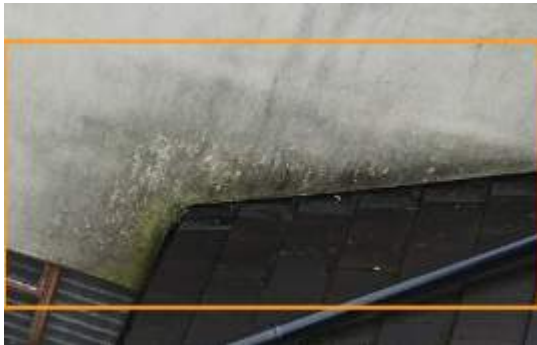
2675621 Severity: 1 Staining

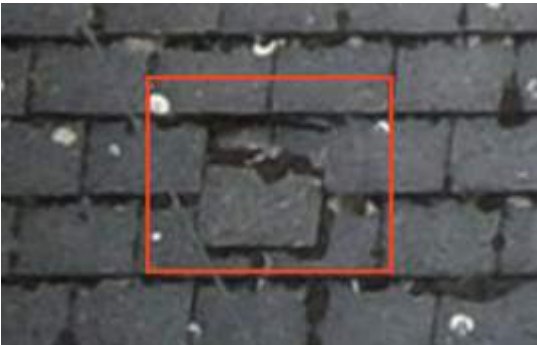
2675631 Severity: 4 Damaged Tile

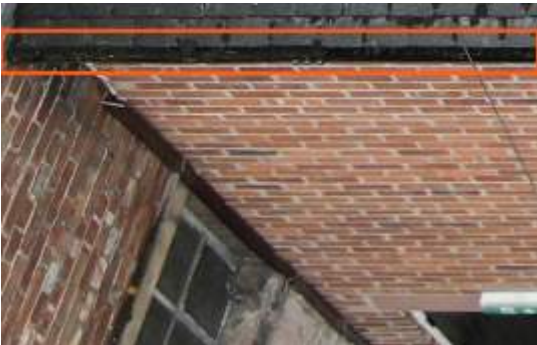
2675638 Severity: 3 Minor Debris in Gutter

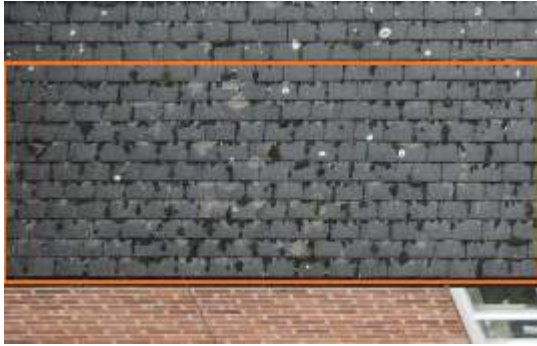
2675641 Severity: 2 Moss Growth

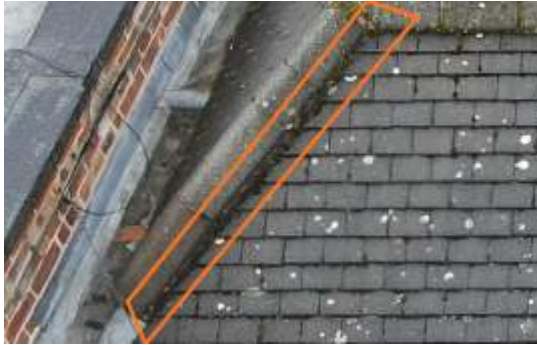
2675651 Severity: 2 Moss Growth

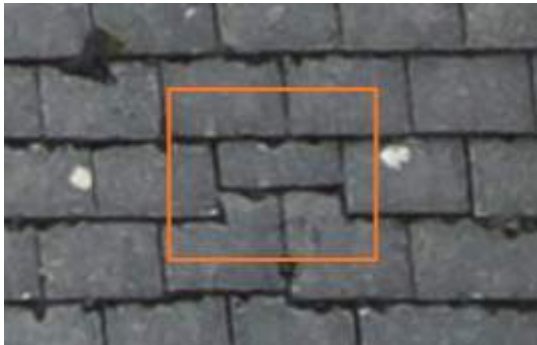
2675663 Severity: 2 Tile

Tile pushed up

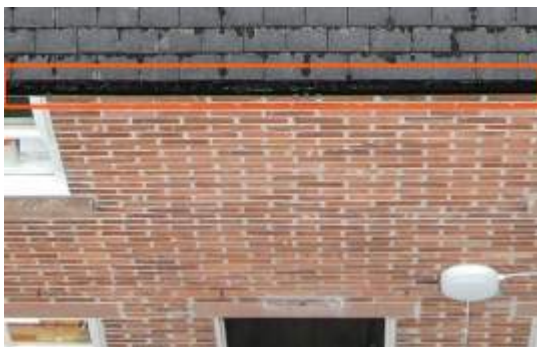
2675666 Severity: 3 Minor Debris in Gutter

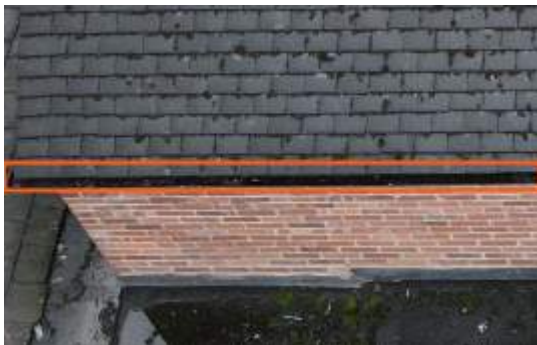
2675669 Severity: 3 Minor Debris in Gutter

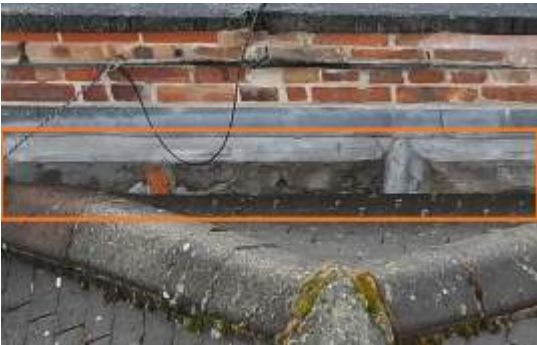
2675691 Severity: 2 Loose Object

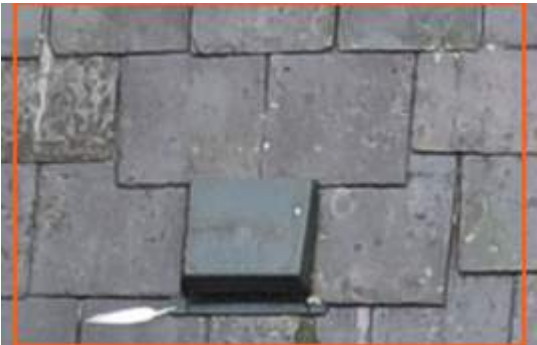
2675712 Severity: 3 Slipped Slate

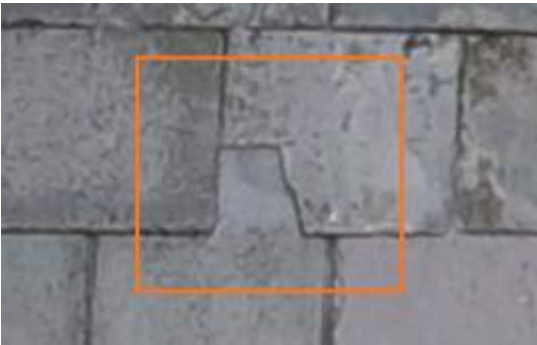
2675713 Severity: 2 Damaged Slate

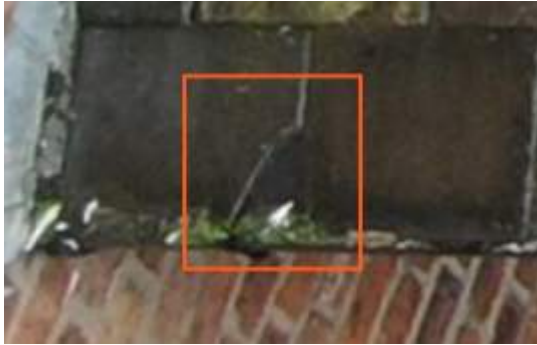
2675715 Severity: 3 Damaged Slate

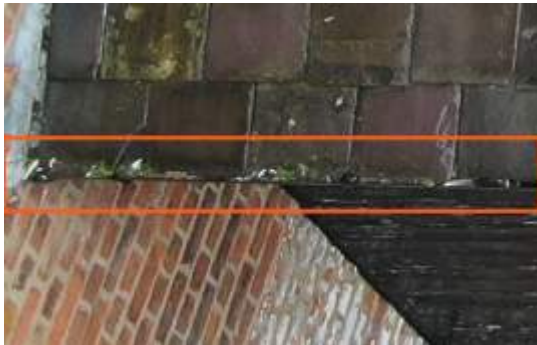
2675716 Severity: 3 Significant Debris in Gutter

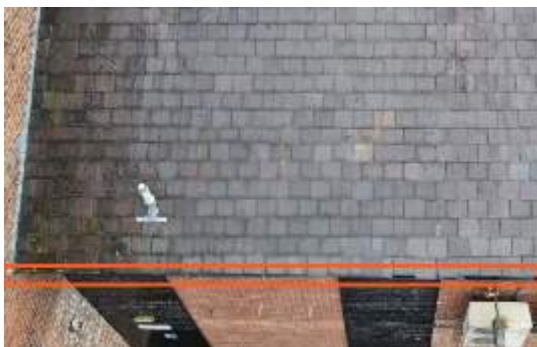
2675718 Severity: 3 Guttering

Gutter appears set back from edge of slate. Ensure water will be collected in gutter without overspill.

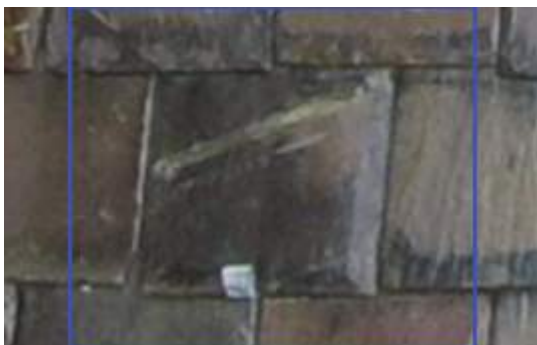
2675730 Severity: 0 Historic Repair

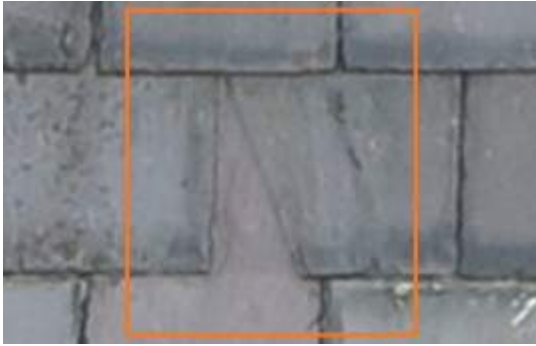
2675735 Severity: 2 Damaged Slate

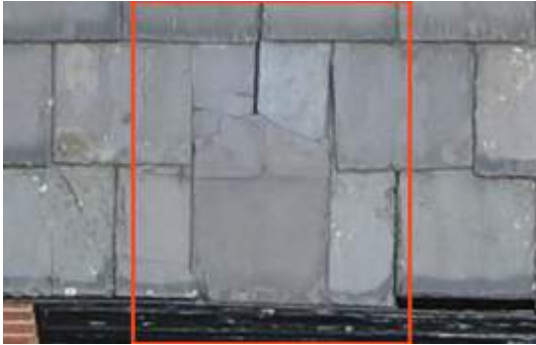
2675739 Severity: 4 Damaged Slate

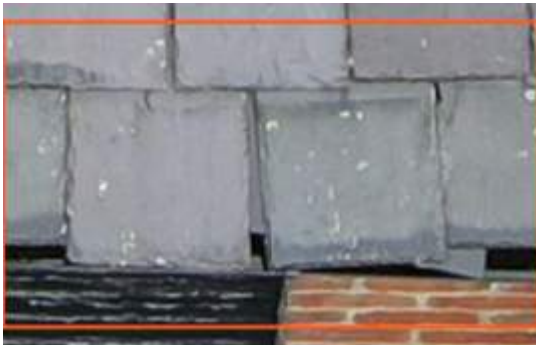
2675744 Severity: 3 Slipped Slate

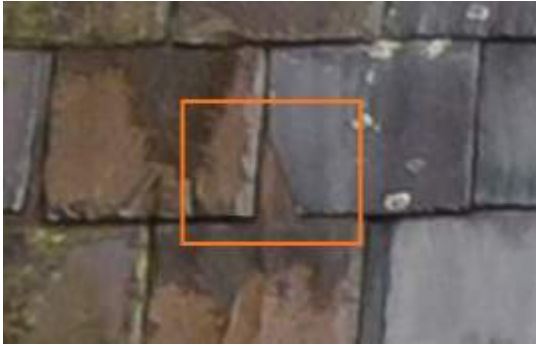
2675762 Severity: 2 Damaged Slate

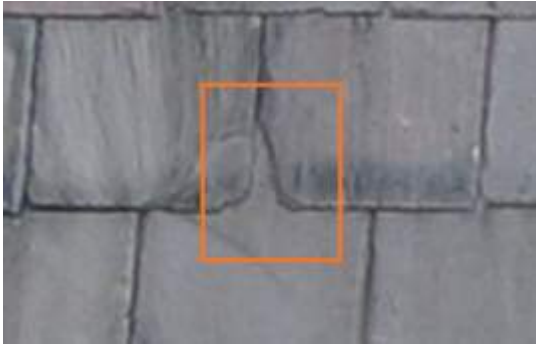
2675764 Severity: 2 Damaged Slate

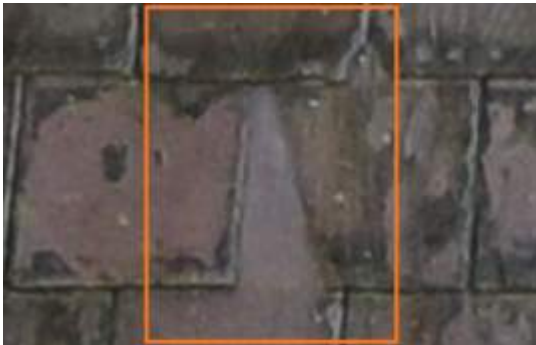
2675768 Severity: 2 Damaged Slate

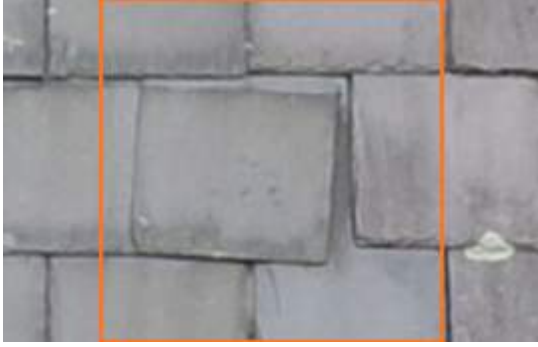
2675783 Severity: 2 Misaligned Slate

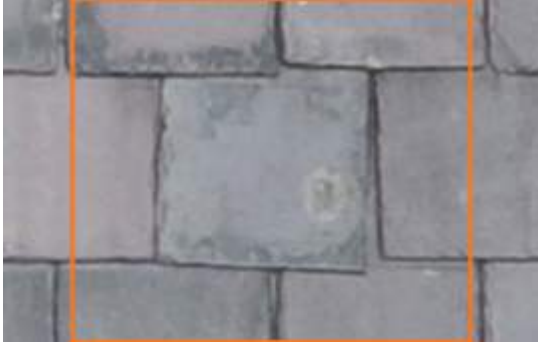
2675786 Severity: 2 Misaligned Slate

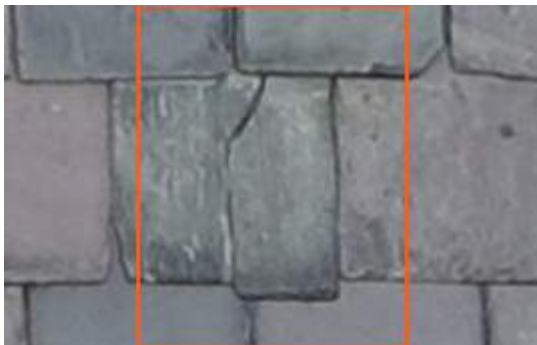
2675794 Severity: 3 Damaged Slate

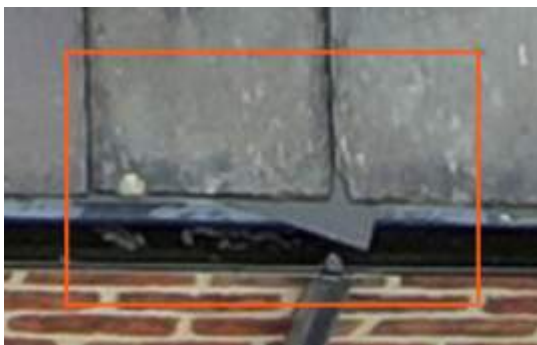
2675798 Severity: 3 Slipped Slate

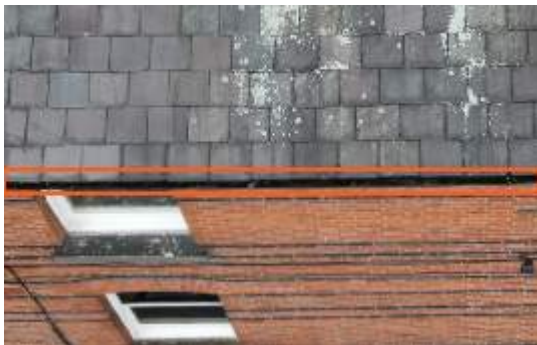
2675812 Severity: 3 Significant Debris in Gutter

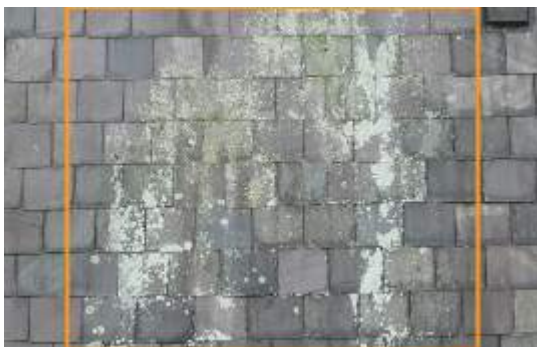
2675817 Severity: 1 Lichen Build Up

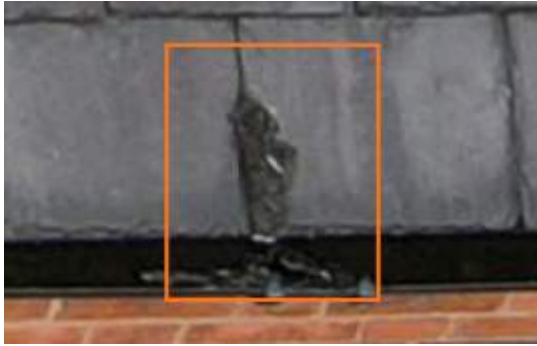
2675820 Severity: 2 Debris

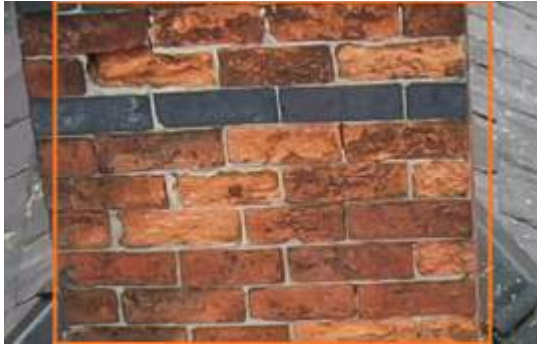
2675824 Severity: 2 Spalled Brick

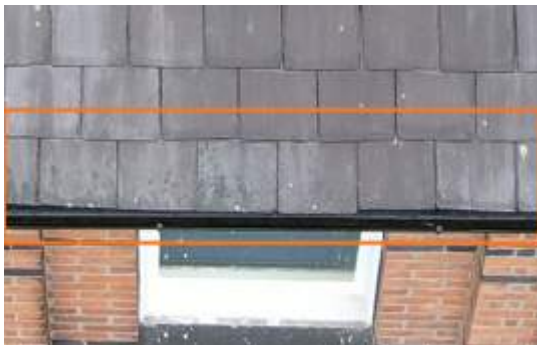
2675836 Severity: 2 Misaligned Slate

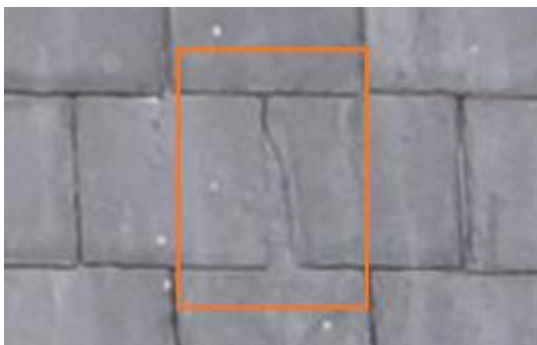
2675837 Severity: 2 Damaged Slate

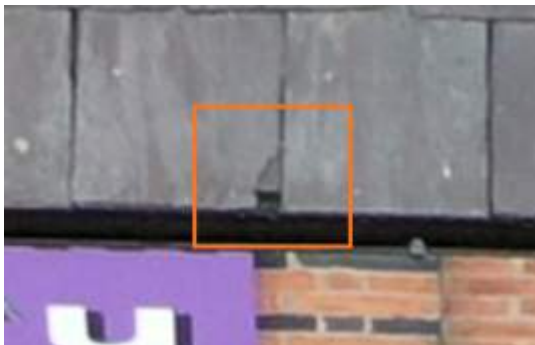
2675841 Severity: 2 Damaged Slate

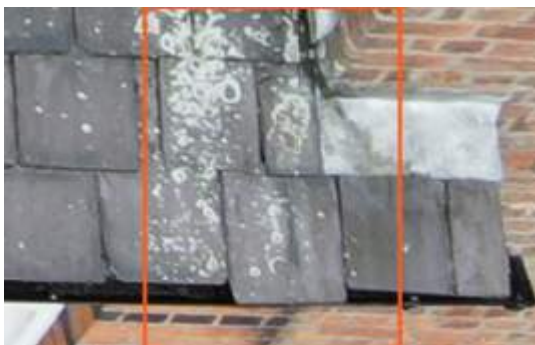
2675844 Severity: 3 Slipped Slate

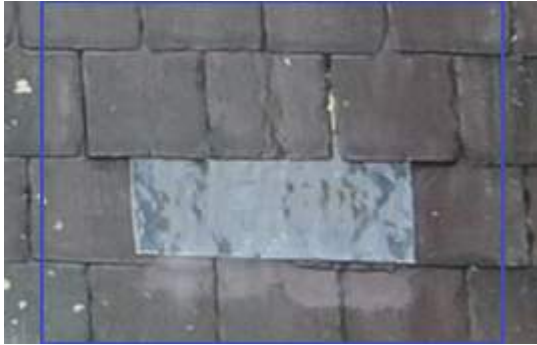
2675848 Severity: 0 Historic Repair

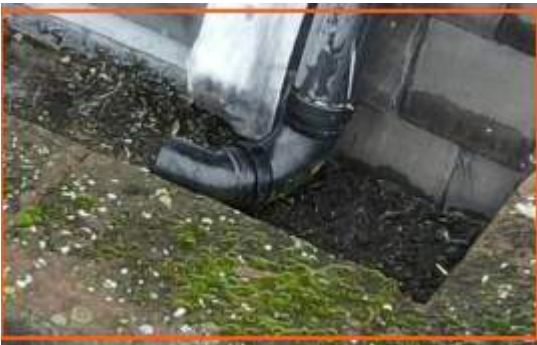
2675853 Severity: 3 Significant Debris in Gutter

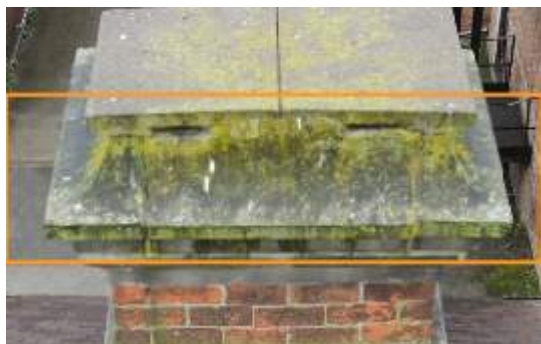
2675856 Severity: 1 Algae

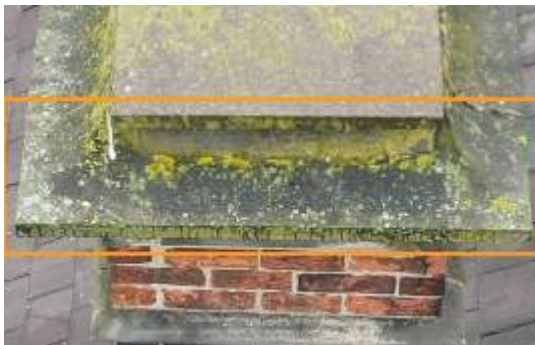
2675868 Severity: 1 Lichen Build Up

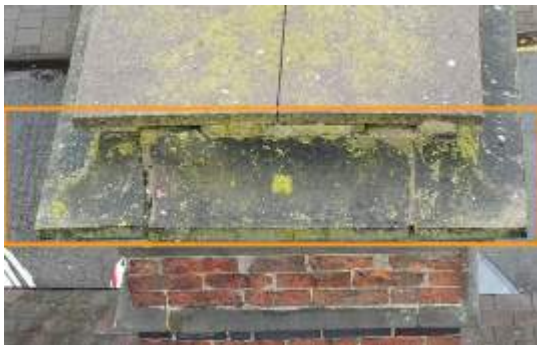
2675874 Severity: 1 Lichen Build Up

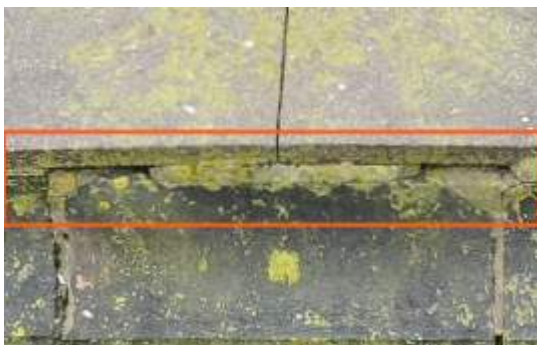
2675875 Severity: 3 Missing Mortar

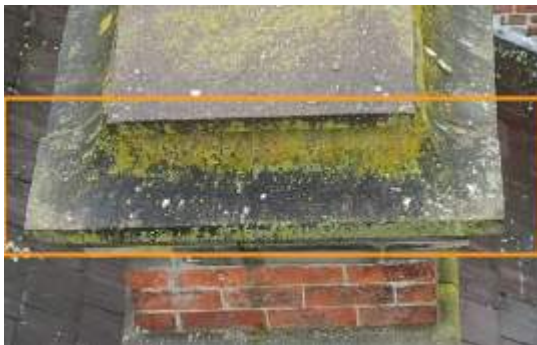
2675885 Severity: 1 Lichen Build Up

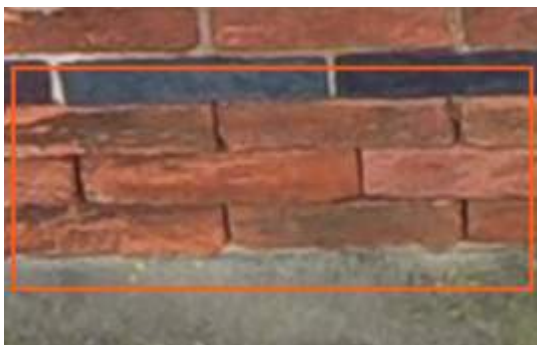
2675886 Severity: 3 Missing Mortar

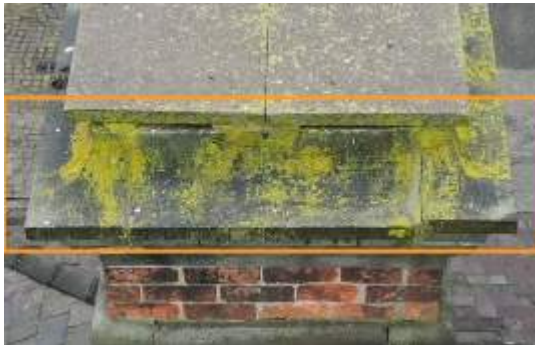
2675889 Severity: 1 Lichen Build Up

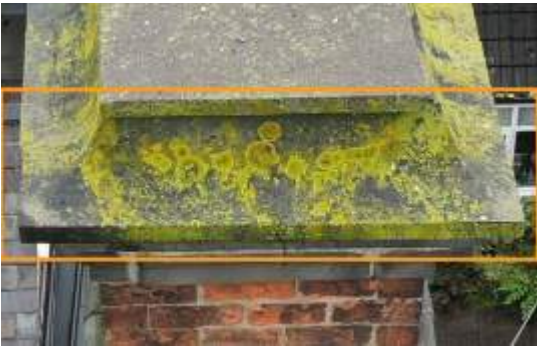
2675894 Severity: 1 Lichen Build Up

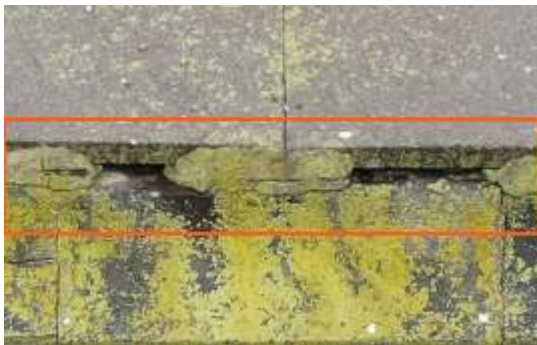
2675895 Severity: 3 Missing Mortar

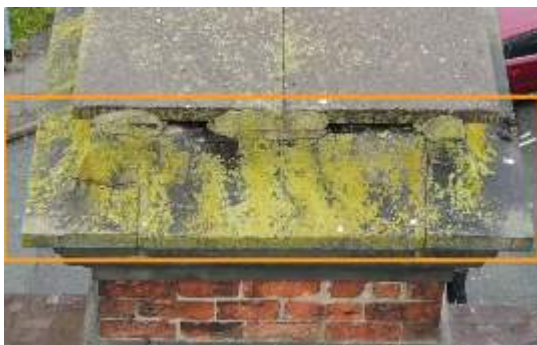
2675896 Severity: 1 Lichen Build Up

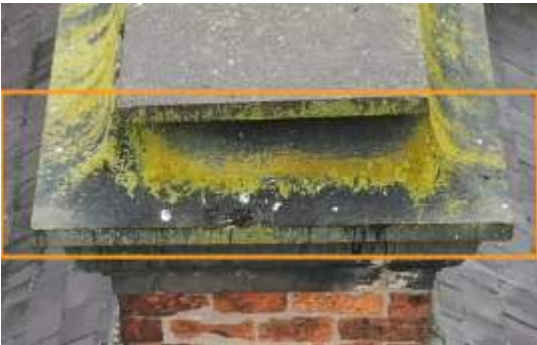
2675898 Severity: 1 Lichen Build Up

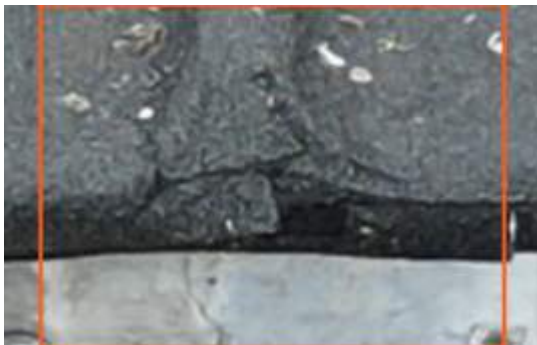
2675900 Severity: 3 Felt Defect

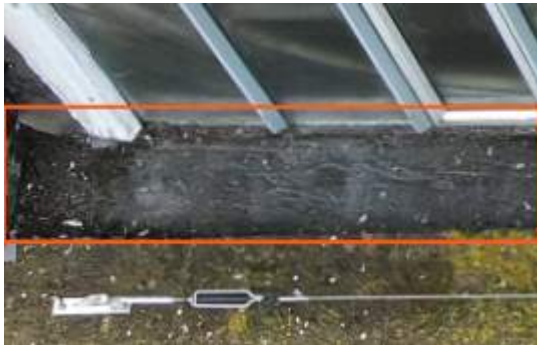
2675906 Severity: 3 Minor Debris in Gutter

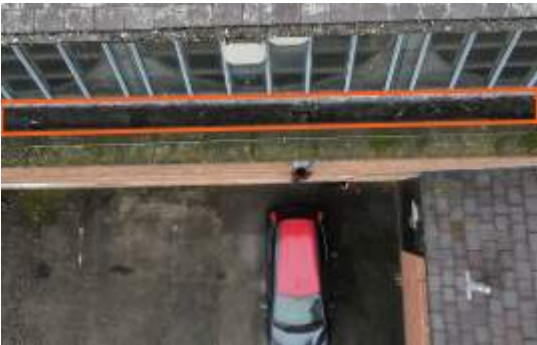
2675908 Severity: 3 Minor Debris in Gutter

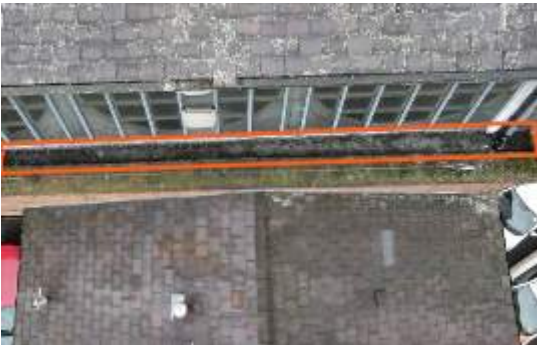
2675909 Severity: 3 Minor Debris in Gutter

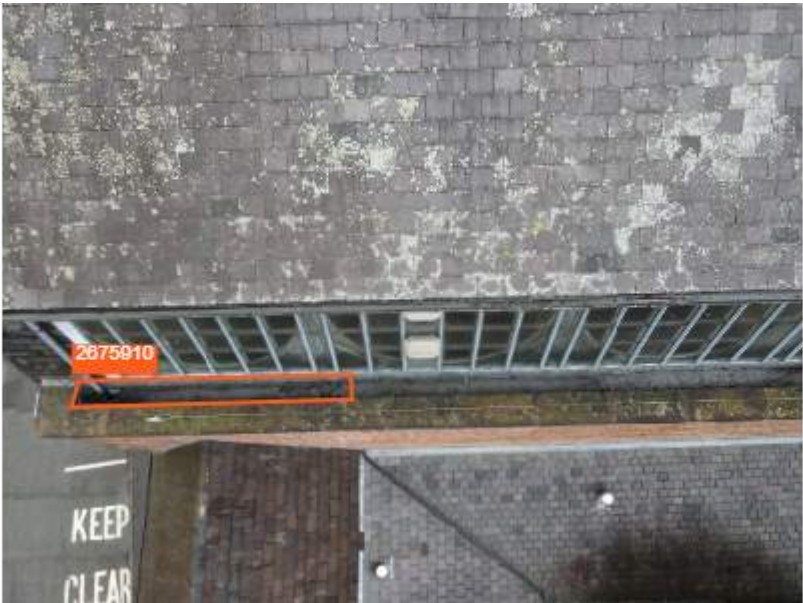
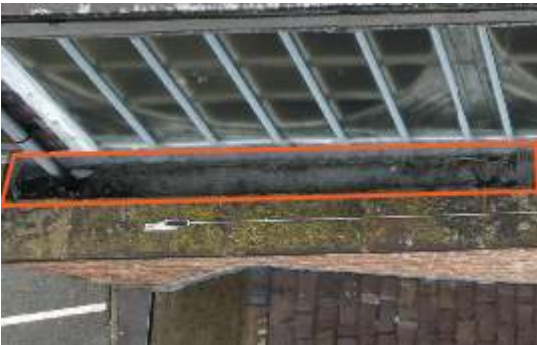
2675910 Severity: 3 Minor Debris in Gutter

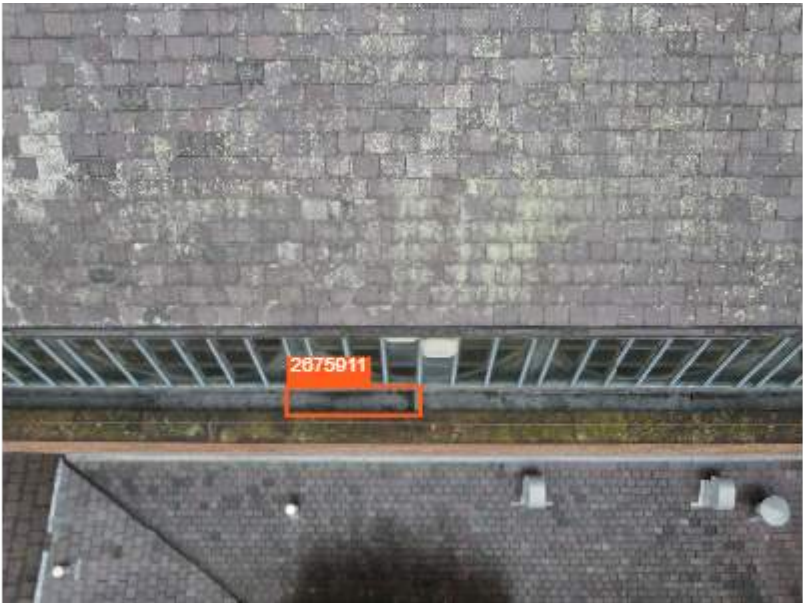
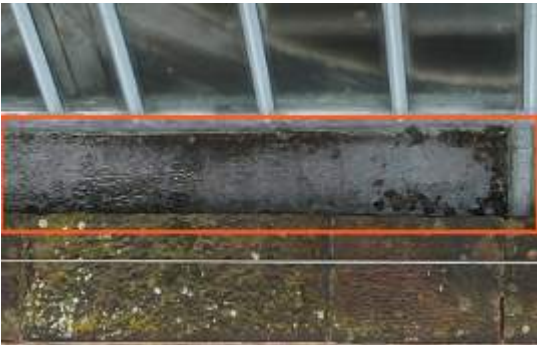
2675911 Severity: 3 Minor Debris in Gutter

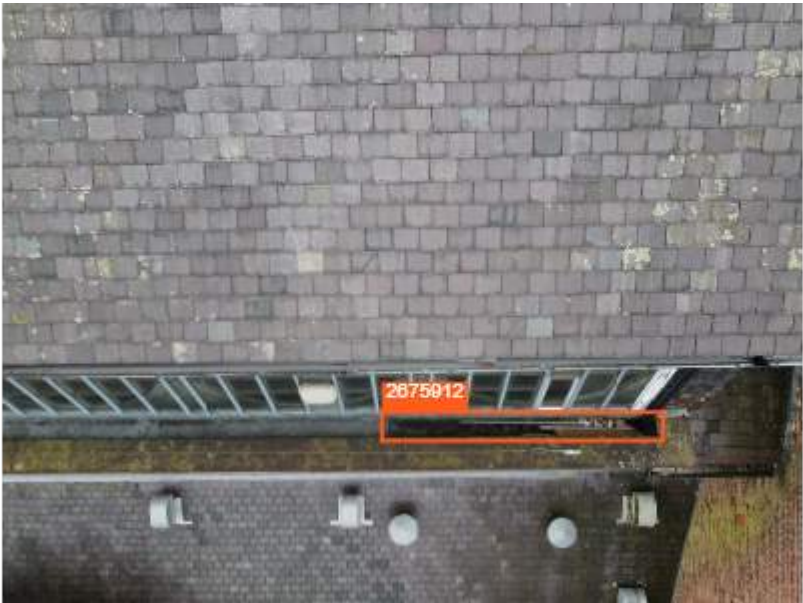
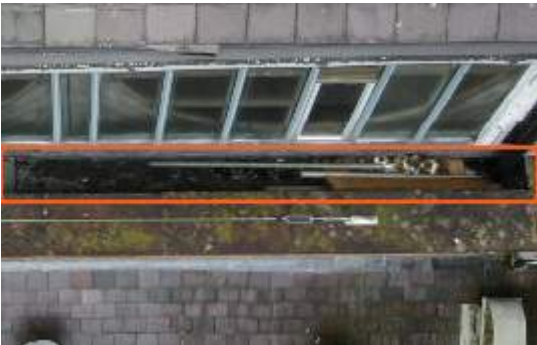
2675912 Severity: 3 Significant Debris in Gutter

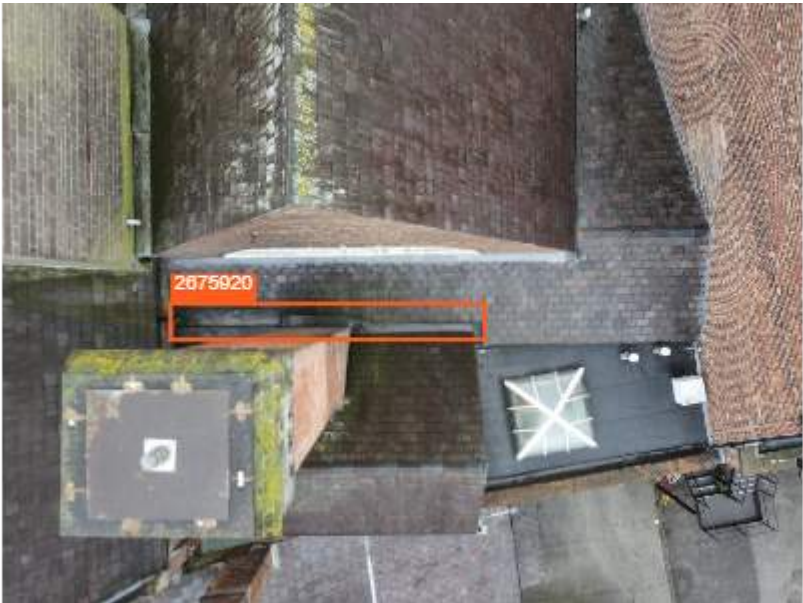
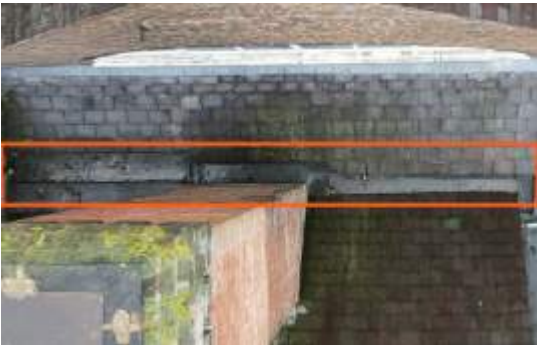
2675920 Severity: 3 Minor Debris in Gutter
